Our Ref: Chilt/IF12076

Re: Indicative Fire Resistance Test to the temperature and pressure conditions of BS 476: Part 20: 1987 (and current FTSG Resolutions where applicable) (Chilt/IF12076)

The specimen comprised a single acting steel leaf access hatch within a 120 minute specification ceiling membrane.

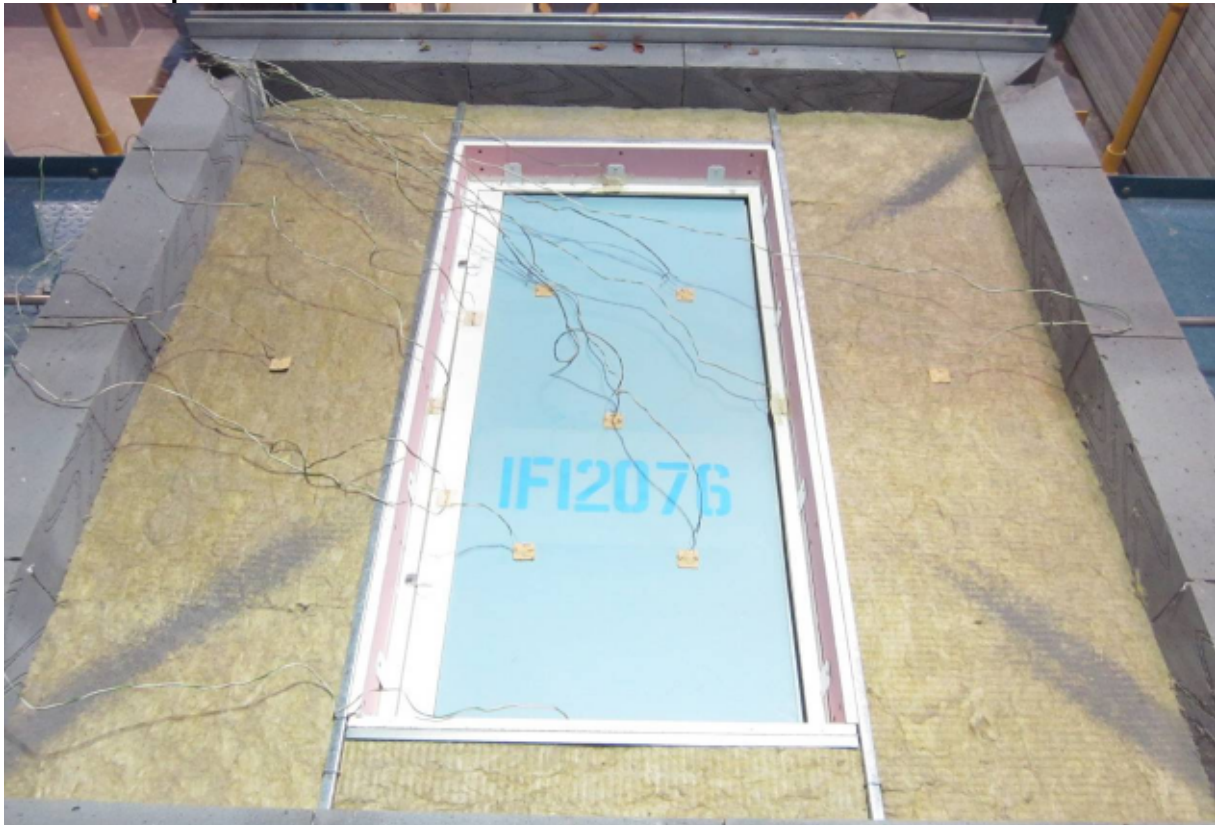
Unexposed face at start of test

Time (minutes)	Comments
00.00	Test started.
02.00	There is smoke issuing from the perimeter of the leaf.
04.00	There is distortion at the middle of the leaf.

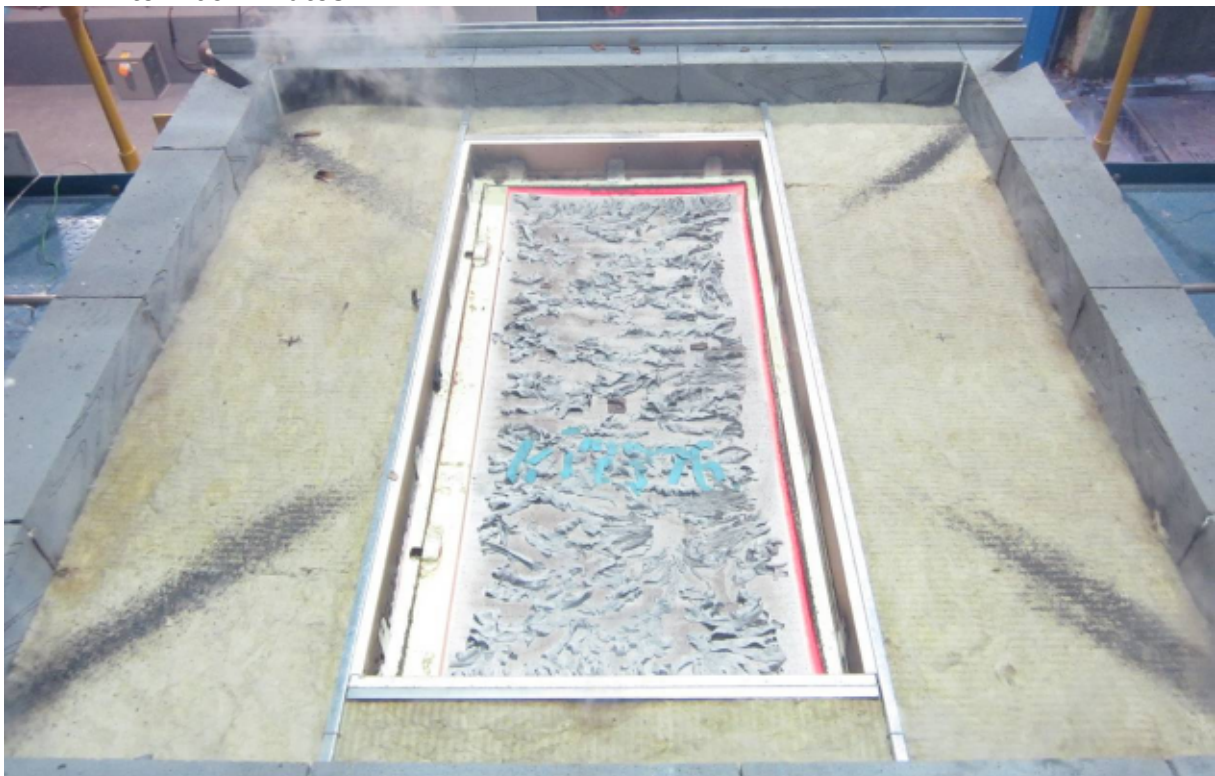
After 105 minutes

- 82.00 There is a glow visible at the middle of the closing edge between the box section and frame where the box section is deflecting down.
- 85.00 There is a glow visible at the box section around both latch positions.

- 87.00 There is a glow visible behind the frame at the hanging edge.
- 91.00 The box section has deflected further resulting in a glow visible.
- 99.00 There is still a glow visible behind the hanging edge of the frame which is now the entire length of the aperture.

- 106.00 There is a glow visible behind the frame at the closing edge of the leaf.
- 118.00 Exposed face, the three layers of plasterboard alongside the closing edge have fallen away.

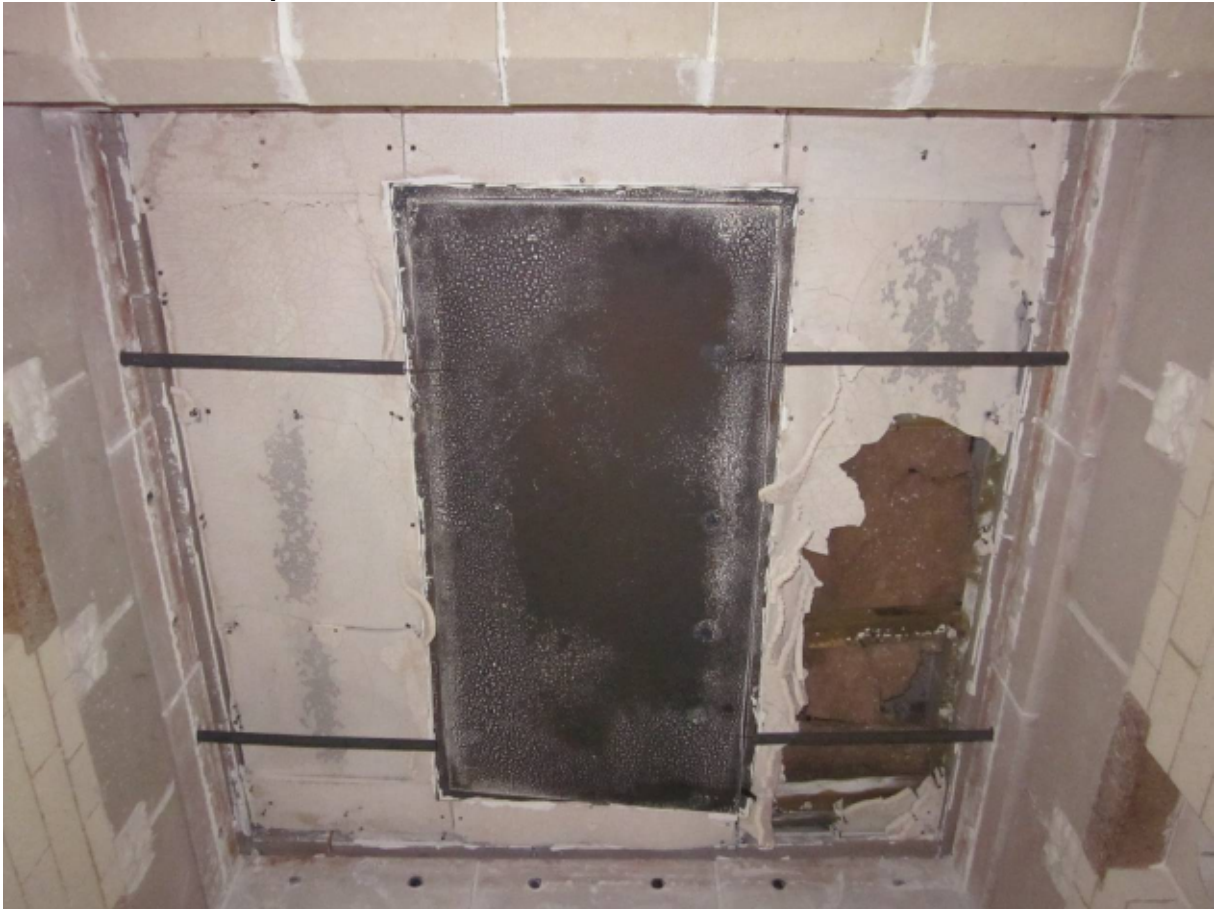
Post test - exposed face

- 118.00 Exposed face, the three layers of plasterboard alongside the closing edge have fallen away.
- 118.25 There is flaming for in excess of 10 seconds on the right (closing edge) side of the ceiling around the edge of the mineral wool insulation where the plasterboard has fallen away.
- 120.00 Test terminated.
