**Fire resistance test in accordance with B.S. 476 : Part 22 : 1987 on a plasterboard ceiling membrane incorporating a Fire Proofing Services Ltd. single-leaf access panel.**

Prepared for:  
Fire Proofing Services Ltd.,  
Evolution House,  
Aston Road,  
Nuneaton.  
CV11 5EL

24<sup>th</sup> February 2011

Test report number 265024

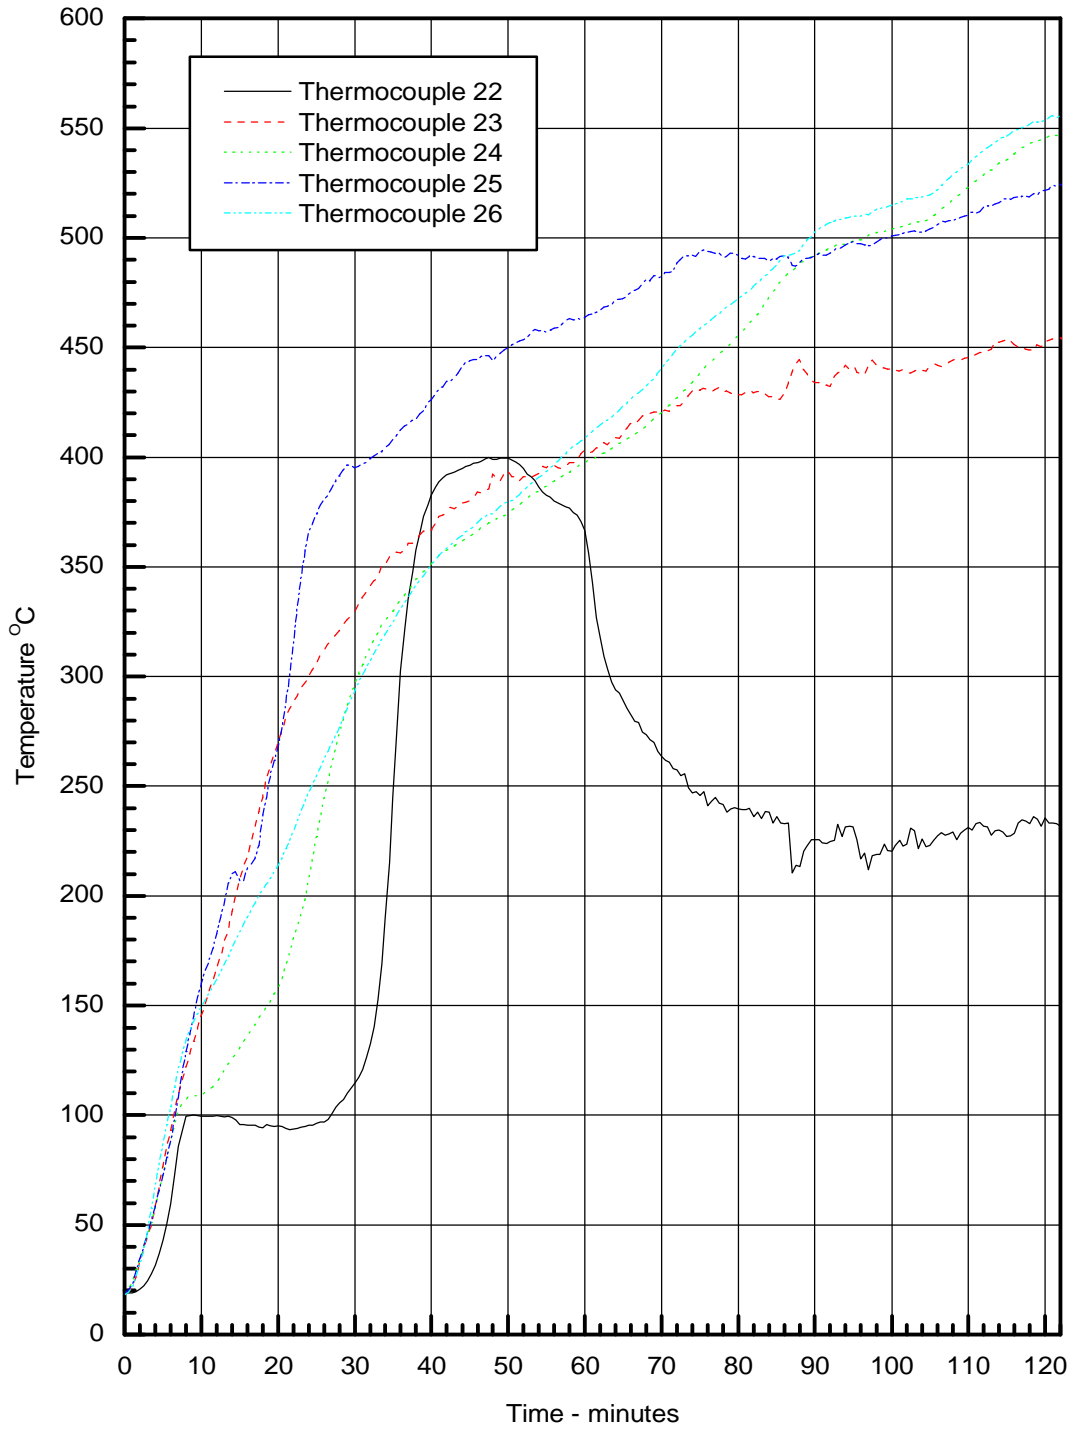
The maximum temperature rise limit for insulation (180°C rise) was first exceeded by thermocouple number 25 after 13 minutes.

Temperatures recorded on the unexposed face by thermocouples 22 to 26.

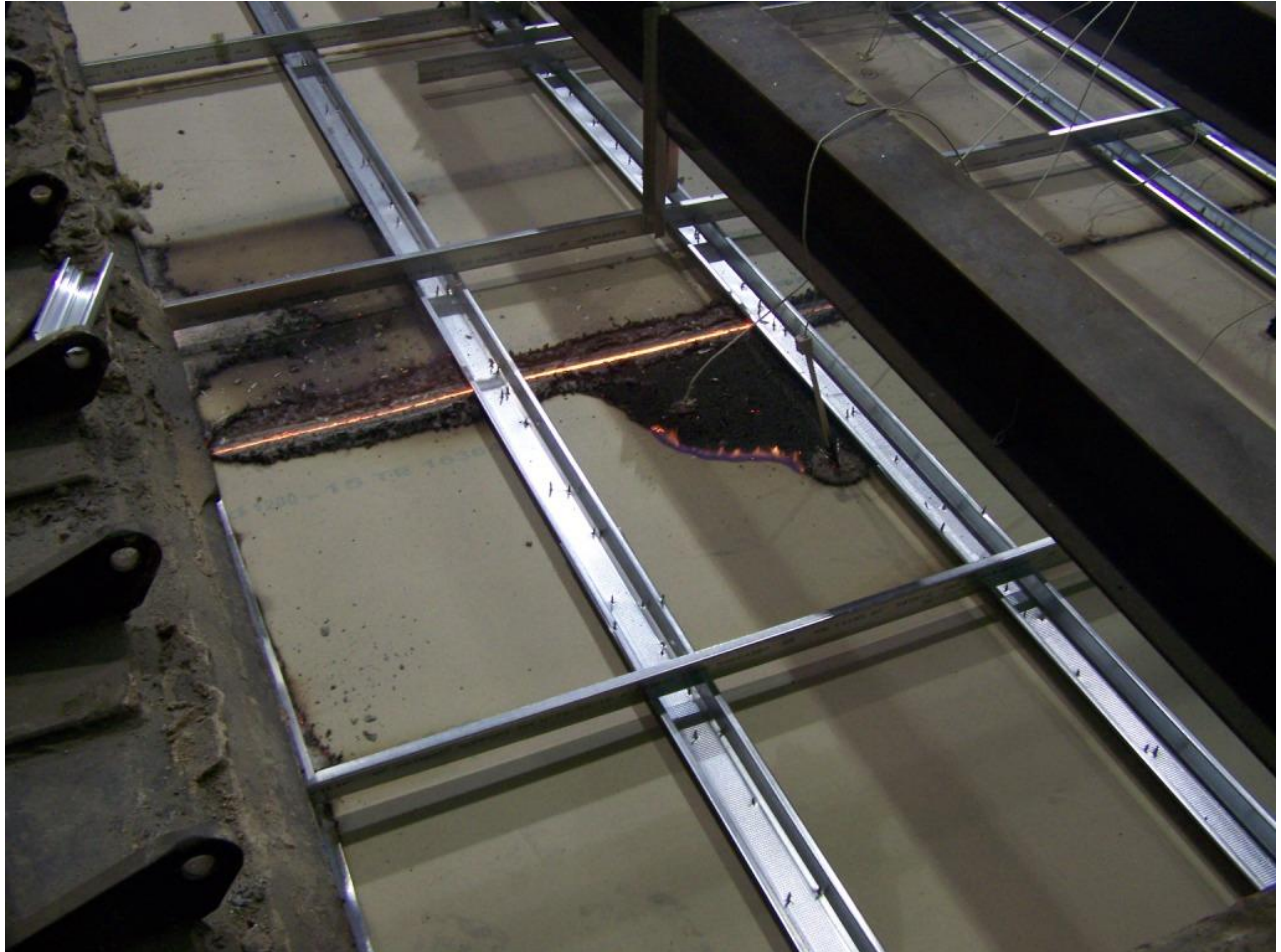
| Time minutes | Observation |
|---|--|
| 106 | <b>Failure of integrity</b> using the cotton pad over a joint in the third layer of plasterboard where the second layer has fallen from the exposed face. This location is remote from the access panel. |

**Location of first integrity failure.**

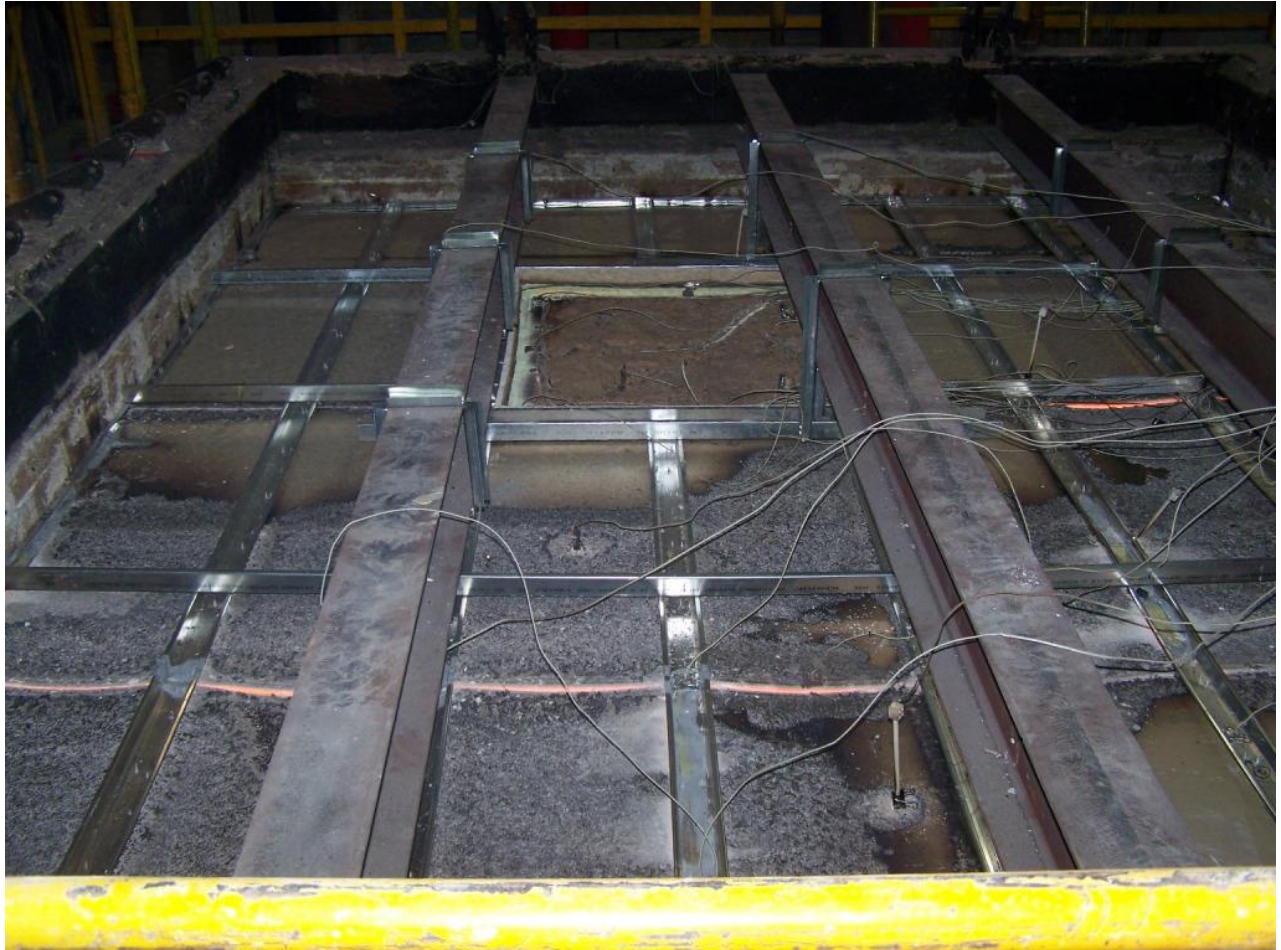
| Time minutes | Observation |
|---|--|
| 111 | Several areas of the ceiling are now glowing as the paper facing on the plasterboard chars. Failure of integrity using the 6mm gap gauge at some of the plasterboard joints. |

**Unexposed face at end of test.**

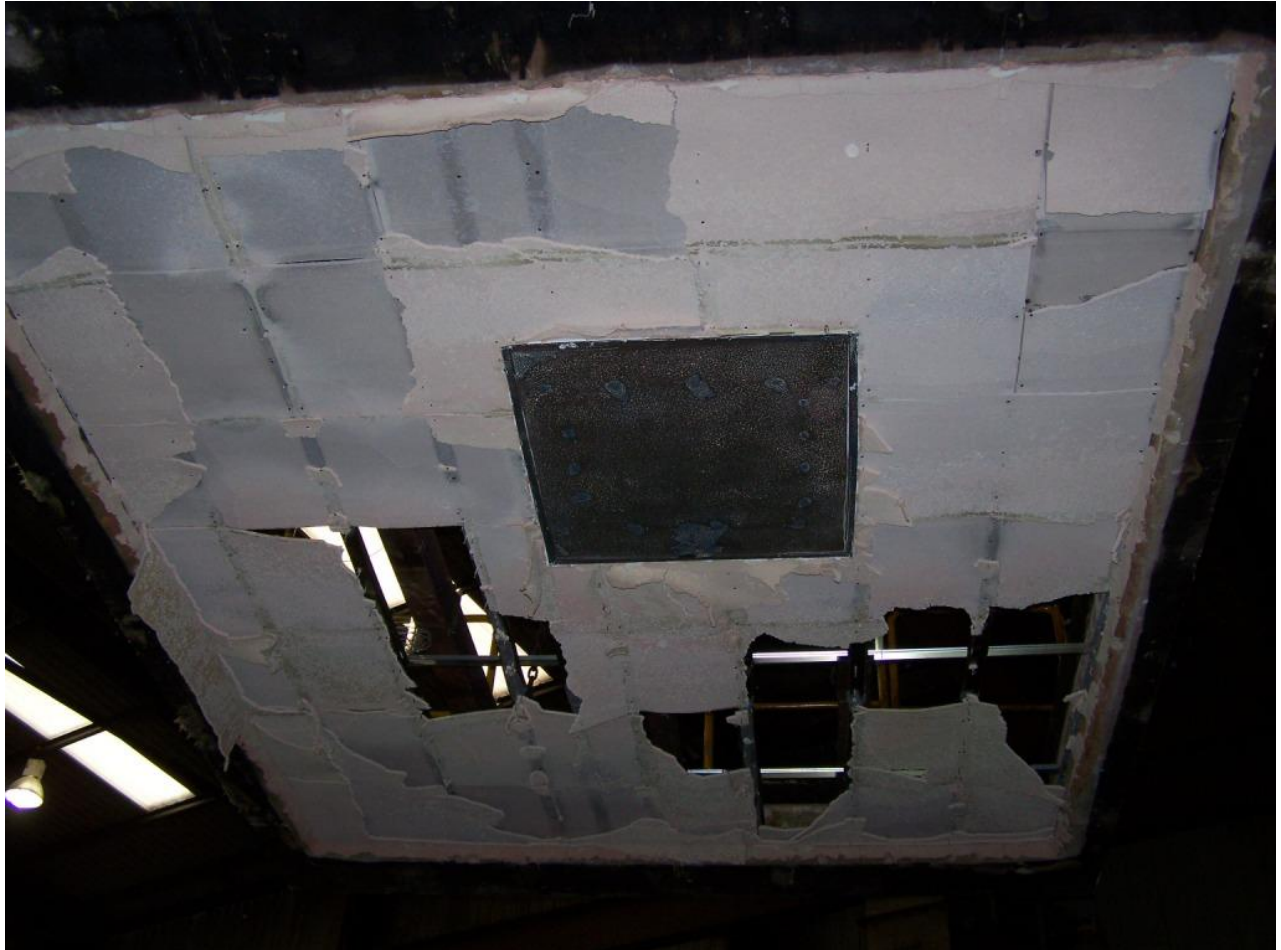
| Time minutes | Observation |
|---|--|
| 88 | Approximately 25% of the exposed face layer of plasterboard has fallen from the ceiling. All plasterboard around the access panel is still intact on the exposed face. |
| 103 | Large pieces of the second layer of plasterboard remote from the access panel are falling from the ceiling. The access panel is still intact, and is glowing red hot at the corners of the leaf. One of the hinged edge corners of the leaf was observed to have dropped by approximately 5mm. |

**Exposed face after test.**
