C A M B R I D G E
FIRE RESEARCH

REPORT NUMBER
CFR1511131

FIRE RESISTANCE TEST
IN ACCORDANCE WITH UL10B (Tenth Edition)

Doorset A insulated inward opening
 UL53-120-PD-BF-L12A
 Leaf size: 1998 high x 595 wide x 45 thick.
 Doorset B insulated outward opening
 UL53-120-PD-BF-L12A
 Leaf size: 1998 high x 595 wide x 45 thick.
 Doorset C uninsulated inward opening
 UL51-120-MD-PF-L12A
 Leaf size: 1995 high x 595 wide x 45 thick.
 Doorset D uninsulated outward opening
 UL51-120-MD-PF-L12A
 Leaf size: 1995 high x 595 wide x 45 thick.

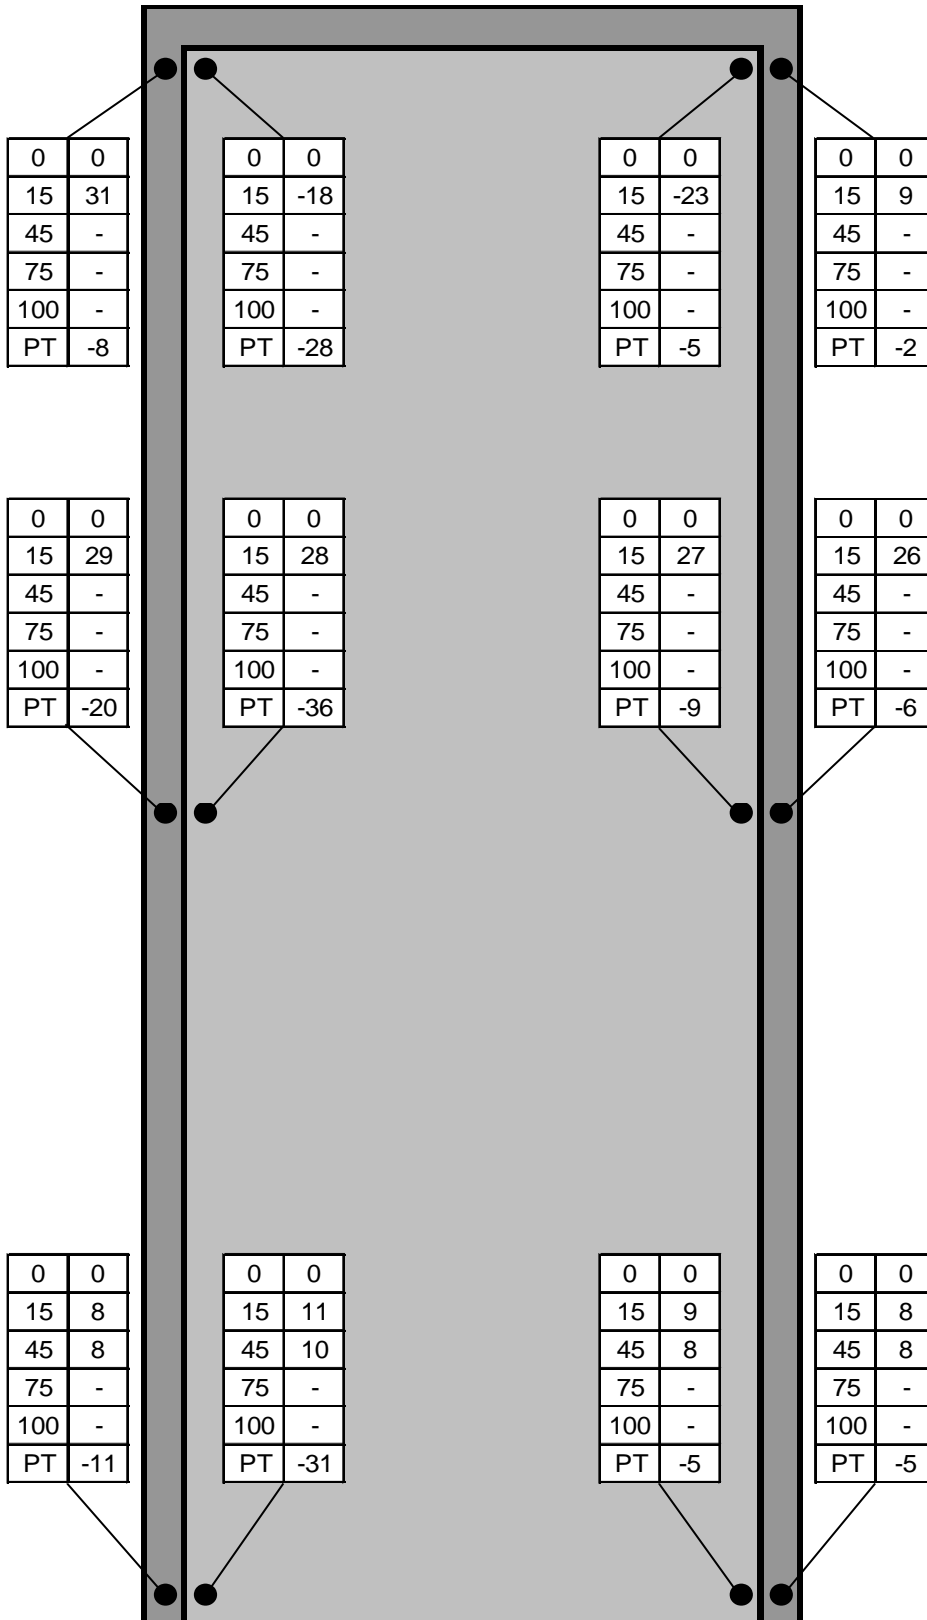
Doorset C

Deflections could not be measured during some of the test due to Health and Safety concerns.

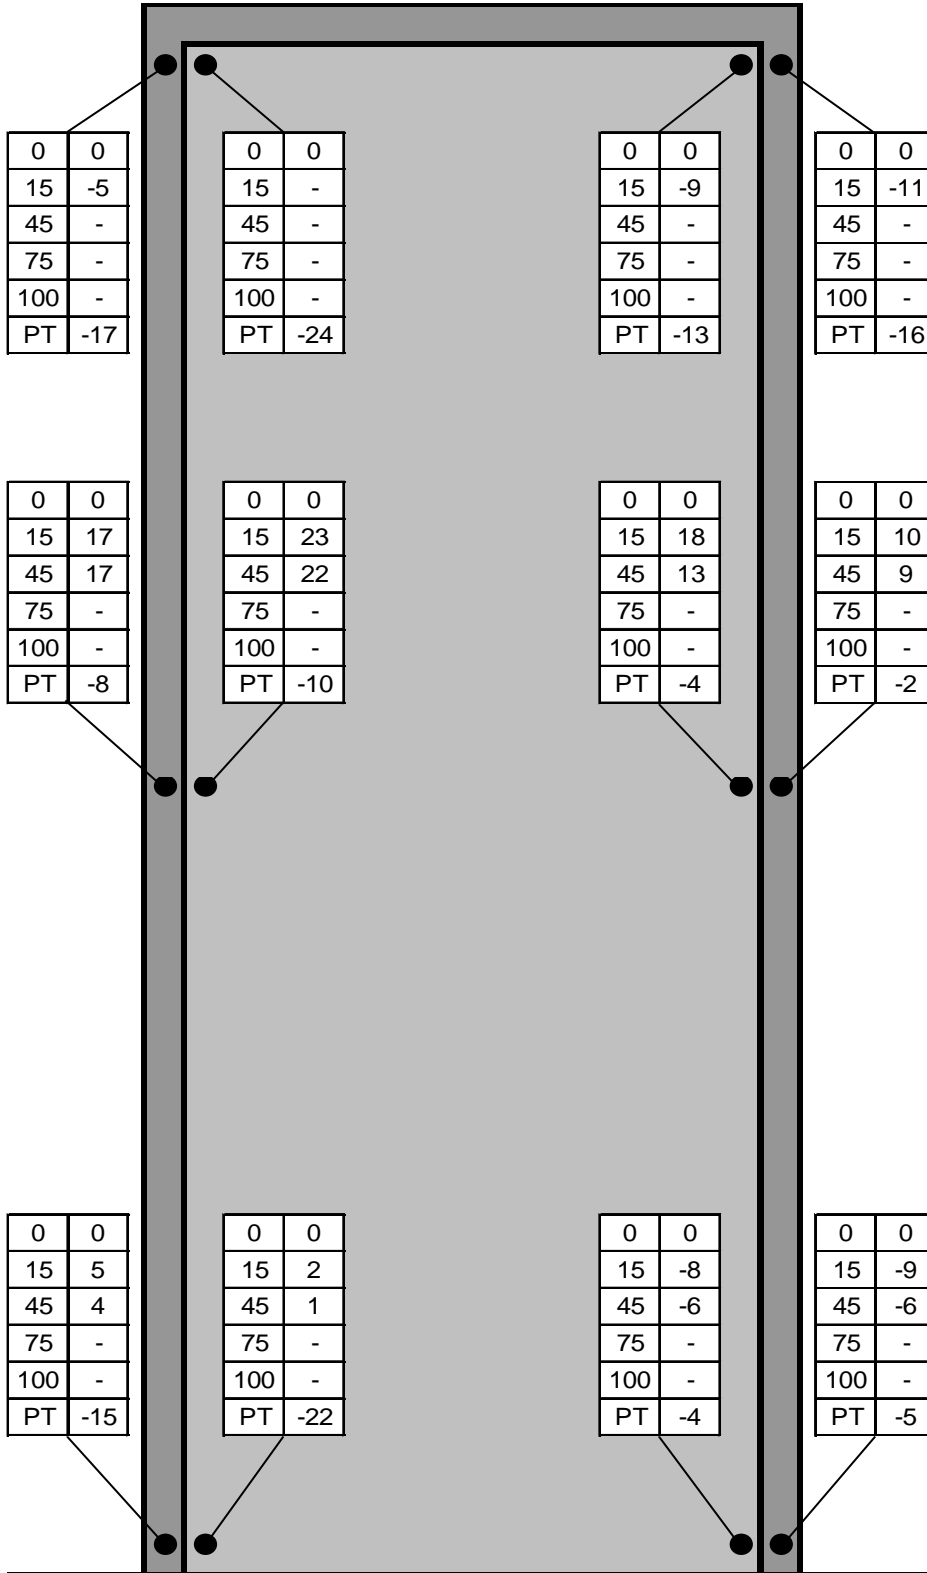
Doorset D

Deflections could not be measured during some of the test due to Health and Safety concerns.

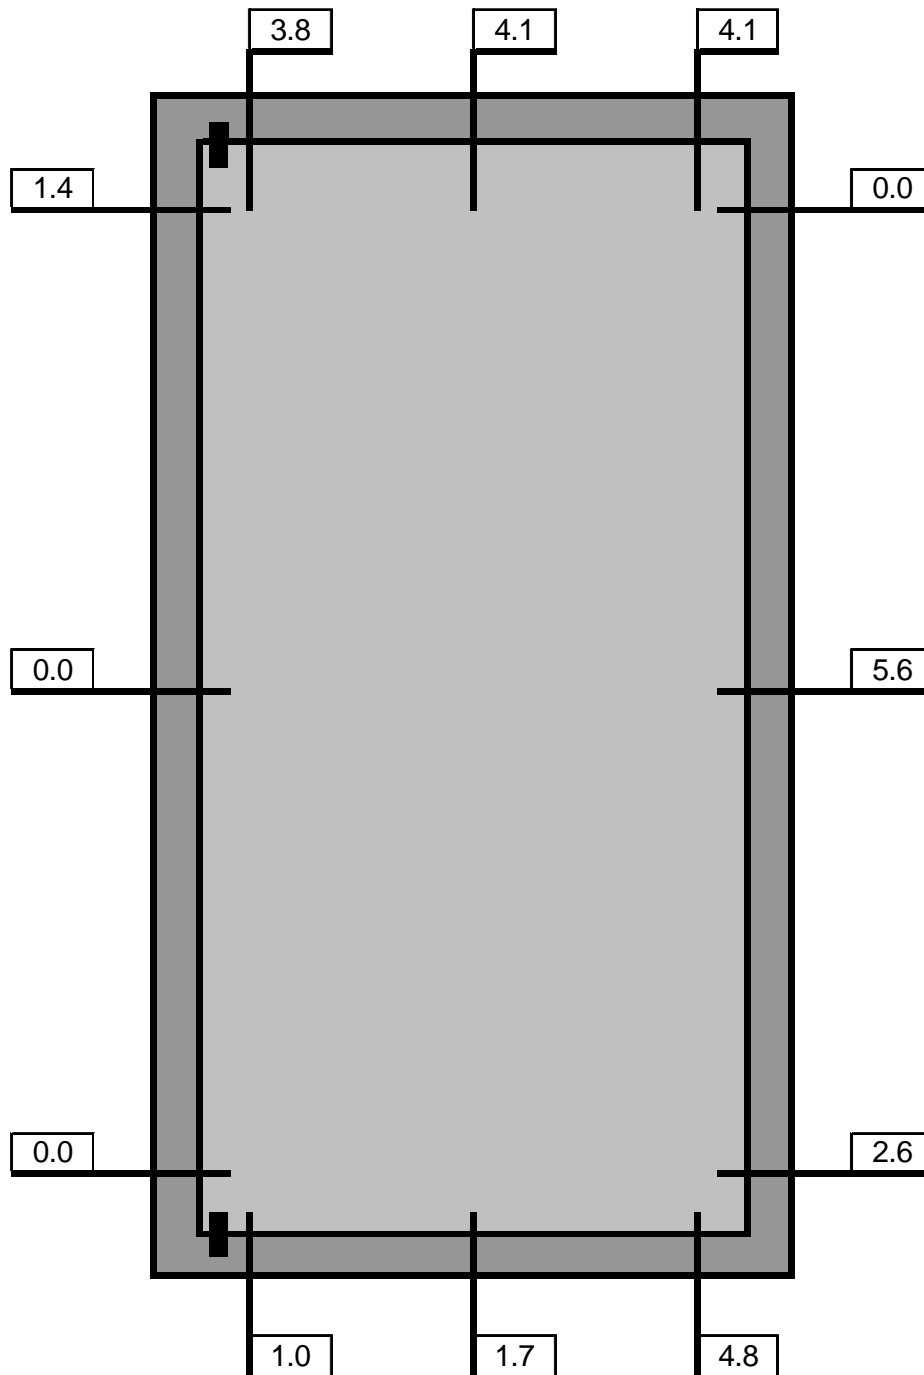
Doorset B Through holes were observed in the doorset at the top and bottom of the hanging stile but they did not develop during the Fire Endurance test so the doorset did meet the conditions of acceptance during the Fire Endurance Test. The holes continued to be present during the Hose Stream Test but did not develop so this doorset did pass the conditions of acceptance for the Hose Stream Test.

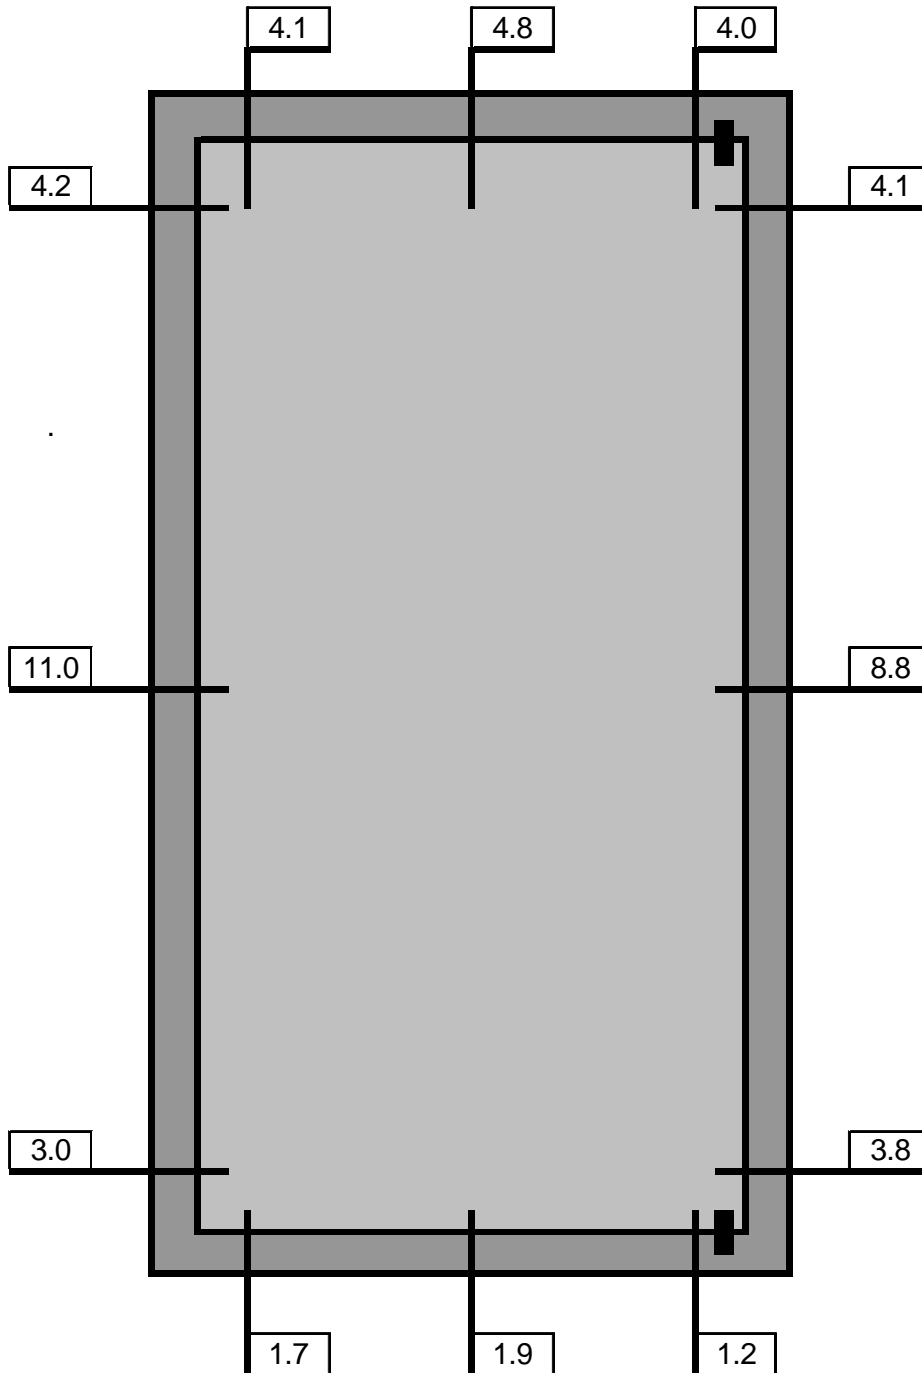
Doorset C flamed at the head after 10 minutes of the Fire Endurance Test so it did not meet the flaming condition of acceptance of this test but it did meet the conditions of acceptance during the Hose Stream Test.
