TE 200479

TEST REPORT

Fire resistance test in accordance with B.S. 476: Part 22: 1987 on a plasterboard ceiling membrane with a Fire Proofing Services Ltd. access panel fitted.

Fire Proofing Services Ltd., 13 Shilton Road, Barwell, Leicestershire, LE9 8NB.

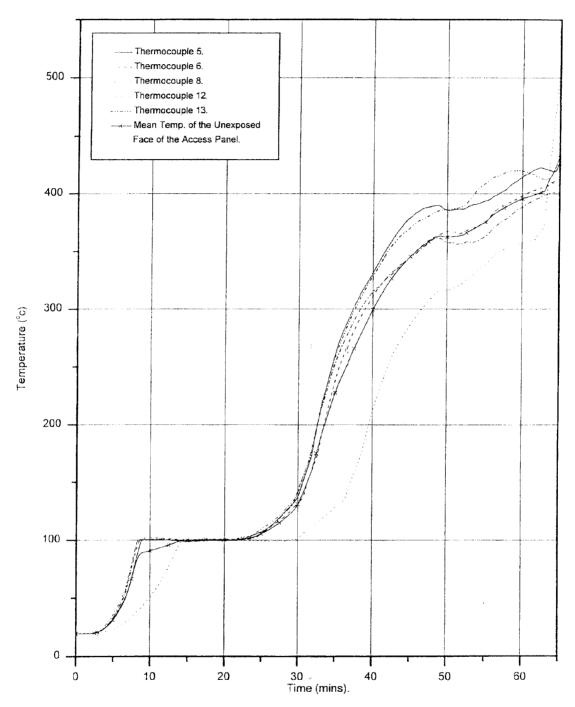
The temperatures recorded on the unexposed face of the specimen along with the mean temperature of the unexposed face of the construction (calculated from thermocouples 1,2,10,18, and 19) and the mean temperature of the unexposed face of the access panel (calculated from thermocouples 5,6,8,12 and 13) are plotted against time in Figures 6 to 10. The maximum temperature measured was 559°C recorded by thermocouple 7 at the end of the test.

Figure 7 Temperatures recorded from the thermocouples on the access panel

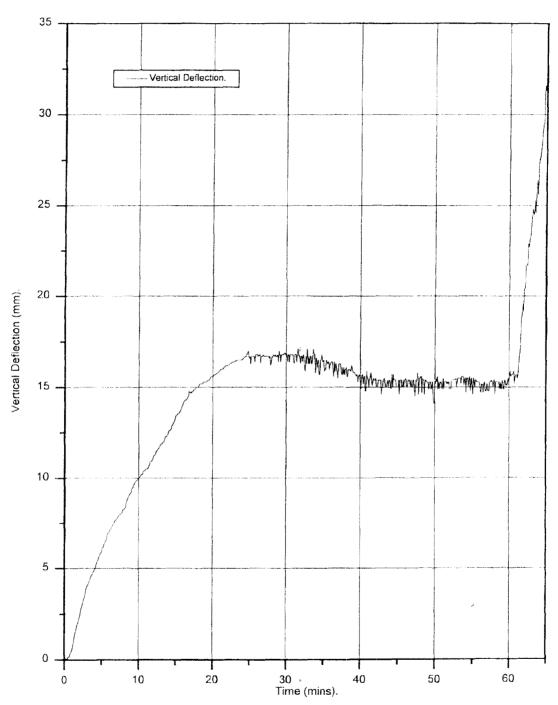
The deflection recorded by the transducer is plotted against time in Figure 11. A maximum of 34.5mm was recorded at the end of the test. The position of maximum deflection was at the point of measurement, and was towards the furnace.

Figure 7 Vertical deflection

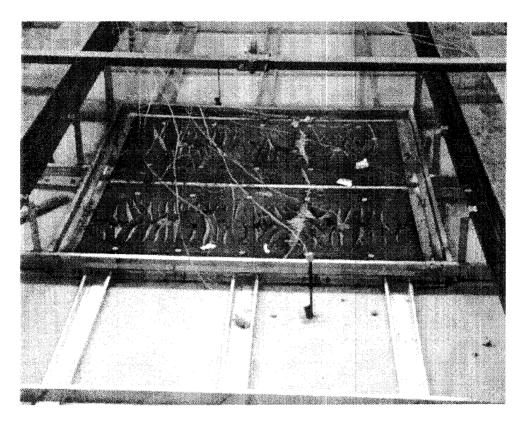
19:00	Failure of insulation due to the temperature of thermocouple 7.
24:00	A slight crack has developed in the backing plasterboard of one of the door leaves running across the whole width of the door leaf.

32:00	A similar crack as at 24min has appeared in the second door leaf. Both of the cracks meet at the meeting stile between the two door leaves.
37:00	Each door leaf is heavily discoloured centrally, down the whole length, in the form of a strip approximately 150-200mm wide.

39:00	The two cracks in the door leaves now have lots of smaller cracks emanating from them at right angles and are also heavily charred. The cracks are approximately 4-5mm wide and both of the door leaves are now completely discoloured. (see Plate 5)

Plate 5 - Cracking of plasterboard backing of door leaves

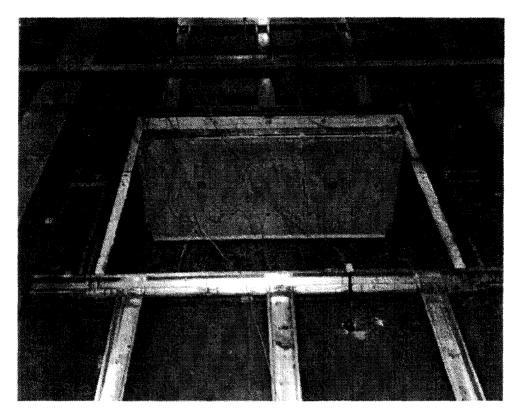
46:00	The joins in the plasterboard partition are starting to discolour.
56:00	The hinged edge of each door leaf is heavily charred and cracked.
61:00	All of the joins in the plasterboard are now blackened and the paper backing sheet on the back of the plasterboard is starting to char in places.

65:00	Failure of integrity due to the fact that the doors fell open.
	Test stopped.

Plate 6 Unexposed face of construction after test

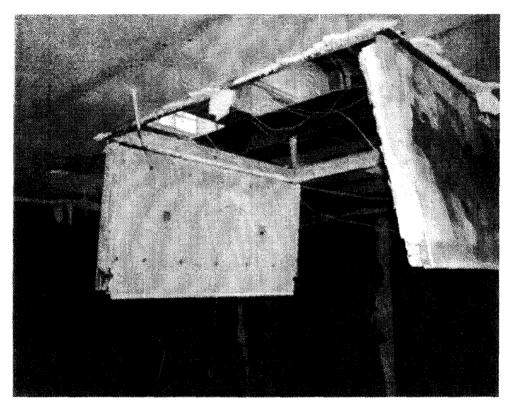
Plate 7 Exposed face of construction after test
