TE 201768

TEST REPORT

Title: Fire resistance test in accordance with B.S. 476 : Part 22 : 1987 on a single-leaf access panel incorporated in a steel stud plasterboard partition.

Client: Fire Proofing Services Ltd.,
13 Shilton Road,
Barwell,
Leicestershire,
LE9 8NB.

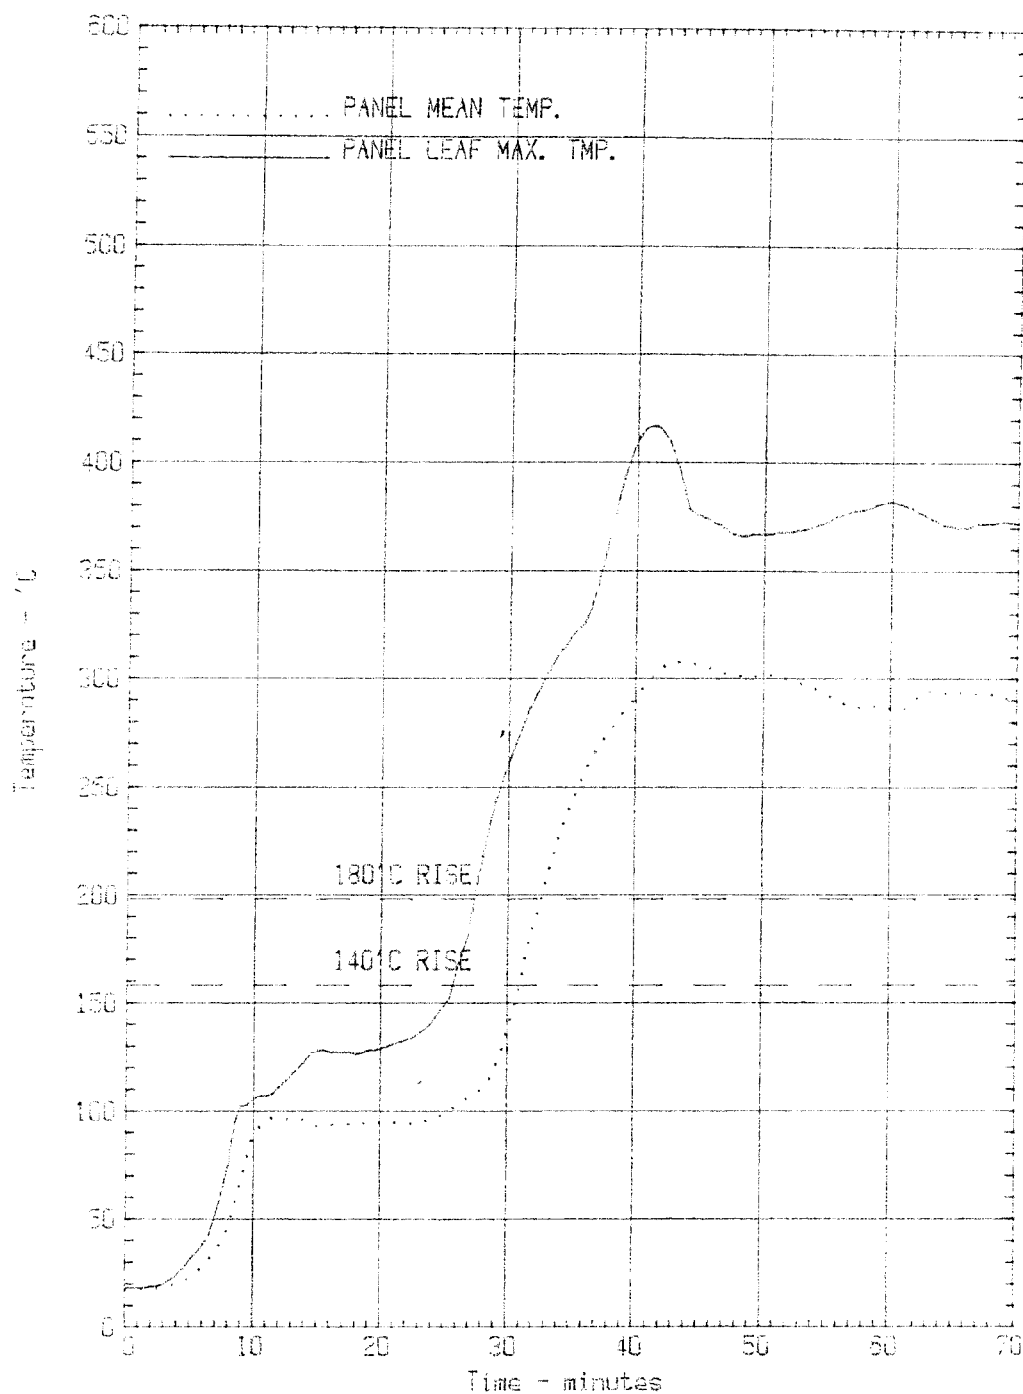
Figure 7 Access panel – mean and maximum temperatures

The mean (recorded by thermocouples 6, 7, 10, 12 and 13 and maximum temperatures recorded on the access panel leaf are plotted against time in Figure 7. Individual temperatures recorded on the access panel frame and leaf are shown in Figures 8 and 9 respectively. Individual surface temperatures recorded on the supporting partition are given in Figure 10.

The limit for maximum temperature rise (180°C) was first exceeded on the access panel frame after 7min by thermocouple number 2. The limit for the rise in mean temperature on the access panel door leaf (140°C) was exceeded after 30min. The limit for maximum temperature rise (180°C) was first exceeded on the access panel door leaf after 27min.

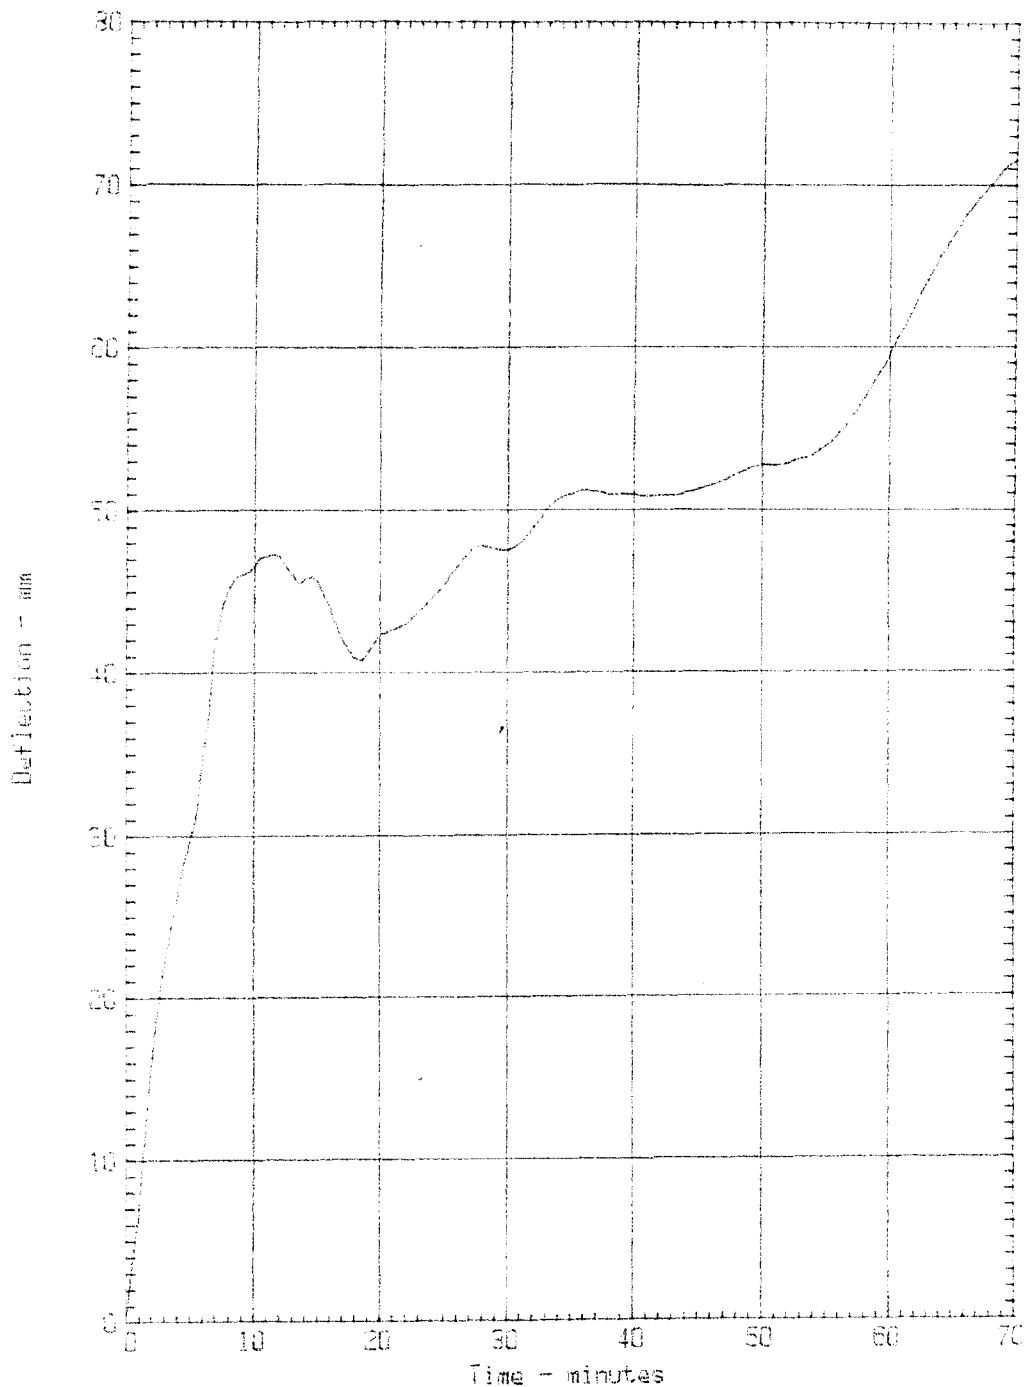
Figure 11 Horizontal deflection at centre of access panel

The deflection recorded at the centre of the access panel is shown plotted against time in Figure 11. Manual deflection measurements made across the construction are given in Table 2. The positions of the manual deflection measurement locations A to G are shown in Figure 5.

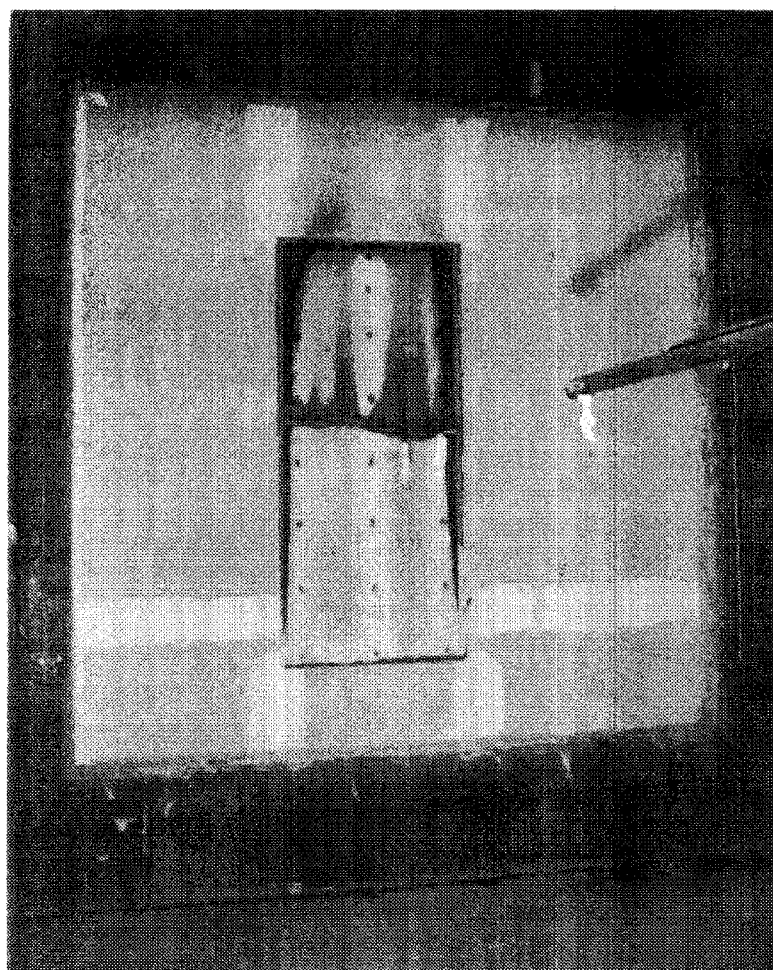
30 : 00	General photograph taken (Plate 3).
37 : 00	All plasterboard in place on the exposed face of the specimen.
39 : 00	Crack in plasterboard on the unexposed face of the access panel now opened up to 15mm wide.
46 : 31	All plasterboard still in place on the exposed face of the specimen.
57 : 00	All plasterboard in place on both exposed and unexposed faces of the specimen.
60 : 00	General photograph taken (Plate 4). No integrity failure.
70 : 00	General photograph taken of specimen (Plate 5) and close-up photograph taken of access panel (Plate 6). Test stopped at the request of the sponsor. There was no integrity failure during the test. Integrity rating 70min.

Plate 3 Unexposed face of specimen at 30min

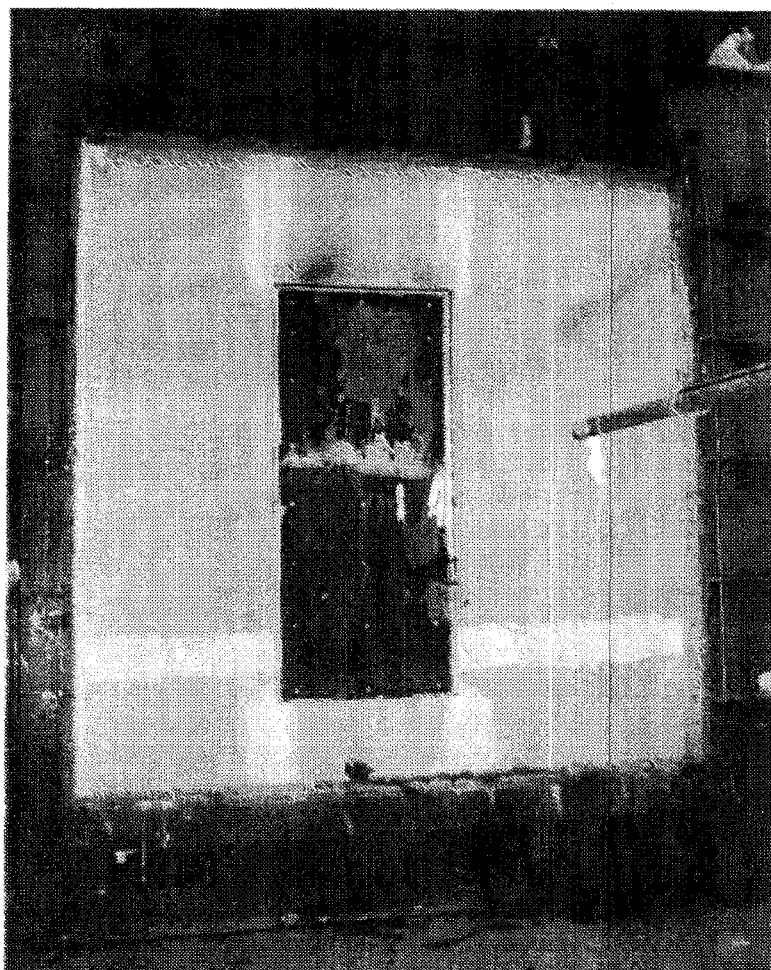
Plate 4 Unexposed face of specimen at 60min

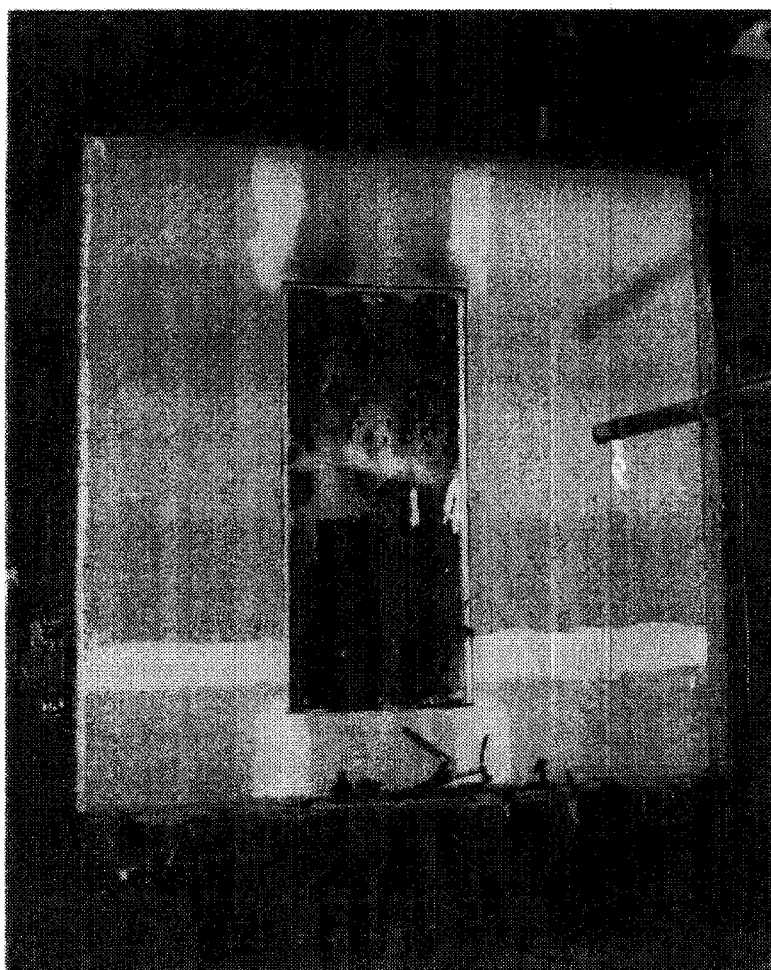
Plate 5 Unexposed face of specimen at 70min

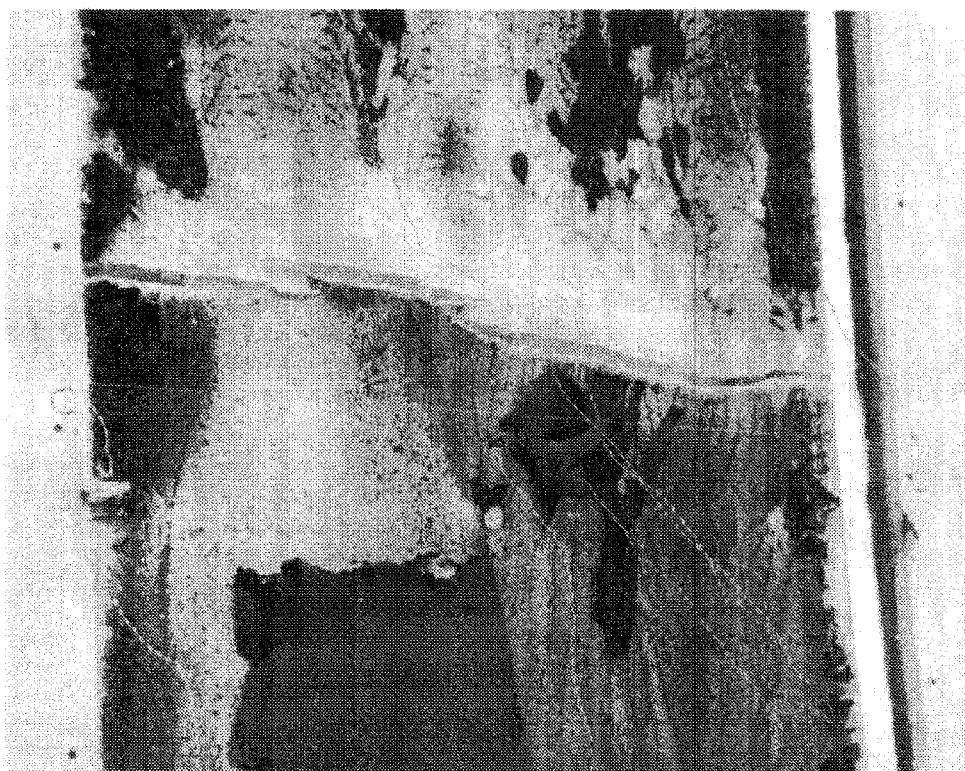
Time min : s	Observation
0 : 00	Test started.
5 : 00	Slight smoke emissions.
8 : 48	Brown scorch mark on the right-hand side vertical edge of the panel adjacent to the frame.
10 : 50	Large bubble formed on the paper cladding of the plasterboard core beneath thermocouple 12.
10 : 57	Scorch marks present on both the right- and left-hand vertical edges of the access panels from ¼ height to full height.
14 : 48	Considerable steam emissions at the periphery of the plasterboard on the access panel.
17 : 56	Bubble noted at 10min 50s decreasing in size. Horizontal tear in paper full width of plasterboard on the access panel at approximately ½ height. Paper very damp.
20 : 00	Plasterboard cracked on access panel extending down to steel across full width of panel at approximately ½ height.
28 : 00	Crack in plasterboard on the access panel now up to 10mm wide maximum. Steel glowing red visible through crack.

Plate 5 Close-up of crack in plasterboard on the access panel at 70min approximately

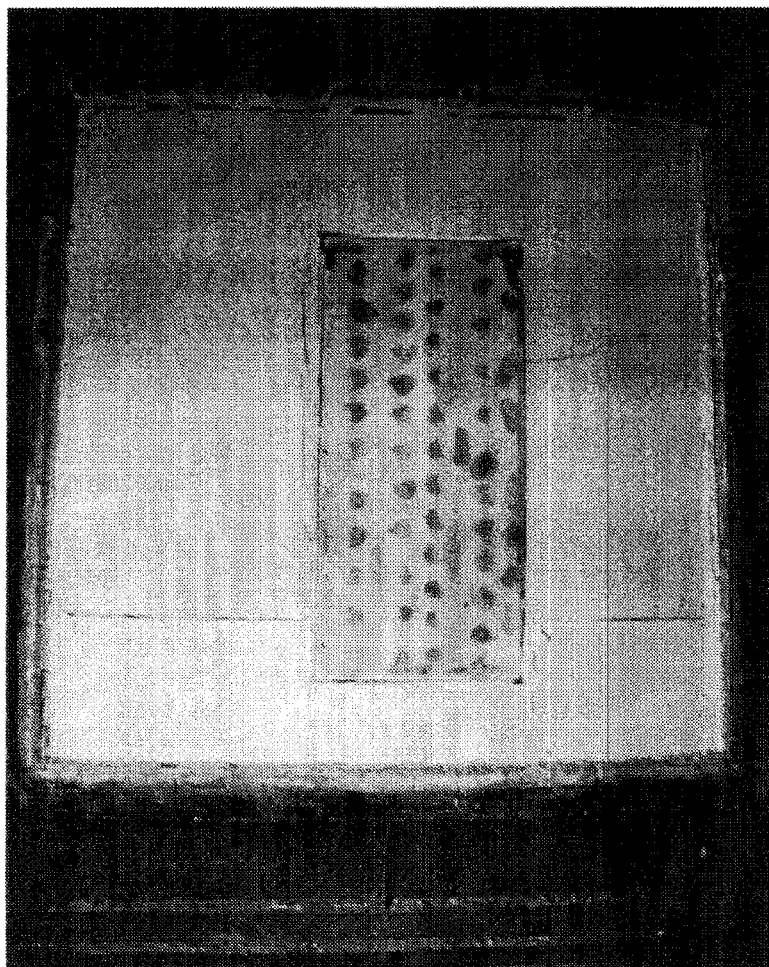
Plate 7 Exposed face of access panel after cooling to ambient temperature
