**Fire endurance and hose
stream test in
accordance with UL 10B
on two single-leaf
access panels.**

Prepared for:
Fire Proofing services Ltd.
Evolution House,
Aston Road,
Nuneaton.
CV11 5EL

Test report number 242658

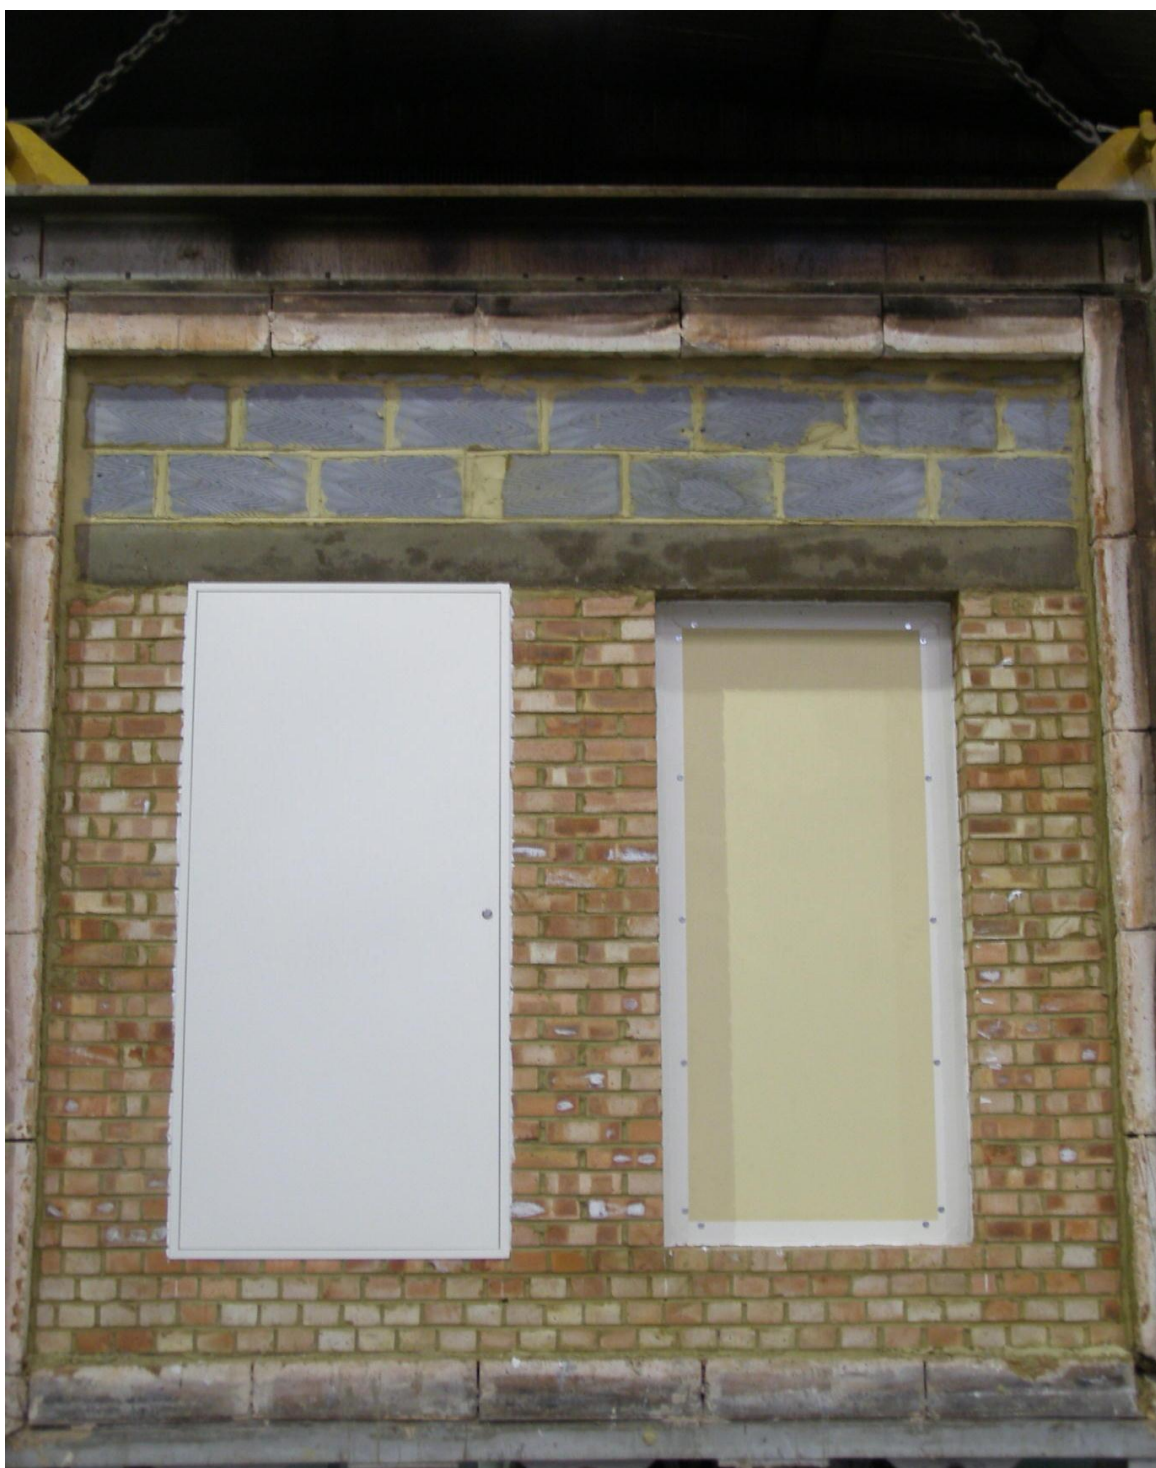
Exposed face of specimens before test.

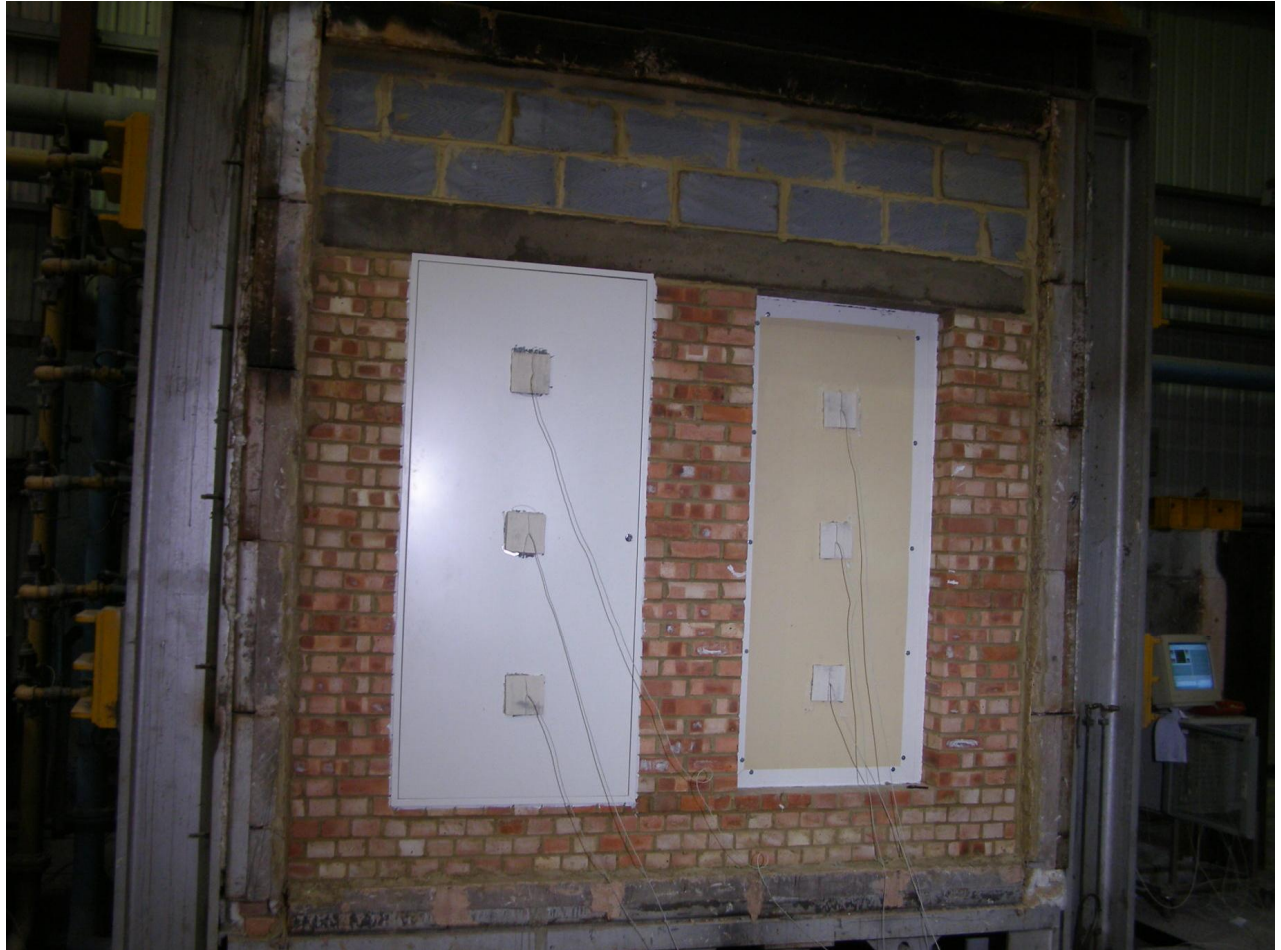
Unexposed face of specimens before test.

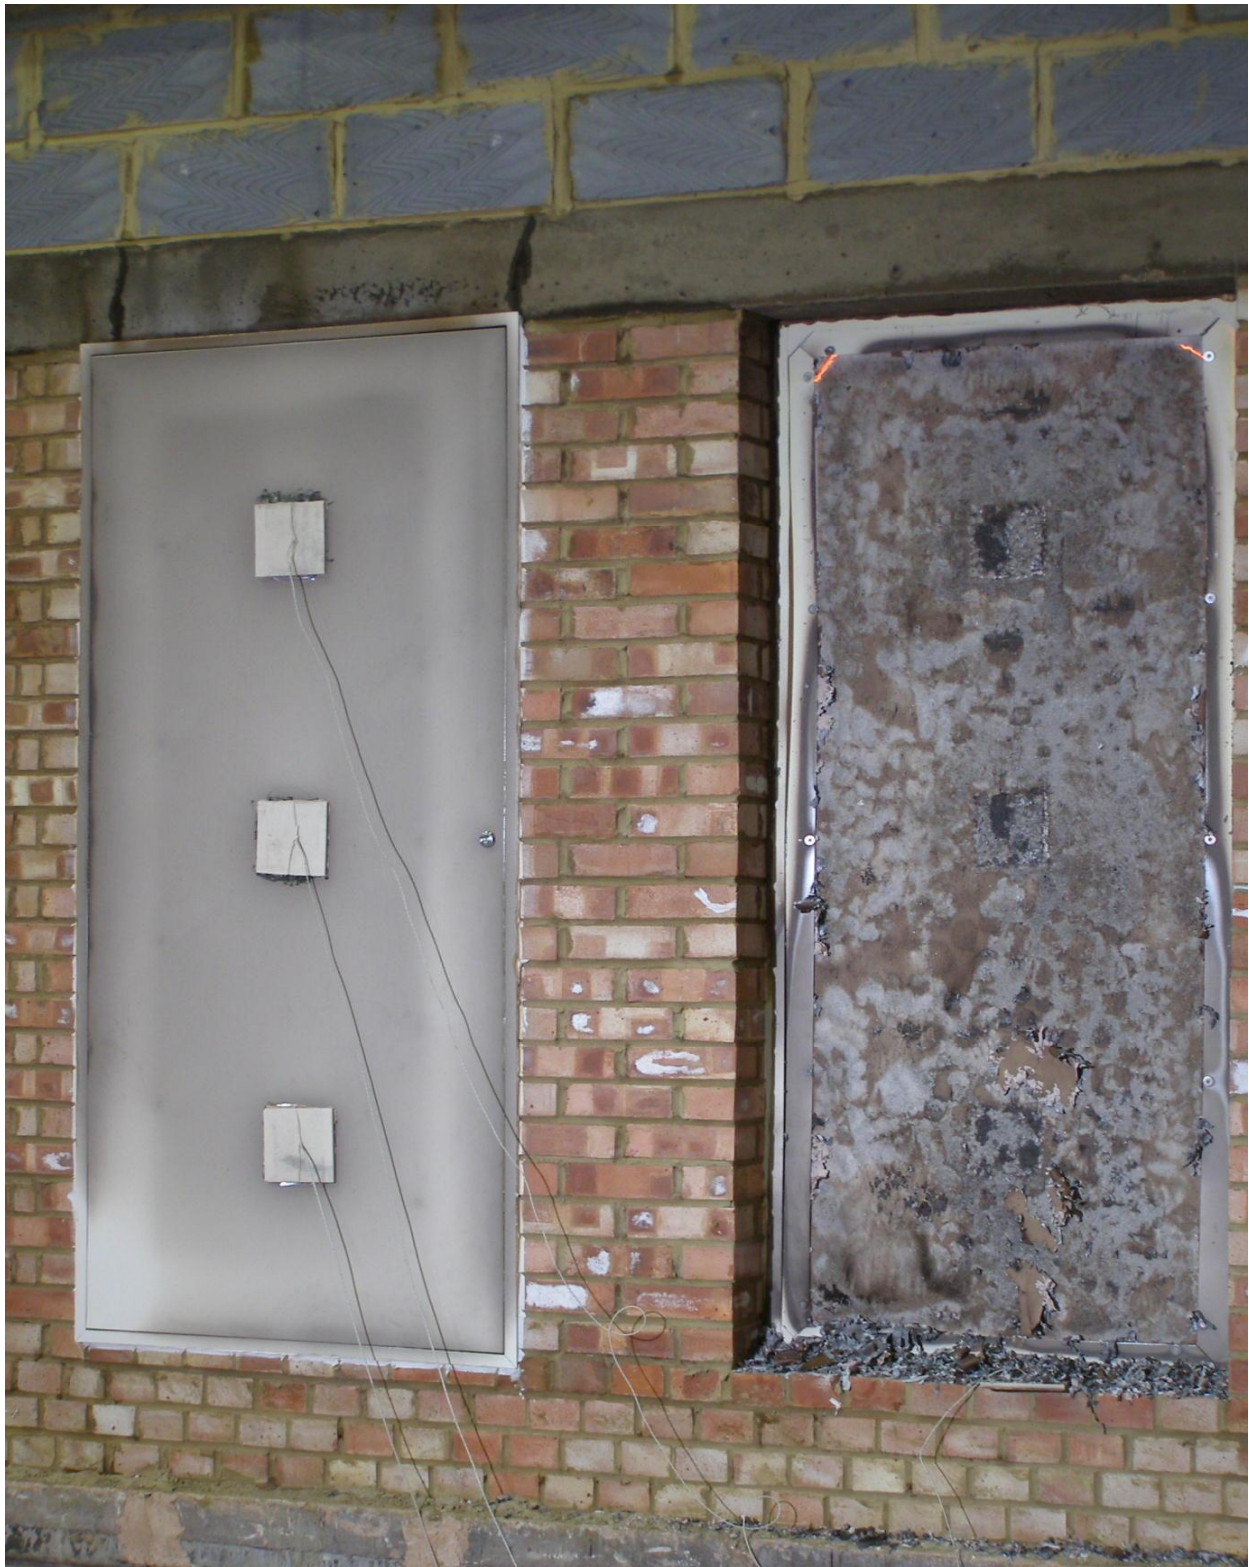
Access panel type fire door assembly B (opening towards the furnace) as described in this report, maintained its structural integrity for the first 44 minutes of the fire endurance test, when flaming occurred in a non-permissible area of the door leaf. The performance of this access type fire door assembly was not within the "conditions of acceptance" specified in the standard after 44 minutes. The access panel was therefore within the "conditions of acceptance" for the ½ hour period.

Unexposed face of specimens at end of fire endurance test.
