#### TEST REPORT

Fire resistance test in accordance with B.S. 476: Part 22: 1987 on a double-leaf access panel incorporated in a steel stud plasterboard partition.

Fire Proofing Services Ltd., 13 Shilton Road, Barwell, Leicestershire, LE9 8NB.

4 July 2000

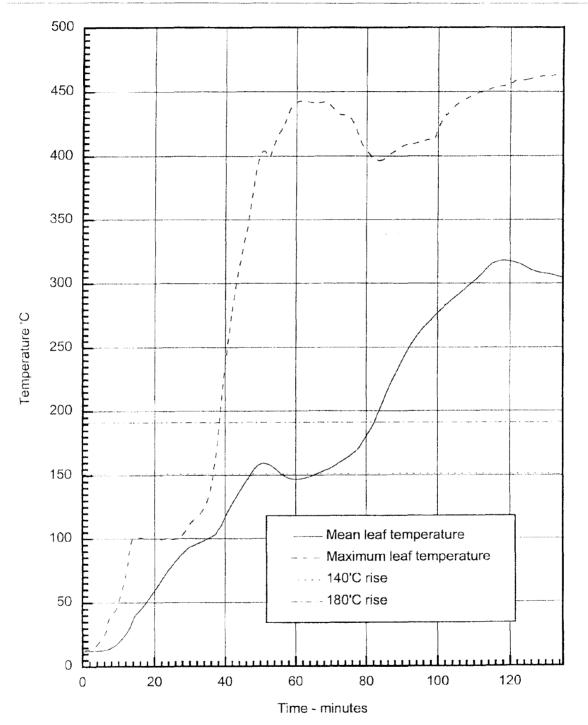
The limit for maximum temperature rise (180°C) was first exceeded on the access panel frame after 16min by thermocouple number 4. The limit for the rise in mean temperature on the door leaf (140°C) was exceeded after 47min.

Figure 7 Mean and maximum temperatures recorded on unexposed face of access panel leaves

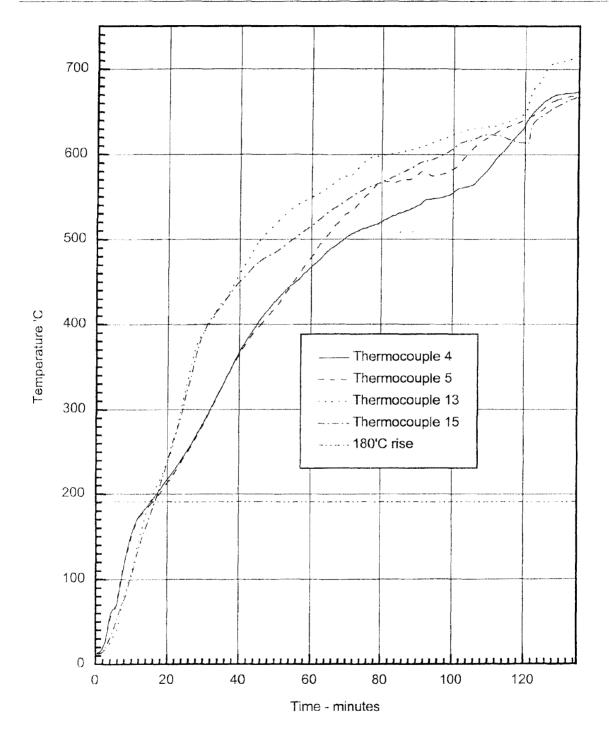
Figure 9 Temperatures recorded on unexposed face of access panel frame

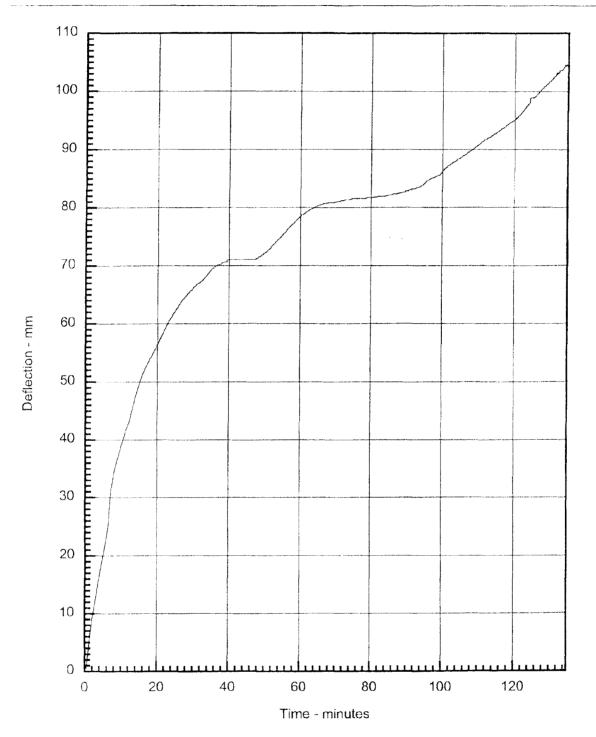
The deflection recorded at the location described in section 3.4 is shown plotted against time in Figure 12. Manual deflection measurements made across the construction are given in Table 3. Position A was located on the supporting construction 100mm from the left edge of the left leaf, B was located on the left leaf, 100mm from the left edge of the leaf, 100mm from the right edge of the leaf, and D was located on the supporting construction, 100mm from the right edge of the right leaf.

Figure 12 Horizontal deflection recorded in top right corner of left-hand side panel leaf

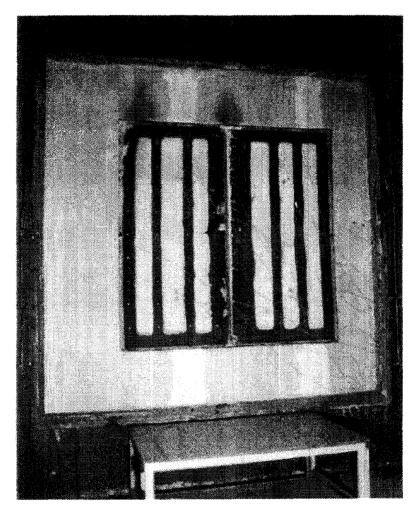
Time	Observation		
min : s			
50:00	The surface of the leaves has now charred a black colour over corresponding locations of the internal top hat sections.		
70:00	The crack referred to at 39 min is now approximately 7mm wide x 200mm long.		
80:00	Two further cracks have formed over the corresponding locations of the internal top hat sections on the left hand side leaf.		
104:00	Both leaves have now turned almost completely black in colour.		
135:00	No loss of integrity. Test stopped.

Plate 3 Unexposed face of specimen after 60min

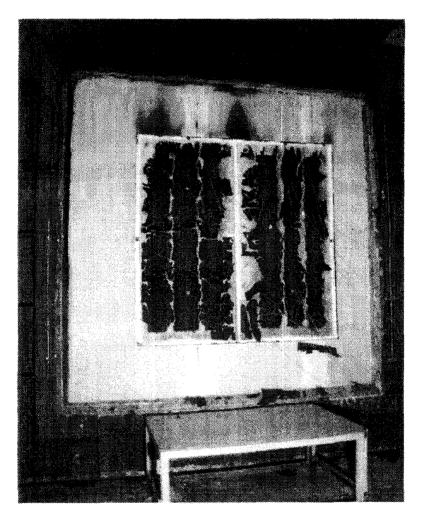
Plate 4 Unexposed face of specimen at termination of test (135min)

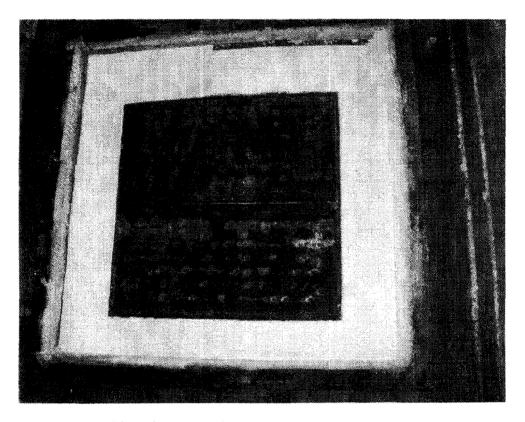
Plate 5 Exposed face of specimen after test
