# Fire Resistance Test

### Report: Chilt/RF13137 Revision A

A fire resistance test performed on a single leaf single acting steel access panel

Test conducted in accordance with BSEN 1634-1: 2008 and BSEN 1363-1: 1999

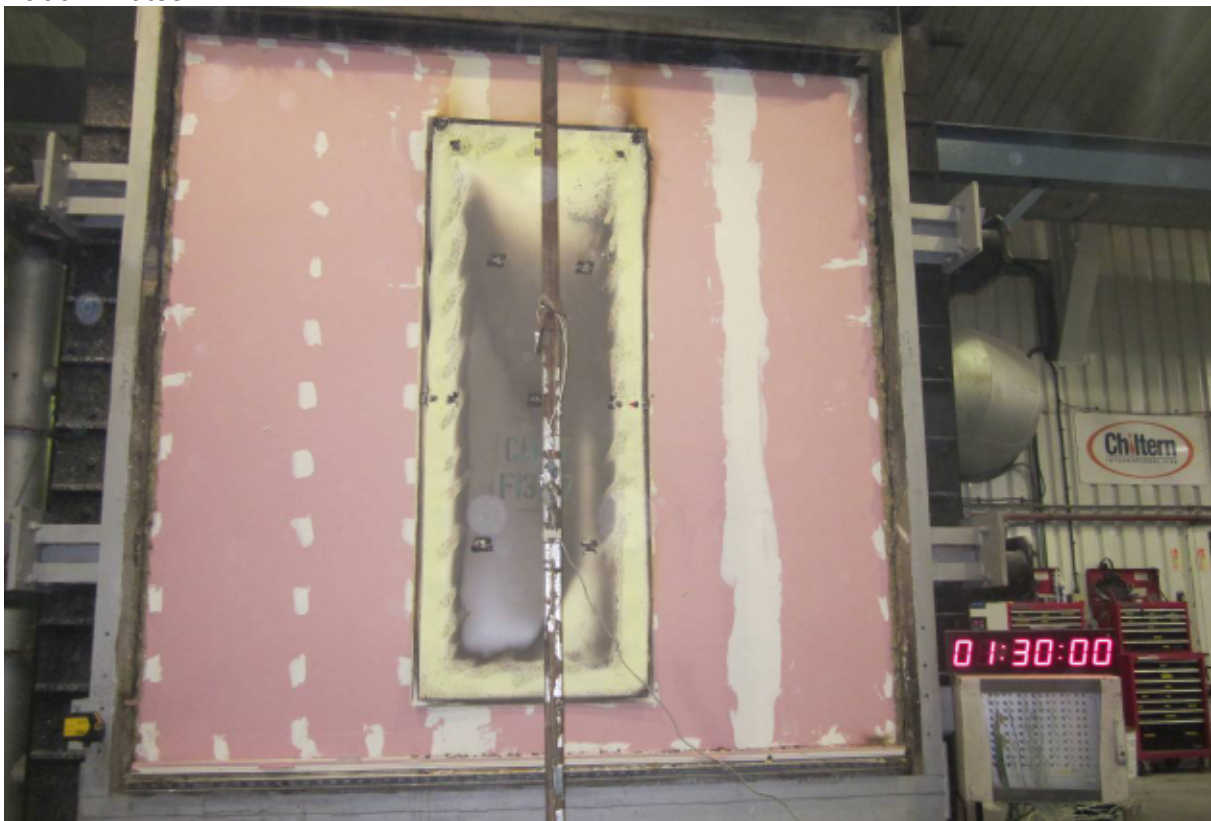
At 90 minutes

- 89.30 The crack in the plasterboard on the exposed face has now opened to approximately 20-25mm.
- 92.00 The exposed face plasterboard has fallen away.

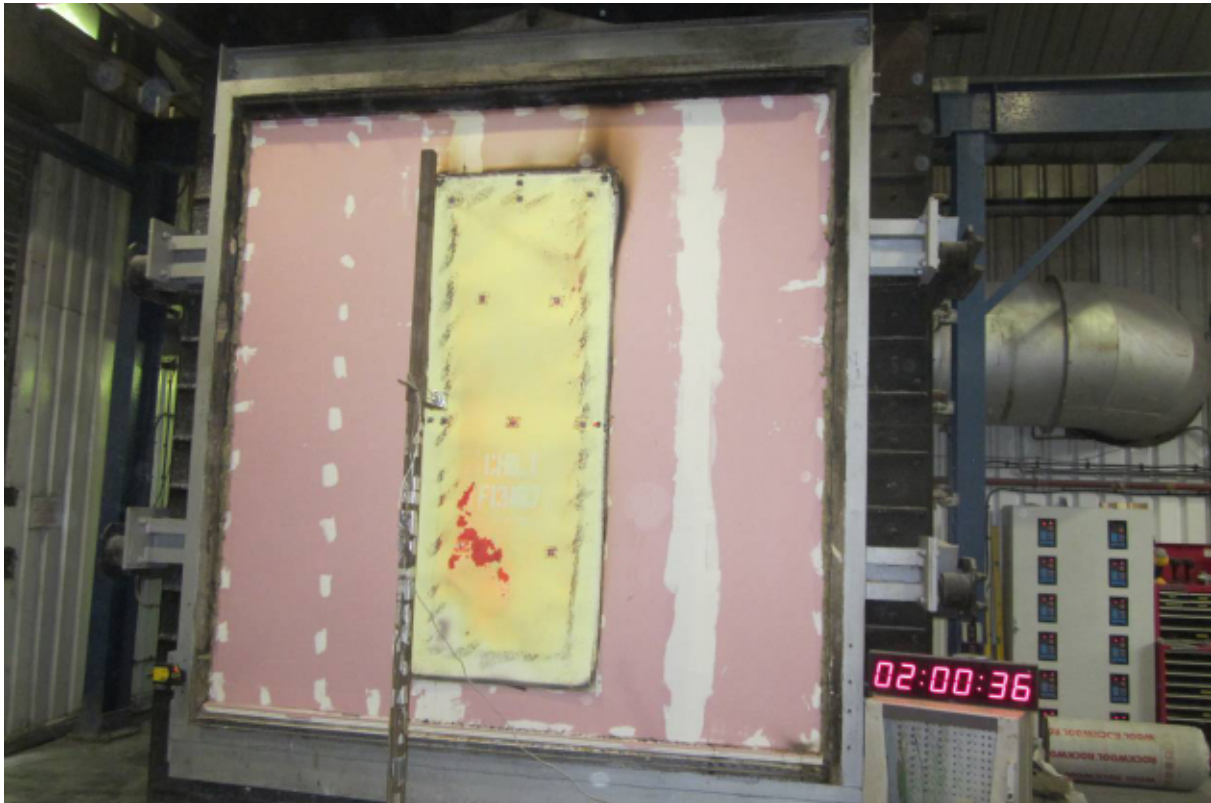
After 120 minutes

- 92.40 The leaf face is now glowing.
- 93.00 The leaf face is starting to ripple and distort.
- 102.30 The entire unexposed face is now glowing.
- 132.00 Test terminated

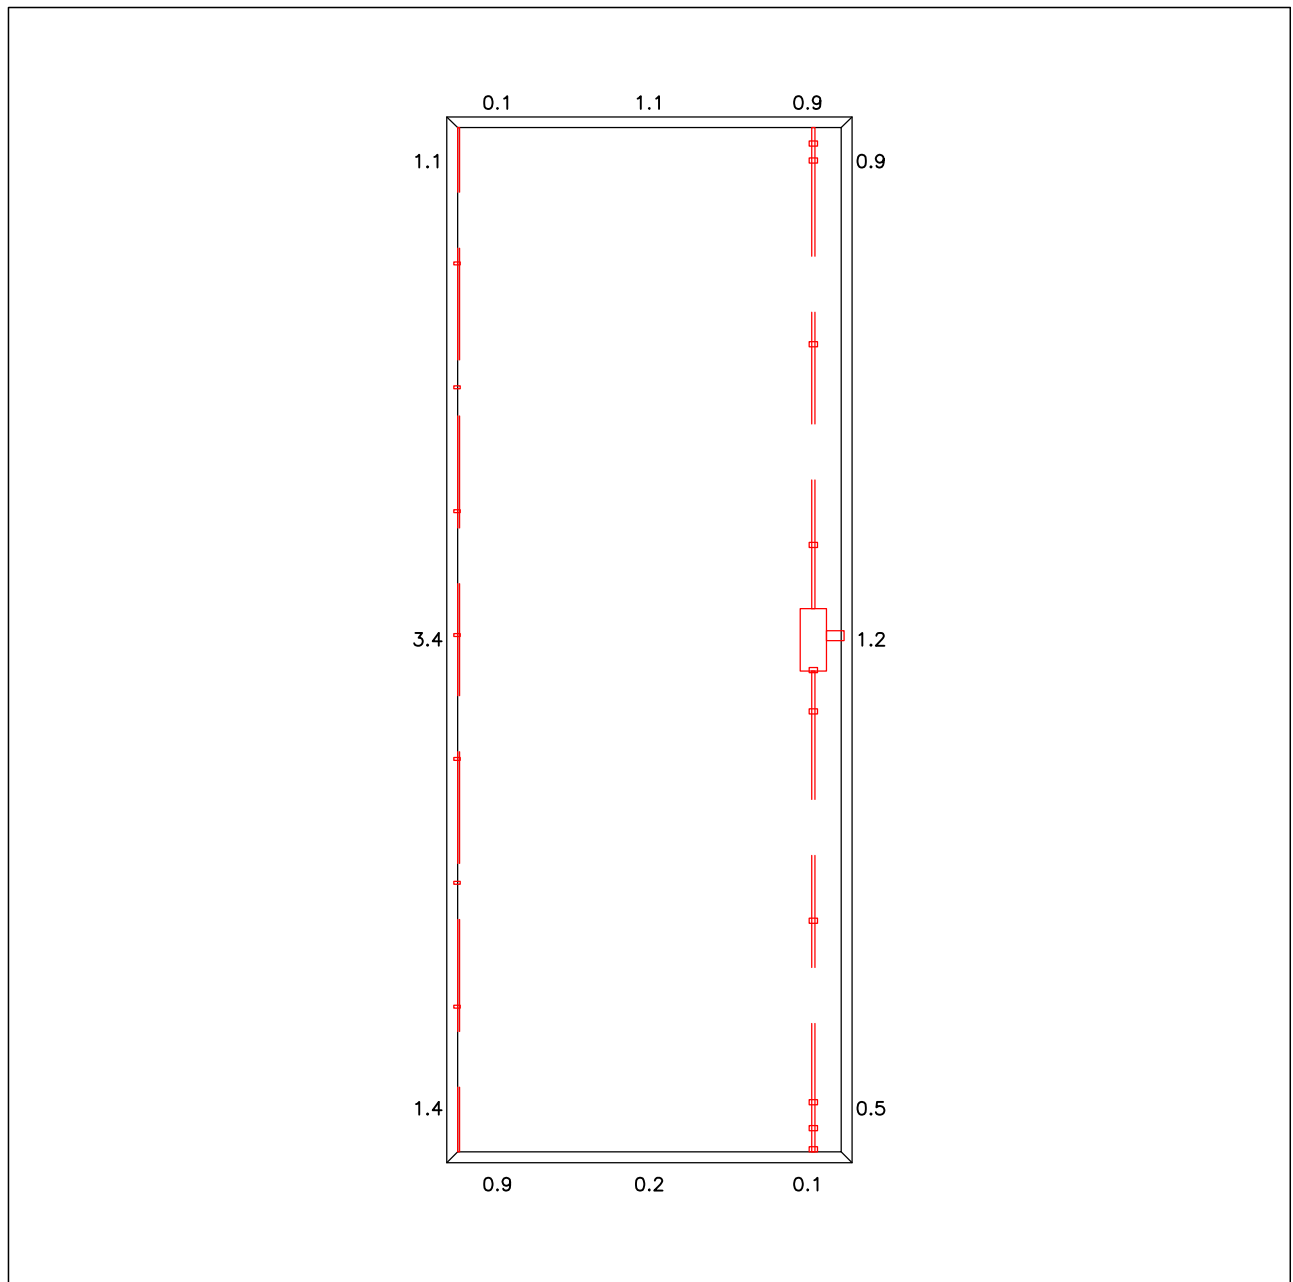
Title Leaf/frame gaps

The gaps between the edge of the leaf and frame were measured prior to test. A total of 12 readings were taken. The measurements (in mm) are given in Figure 5 of the appendix.

The results of this test were obtained using the leaf to frame gaps recorded in Figure 5 of the appendix. The fire resistance performance of access panels of this design may change if substantially different gaps are employed.
