**Fire resistance test in  
accordance with B.S.  
476 : Part 22 : 1987 on a  
plasterboard ceiling  
membrane incorporating  
a Fire Proofing Services  
Ltd. double-leaf access  
panel.**

Prepared for:  
Fire Proofing Services Ltd.,  
Evolution House,  
Aston Road,  
Nuneaton.  
CV11 5EL

17<sup>th</sup> January 2007

Test report number 231891

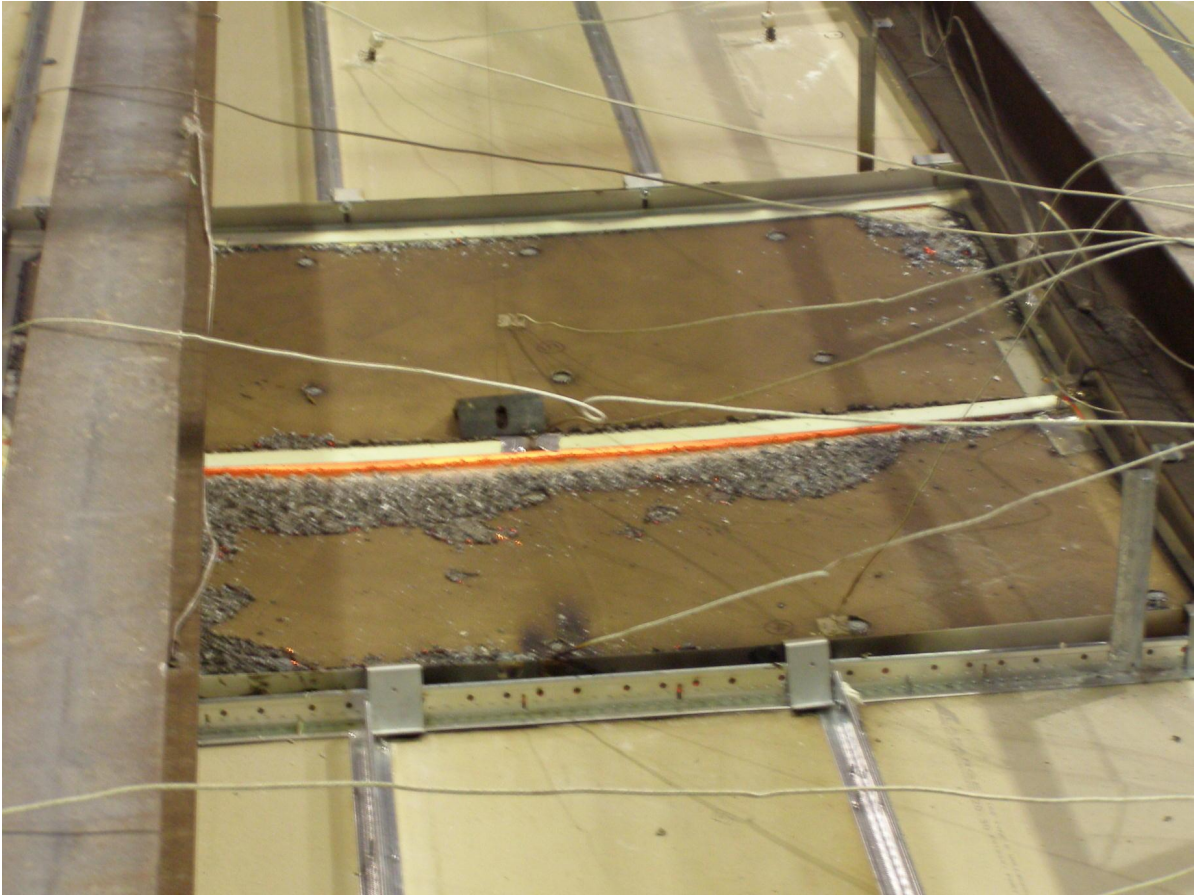
Time Minutes	Observation
56	Some sagging of the plasterboard ceiling is occurring inside the furnace, but all plasterboard is intact. Several pieces of paper continue to glow and char on the unexposed face of the leaves.
62	The first (exposed) layer of plasterboard on the ceiling is starting to fall off.
68	Test stopped. No failure of integrity.

**Photo 4** Unexposed face of access panel at termination of test.

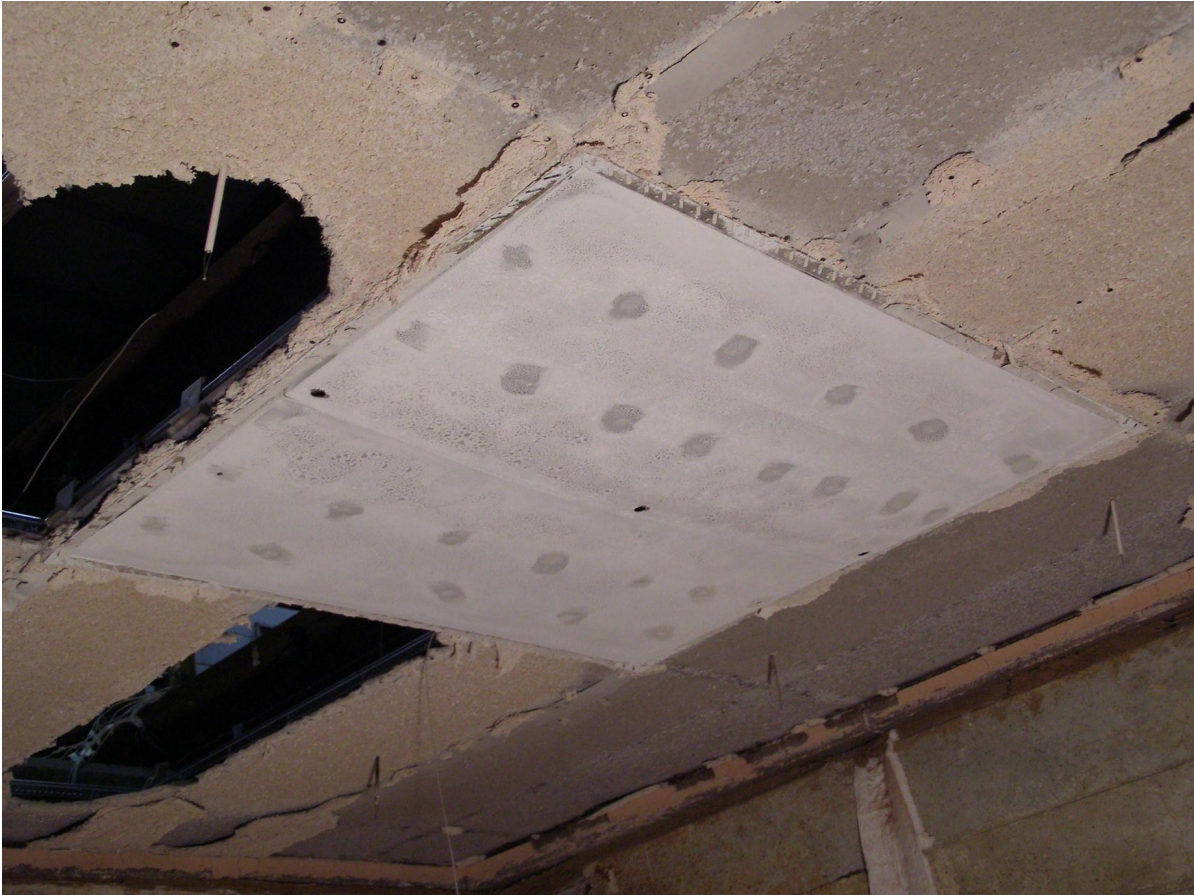
**Photo 5** Exposed face of access panel after test.
