A double-leaf steel/plasterboard access panel incorporated in a steel-framed plasterboard partition, was submitted to a fire resistance test carried out in accordance with BS 476: Part 22: 1987 (Method 6) on 19 March 2007 for a duration of 120min.

A test was carried out in accordance with BS 476: Part 22: 1987¹, at the request of LPCB on behalf of Fire Proofing Services Ltd., to determine the fire resistance of a double-leaf hinged access panel in a plasterboard partition. Legal ownership of this report belongs to Fire Proofing Services Ltd..

BRE FIRE TEST - 19/03/2007.

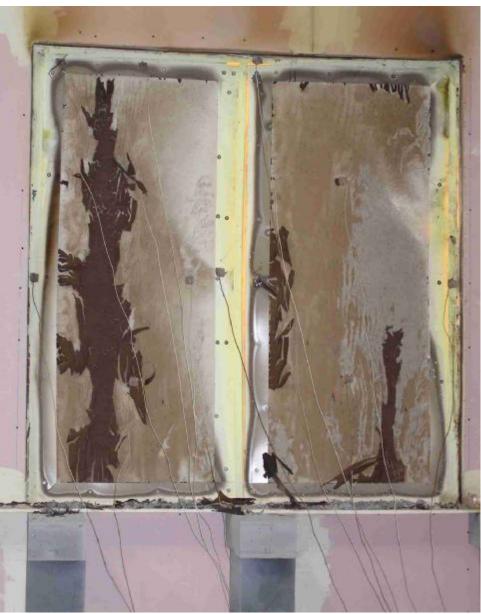
Photo 9 Unexposed face of access panel after test

Time	Observation
19	Handle to passive leaf drooping
29	Left-hand edge of right-hand leaf bowed towards furnace between top and mid-height up to 40mm, and between bottom and mid-height up to 25mm
31	Megadeco become brown coloured over most of its face
31	Paper face of Megadeco charred and flaking away at right-hand edge of right-hand leaf over its upper half
37	Similar charring and flaking of paper face of Megadeco occurring on left-hand leaf
57	Buckle developed in right-hand edge of right-hand leaf and also in adjacent frame at 200mm above thermocouple 10
65	Very bright spot of tiny flaming occurred at centre of door just behind the right-hand leaf leading edge
79	Left-hand edge of left-hand leaf become angled towards furnace increasing the gap between the leaf and frame up to approximately 20mm
120	Test stopped.

There was no failure of integrity throughout the test.

The unexposed-face temperature limit was first exceeded (180° C maximum rise) by thermocouple 1 after 10min. The mean and individual temperatures recorded are plotted against time in Graphs 2-4.
