A twin-leaf access panel door, 2000mm high x 1800mm wide, installed within the aperture of a fire rated plasterboard wall, was submitted to a fire resistance test in accordance with B.S.476:Part 22:1987⁽¹⁾ for a duration of 67 minutes on Wednesday 28th September 2005.

The twin leaf access panel door achieved the following fire resistance rating:

"Integrity: 66 minutes

Insulation: 23 minutes".

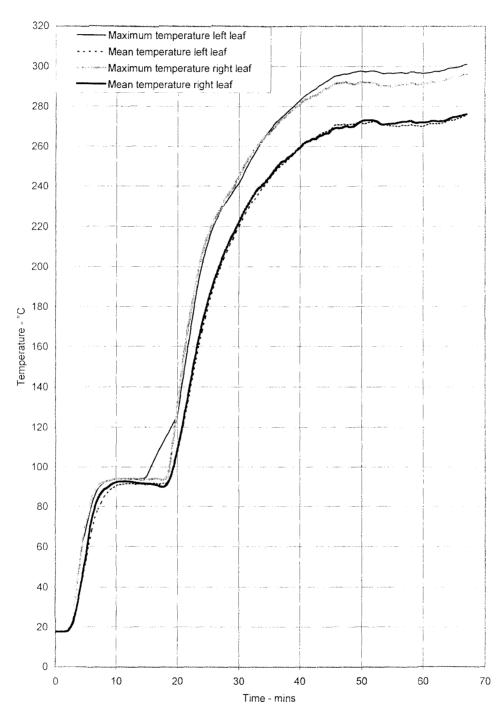
The mean temperature rise for insulation (140°C rise above surface temperature at start of test) on both door leaves was exceeded after 23 complete minutes of the test.

The maximum temperature rise for insulation (180°C rise above the surface temperature at the start of the test) on both door leaves was exceeded after 23 complete minutes, recorded using TC 9 on the left leaf and TC10 on the right leaf.

Graph 2 Showing the mean and maximum temperatures recorded on the unexposed face of the left and right leaves of the access panel door.

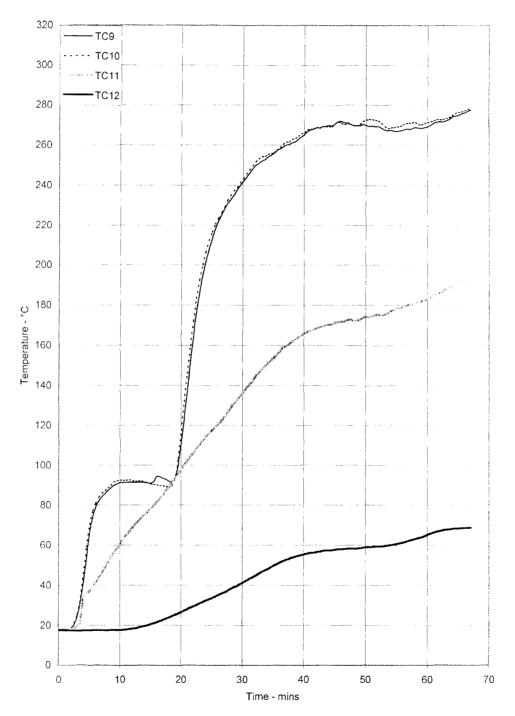
Graph 5 Showing the individual temperatures recorded throughout the test using TC9 to TC12.

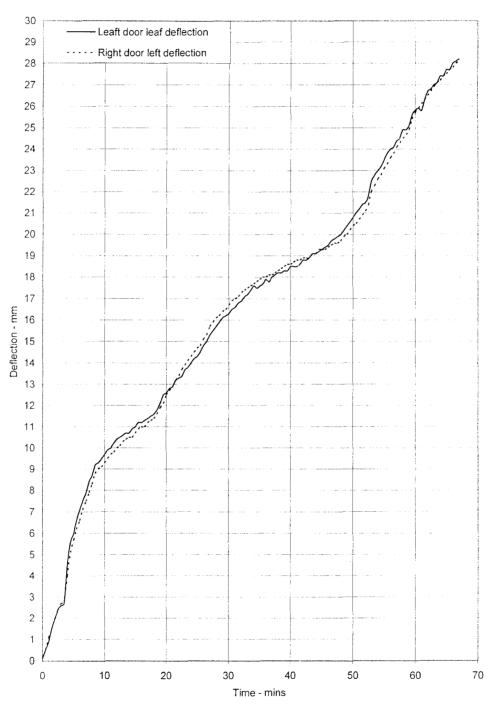
The horizontal deflection recorded at the top right of the left leaf and the top left of the right leaf is plotted against time on Graph 7, positive values indicate deflecting towards the furnace. The maximum deflections achieved during the test were 28.2mm after 67 minutes for the left leaf and 28.1mm after 67 minutes for the right leaf.

Graph 7 Showing the deflection recorded at the top of each leaf, lock side, throughout the test.

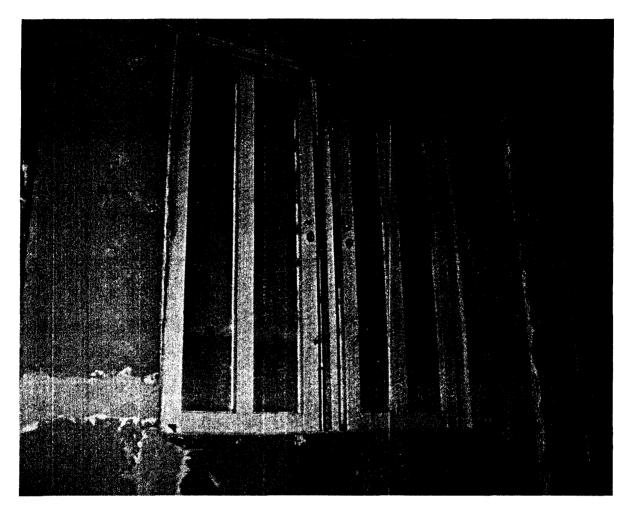
The partition at the end of the test is shown in Photographs 4 and 5.

Photograph 5 Showing the unexposed face of the access panel door at the end of the test.
