Fire Resistance Testing

Report: BMT/FEI/F15014

Ad hoc fire resistance test performed on two steel access hatches fitted within a British Gypsum 120 minute specification ceiling membrane section

Test conducted to the temperature and pressure conditions of BS 476: Part 20: 1987 and utilising the principles of BS 476: Part 22: 1987 where appropriate

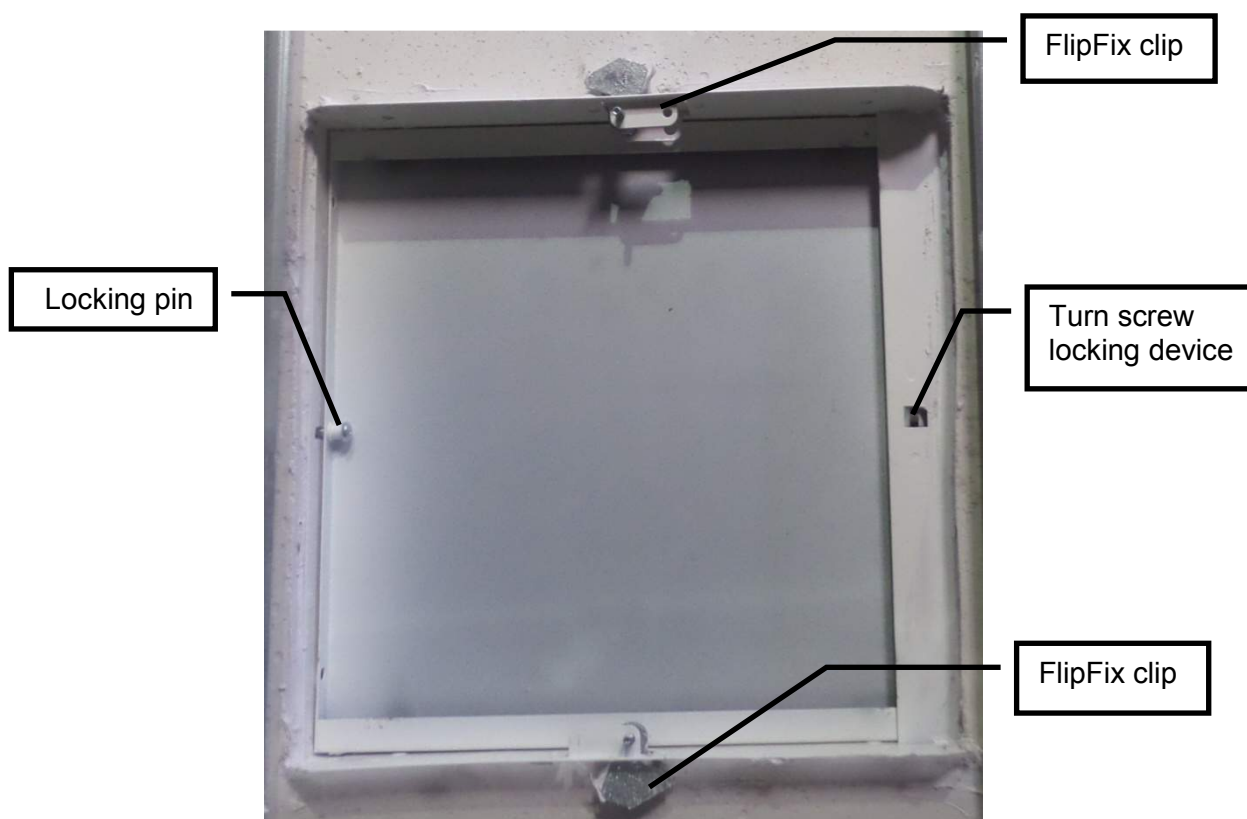
Access hatch A

The hatch panel (product referenced FlipFix with Turnscrew) measured 300mm x 300mm x 13mm thick overall with a 24mm wide platform on the closing edge and a 15mm wide platform on the side edges. The hatch panel comprised a 0.9mm thick profiled powder coated Zintec steel tray section, welded at the corners.

The frame comprised 1.2mm thick profiled powder coated Zintec steel 'L' section, 26mm high x 26mm wide on the hinged and end sides, and 'Z' section 30mm – 14mm – 26mm on the closing edge, welded at the corners.

The frame was fixed into the aperture with 2No. FlipFix fitting devices, one centrally fitted on each hinged edge.

The leaf was hinged on two steel screws, and was secured closed with a turn screw centrally fitted on the closing edge and a locking pin centrally fitted on the opposite edge.

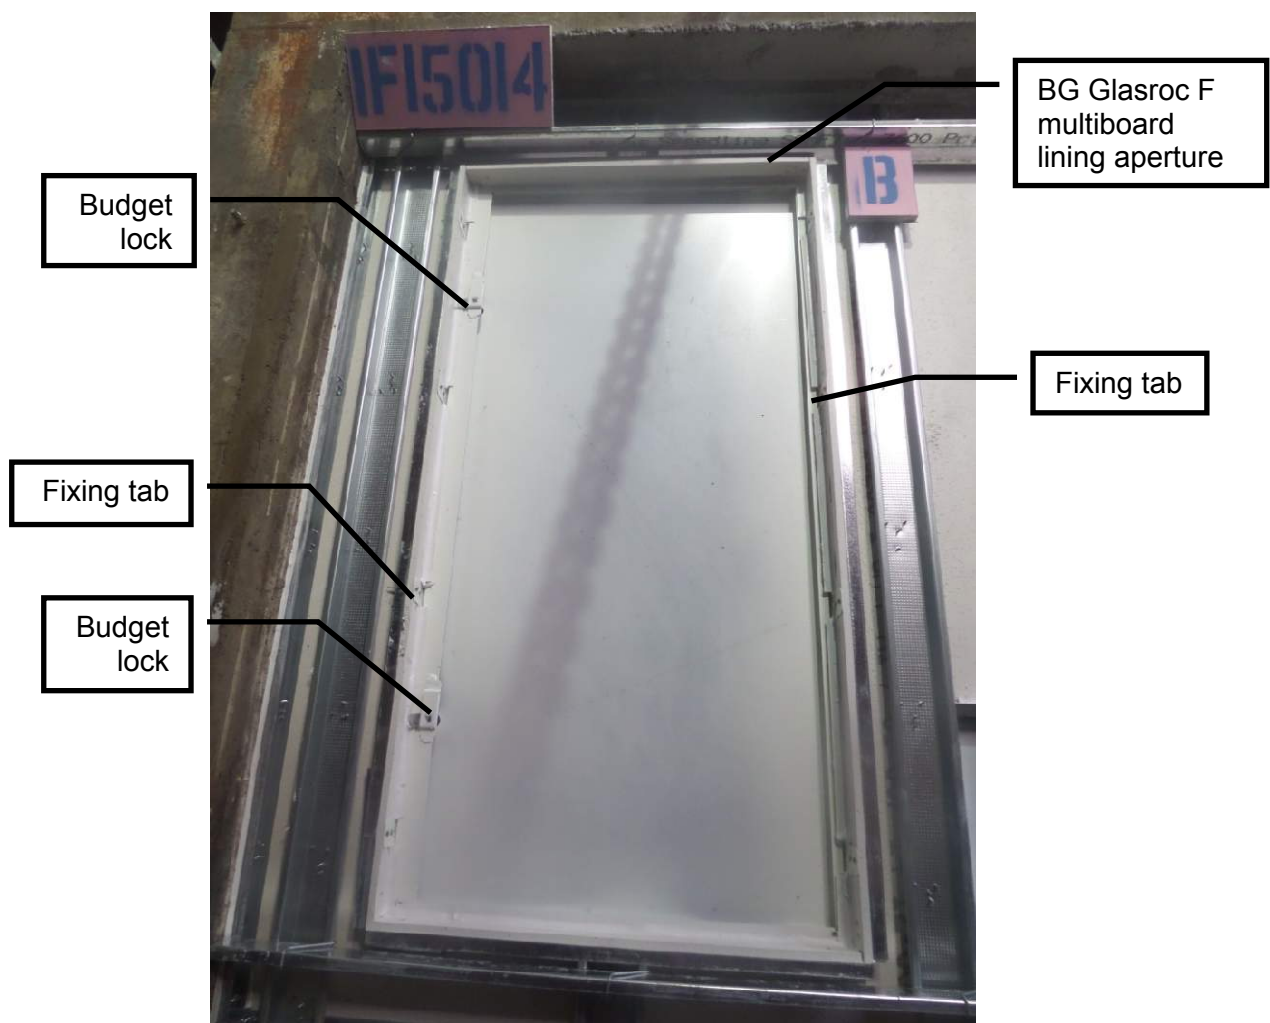
Access hatch B

The access panel leaf measured 1200mm long x 600mm wide x 25mm thick comprising powder coated 0.9mm thick steel tray profile, with a 14mm wide platform on the side and hanging edges, and a 38mm wide platform on the closing edge. The leaf was welded at the corners.

The frame comprised 1.2mm thick powder coated steel 'Z' section, 26mm high x 38mm wide overall with a 13mm wide integral stop on the exposed face and a 25mm wide integral architrave on the unexposed face. The frame was welded at the corners.

The frame was fixed into the aperture with 4 No. steel tabs on each long edge, fitted at 100mm, 435mm, 770mm and 1100mm measured from one edge, fixed with 2No. 40mm long screws per tab.

The access panel was hinged on two Ø5mm steel bolts on one edge, with a Ø5mm steel bolt and threaded insert engaging into a hole in the frame. Two engaged budget type locks (79mm x 22mm) were welded 250mm and 950mm on the platform of the opposite edge.

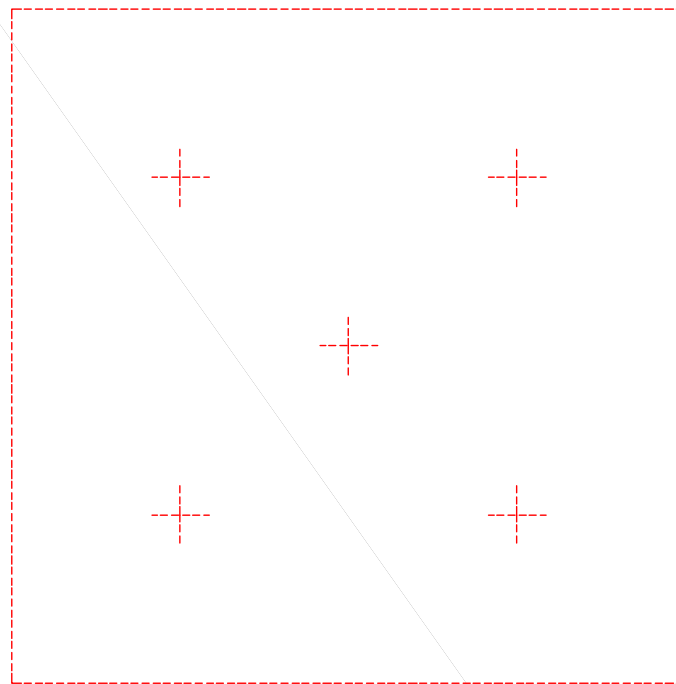
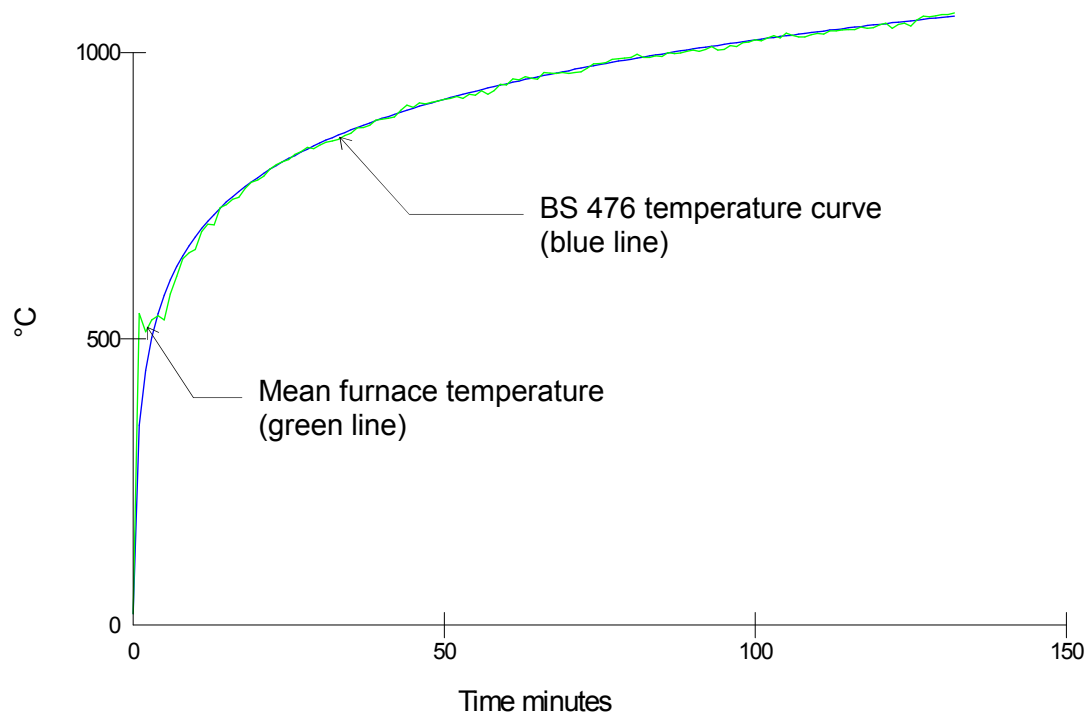
Furnace Temperature

- 6.4 The furnace was controlled to follow the temperature/time relationship specified in BS 476: Part 20: 1987 as closely as possible, using the average of five thermocouples suitably distributed within the furnace in the horizontal plane. The temperatures recorded are shown graphically below:

+ : Furnace Thermocouples

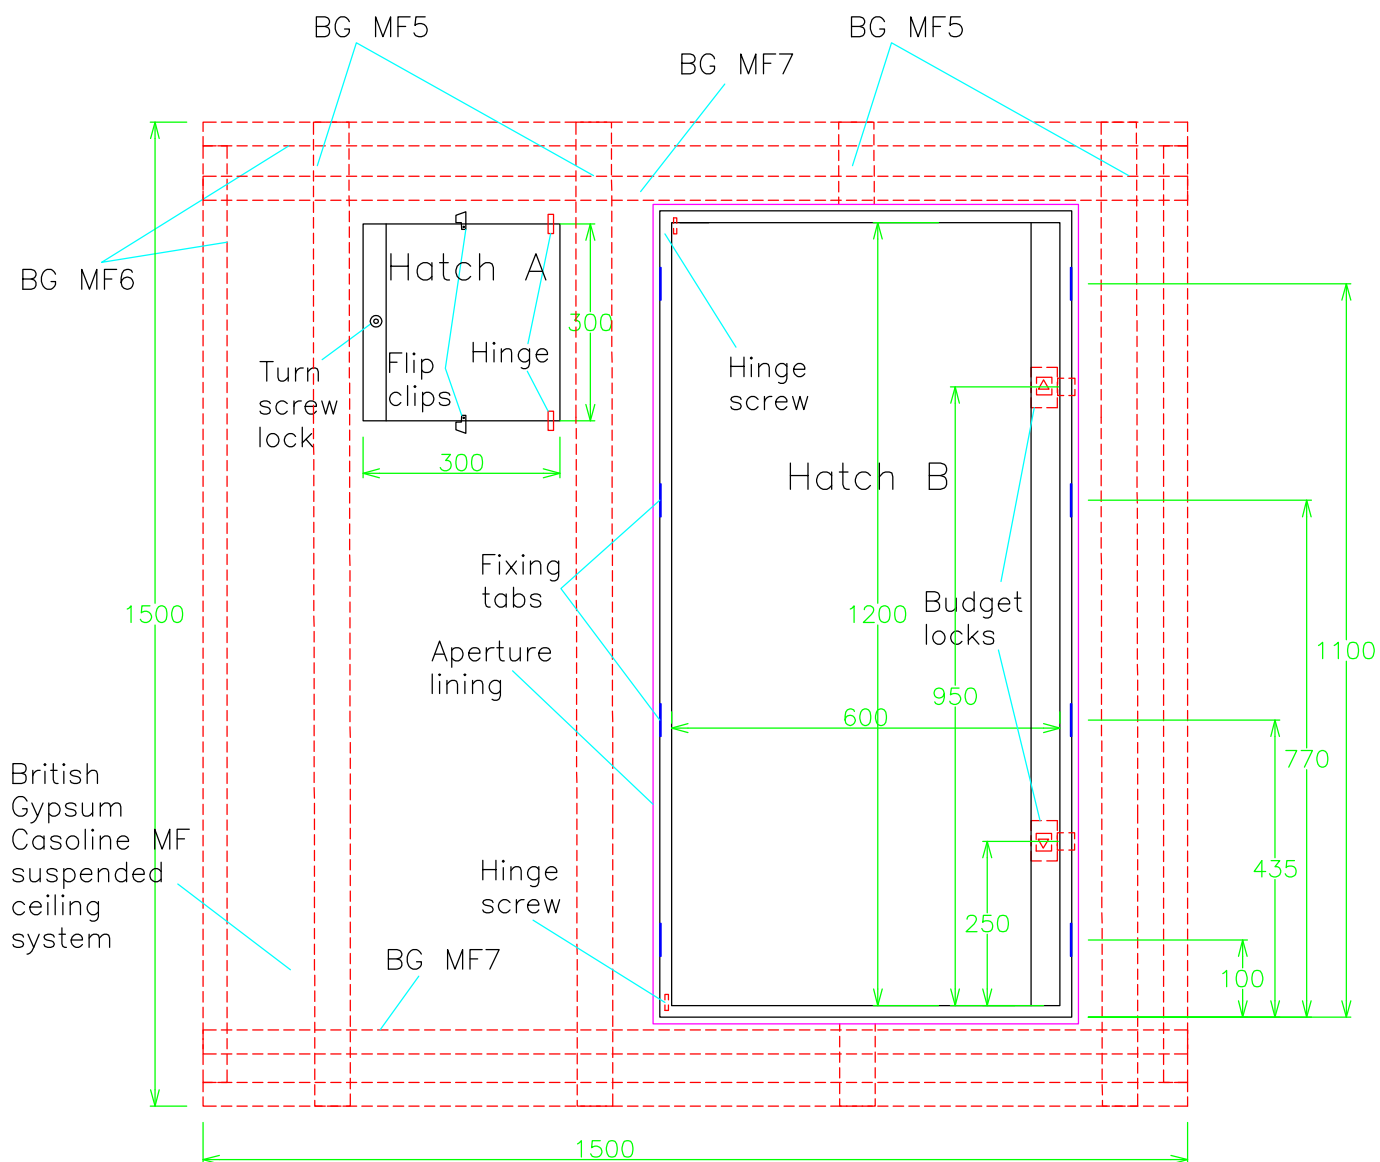
Title Unexposed face plan view
and hardware positions
(All dimensions in mm)
