Our Ref: Chilt/IF11070

Re: Indicative Fire Resistance Test to the temperature and pressure conditions of BS 476: Part 22: 1987 (and current FTSG Resolutions where applicable) (Chilt/IF11070)

The specimen comprised a single acting steel leaf access hatch within a 120 minute specification ceiling membrane

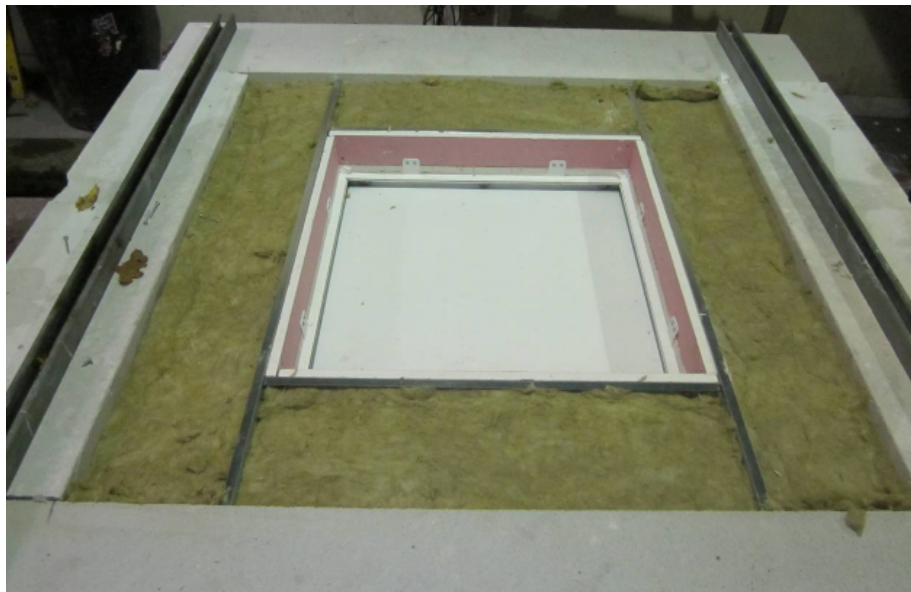
A steel access panel was manufactured and supplied for test by the client and delivered during November 2011. Chiltern International Fire Limited (CIFL) constructed a section of Knauf MF suspended ceiling, including a 605mm x 605mm aperture, into a 150mm thick lightweight aerated autoclaved concrete lintel ring beam and installed the access panel into the suspended ceiling aperture above a 1.1m x 1.1m furnace.

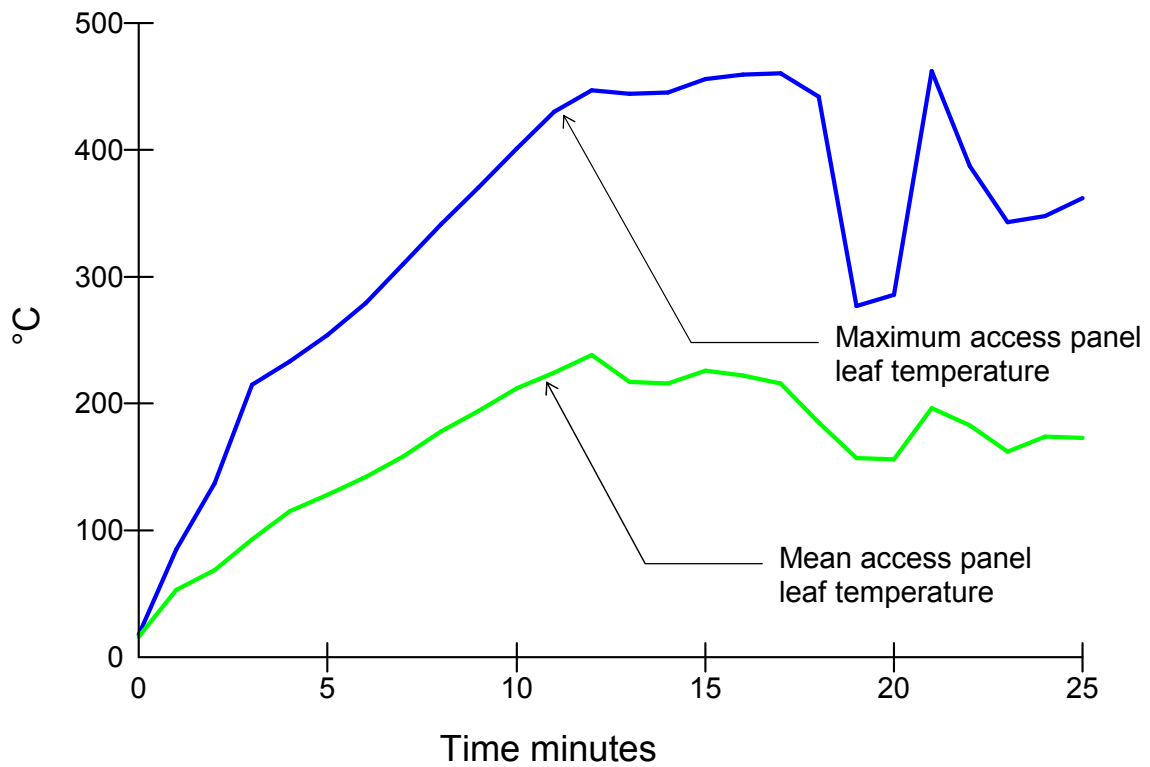
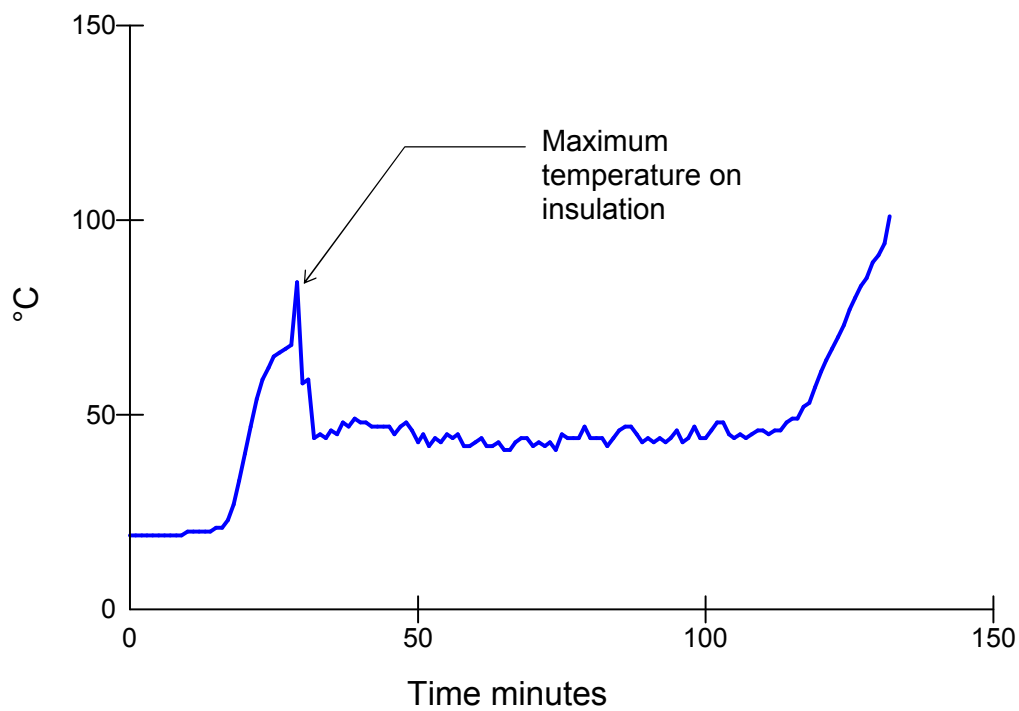
Unexposed face temperature curves

The temperature of the unexposed face was monitored by means of five thermocouples fixed to the surface of the leaf and two thermocouples fixed to the insulation around the access panel.

The thermocouple positions are shown in Figure 4 of the appendix. The average temperature of the panel leaf and maximum temperature of the panel leaf are shown graphically on page 5.

21.00	There is discolouration across the entire unexposed face.
26.50	Thermocouples 5, 7, 8, 11 and 12 have been removed from the unexposed face of the access panel leaf.

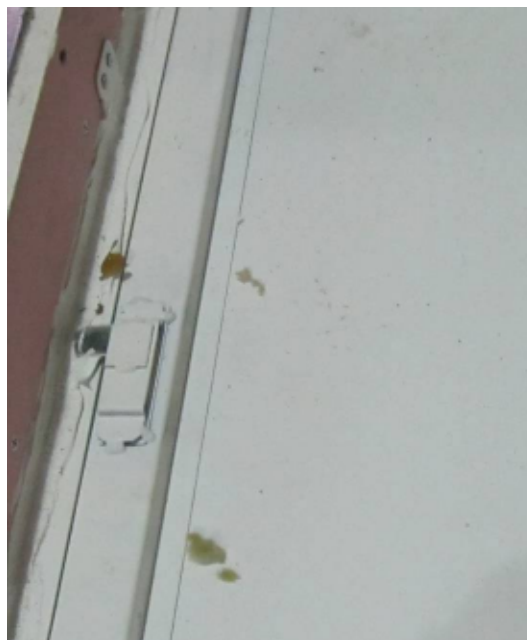
The leaf profile included a box section channel along the closing edge, onto which a Budget lock was mounted on the unexposed face. The results of this test were obtained with the access panel leaf closed with the Budget lock engaged.

Make/type	Location
Hinge	Steel pivot pin	See figure 2
Closer	None fitted	-
Lock	Budget lock	Fitted on the unexposed face of the lock box section
Furniture	Removable grommet	Fitted on the exposed face appropriate to the Budget lock
