Fire Resistance Testing

Report: BMT/FEI/F15003C

Ad hoc fire resistance test performed on a steel access hatch fitted within a British Gypsum 60 minute specification ceiling membrane section

Test conducted to the temperature and pressure conditions of BS476: Part 20: 1987 (and current FTSG Resolutions where applicable)

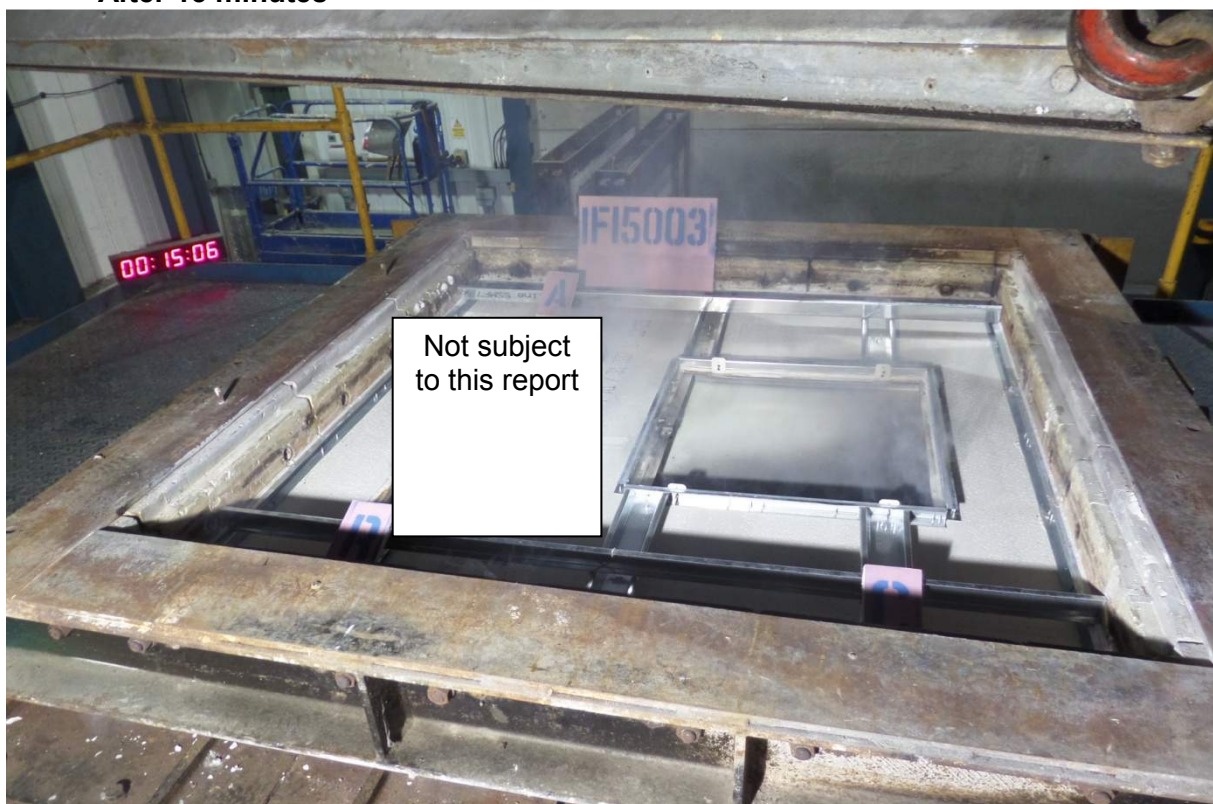
After 15 minutes

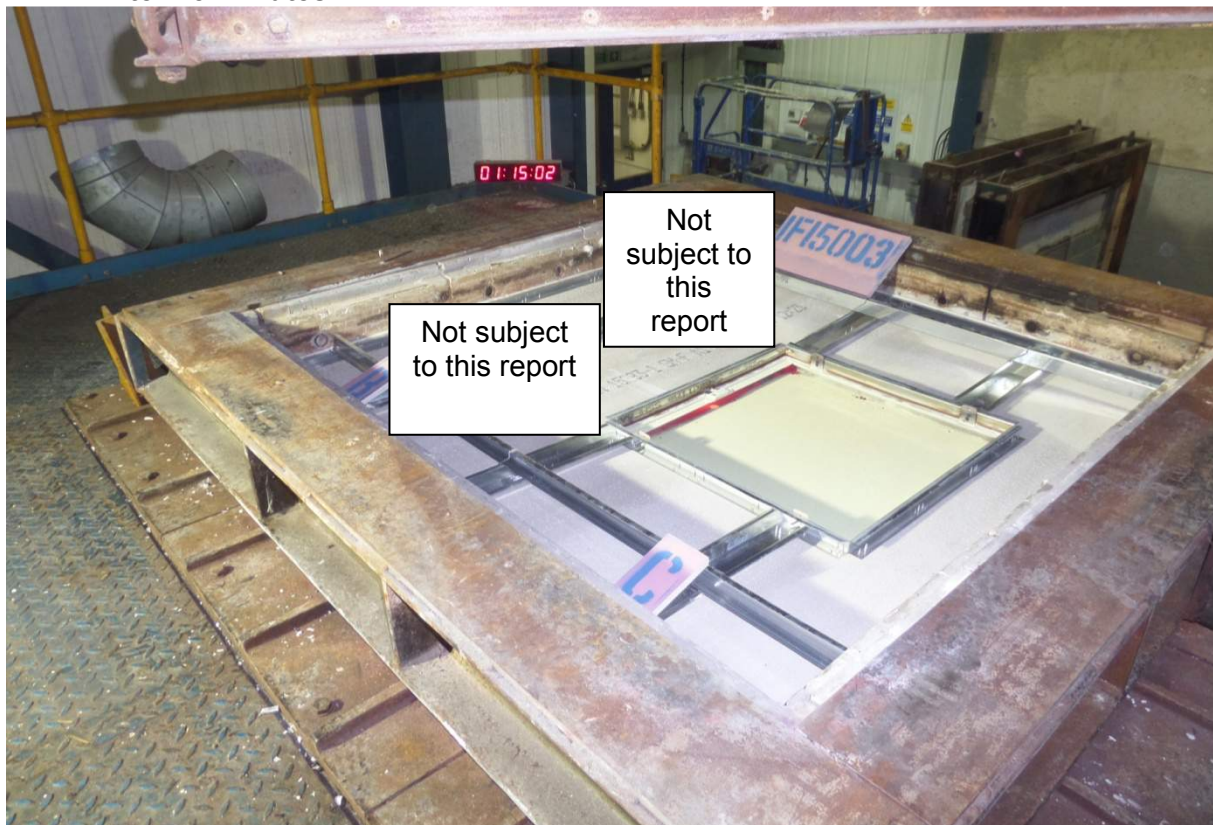
After 75 minutes

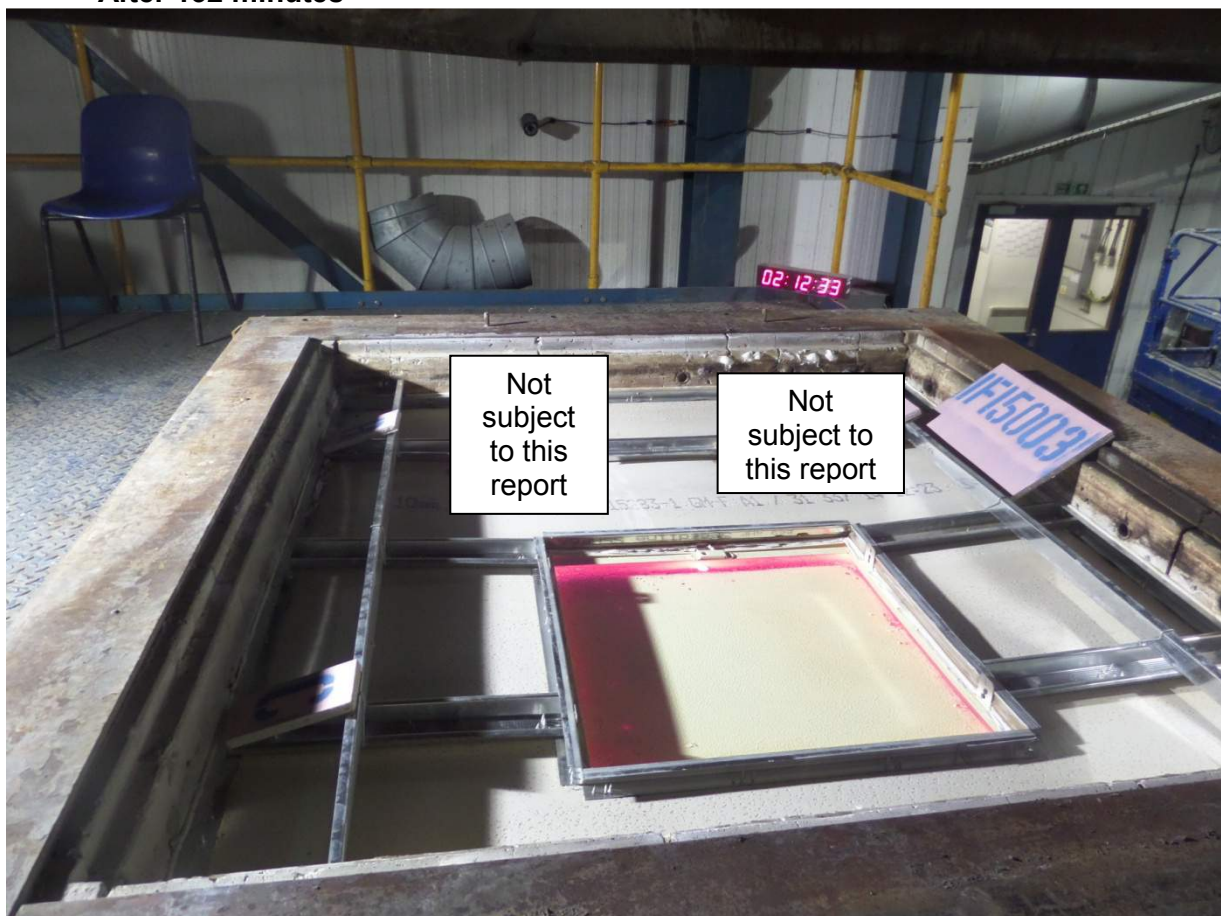
After 132 minutes
