Report: Chilt/IF13036 Revision A

A fire resistance test performed on an insulated single leaf single acting steel access panel

**Test conducted in accordance with
BSEN 1634-1: 2008 and
BSEN 1363-1 1999**

Summary of specimen: Access panel – steel single leaf single acting

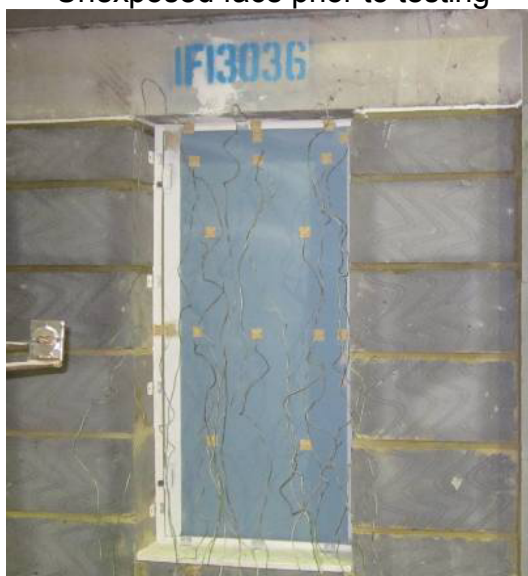
Unexposed face prior to testing

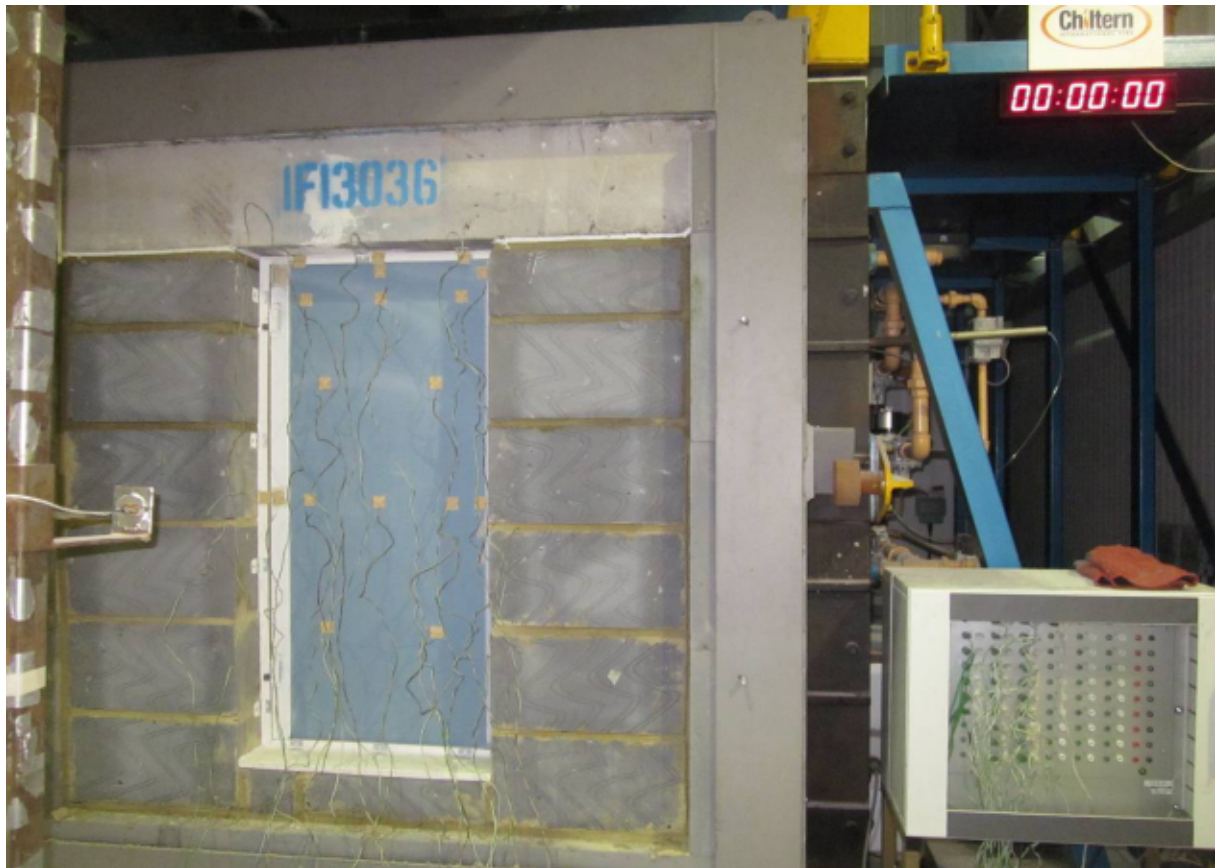
At start of test

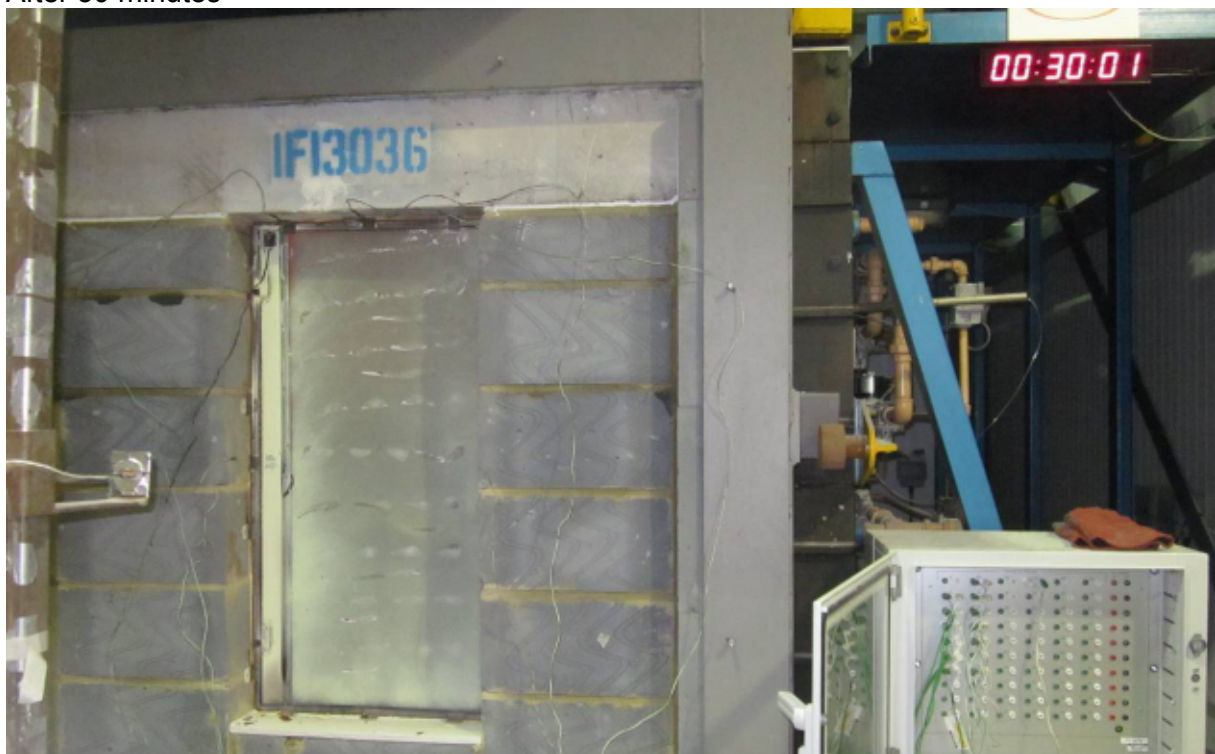
After 30 minutes

22.00	The top half of the closing edge of the leaf is glowing.
25.00	All smoke issuing has stopped.
* 29.03	A cotton pad integrity test was performed at the middle of the leaf which resulted in ignition of the cotton pad thereby constituting integrity failure .*

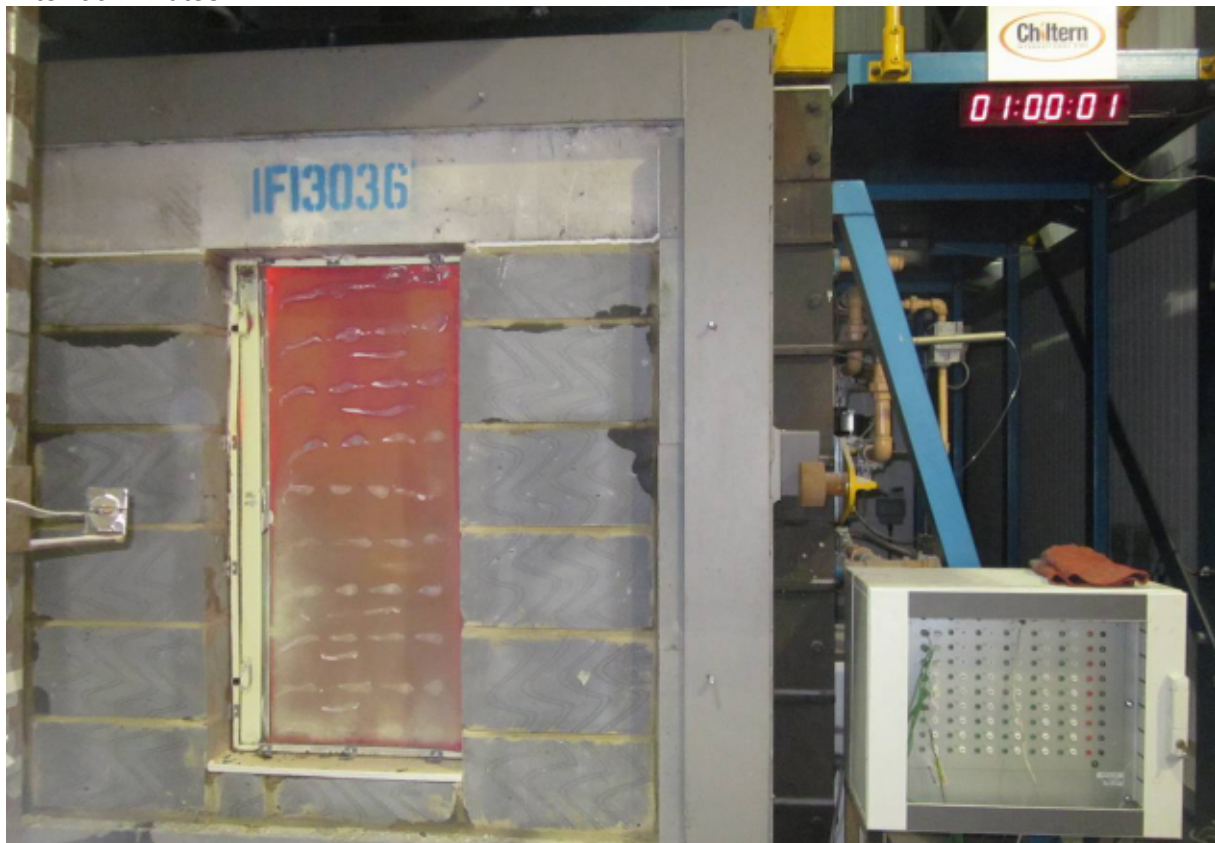
After 60 minutes

55.00	The entire leaf face is glowing.
69.20	The frame at the closing edge of the leaf is glowing.

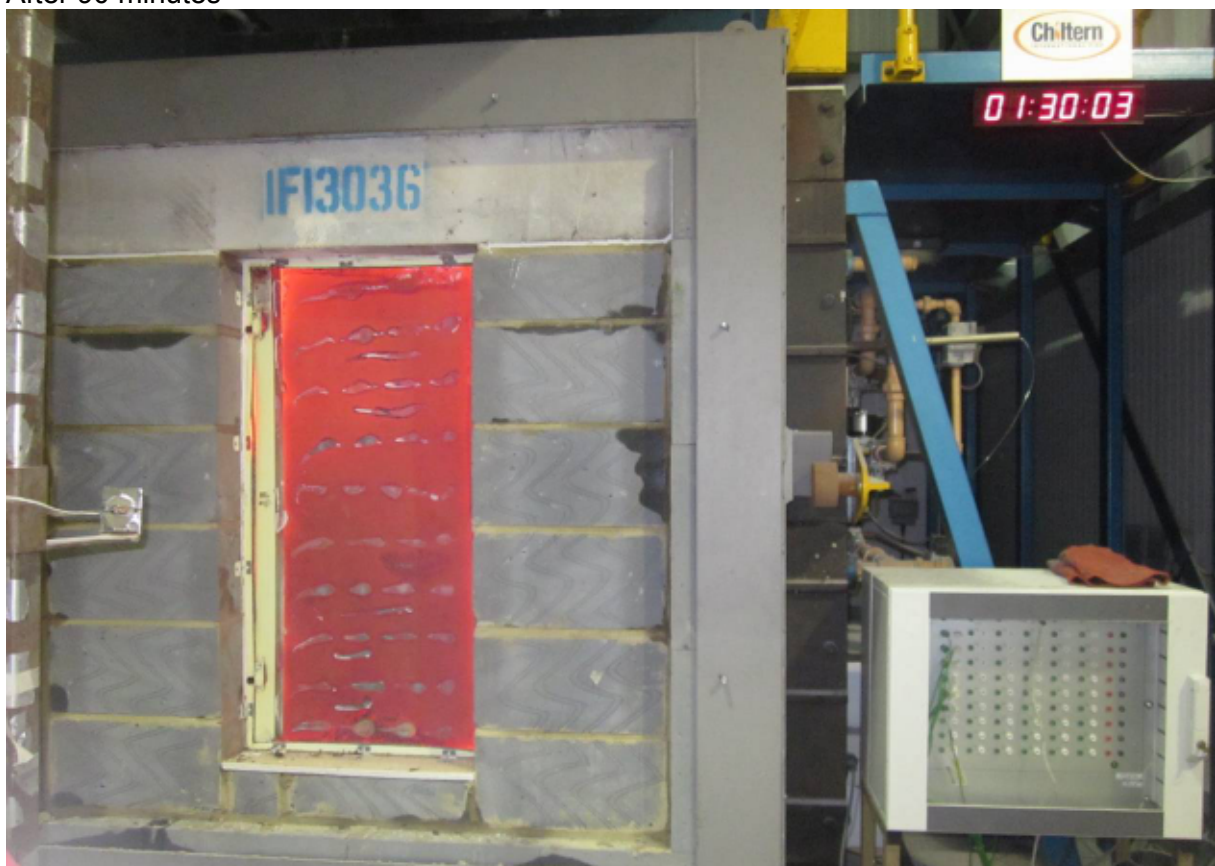
After 90 minutes

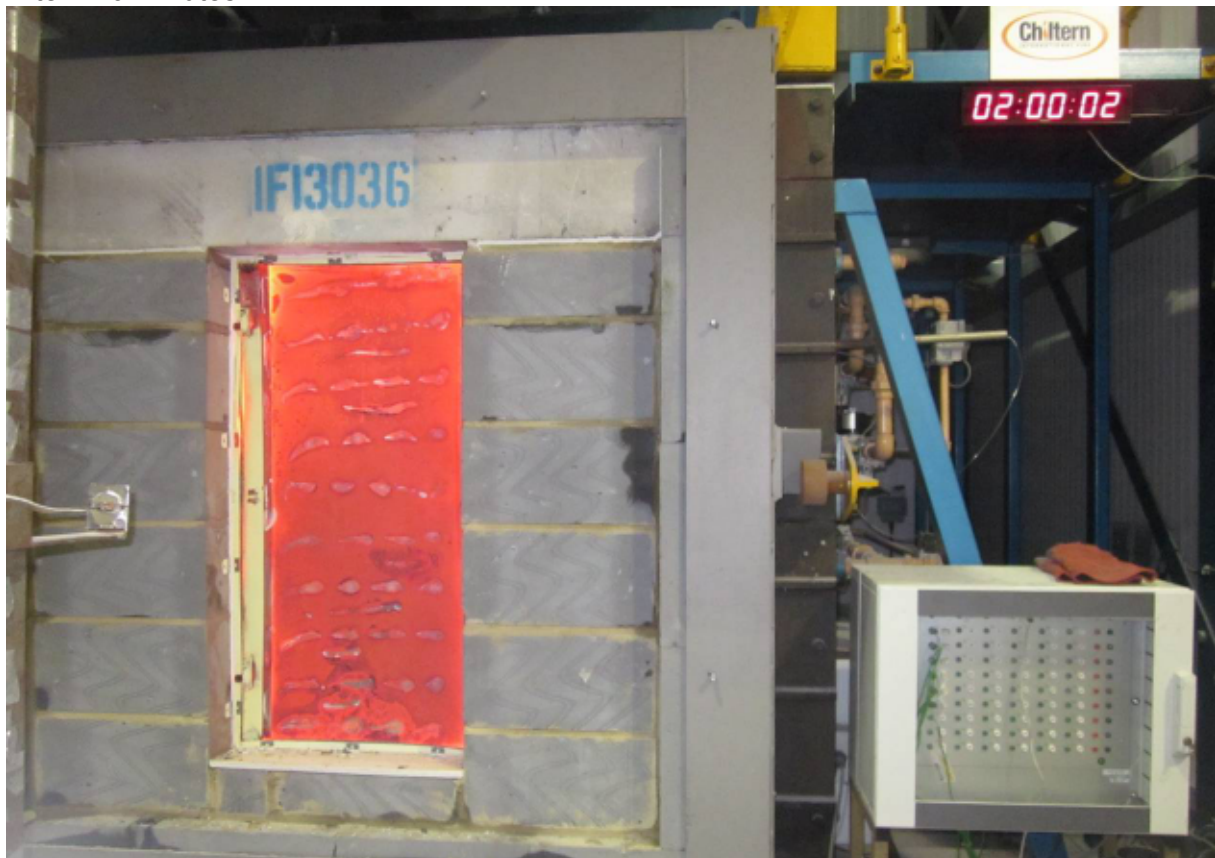
After 120 minutes

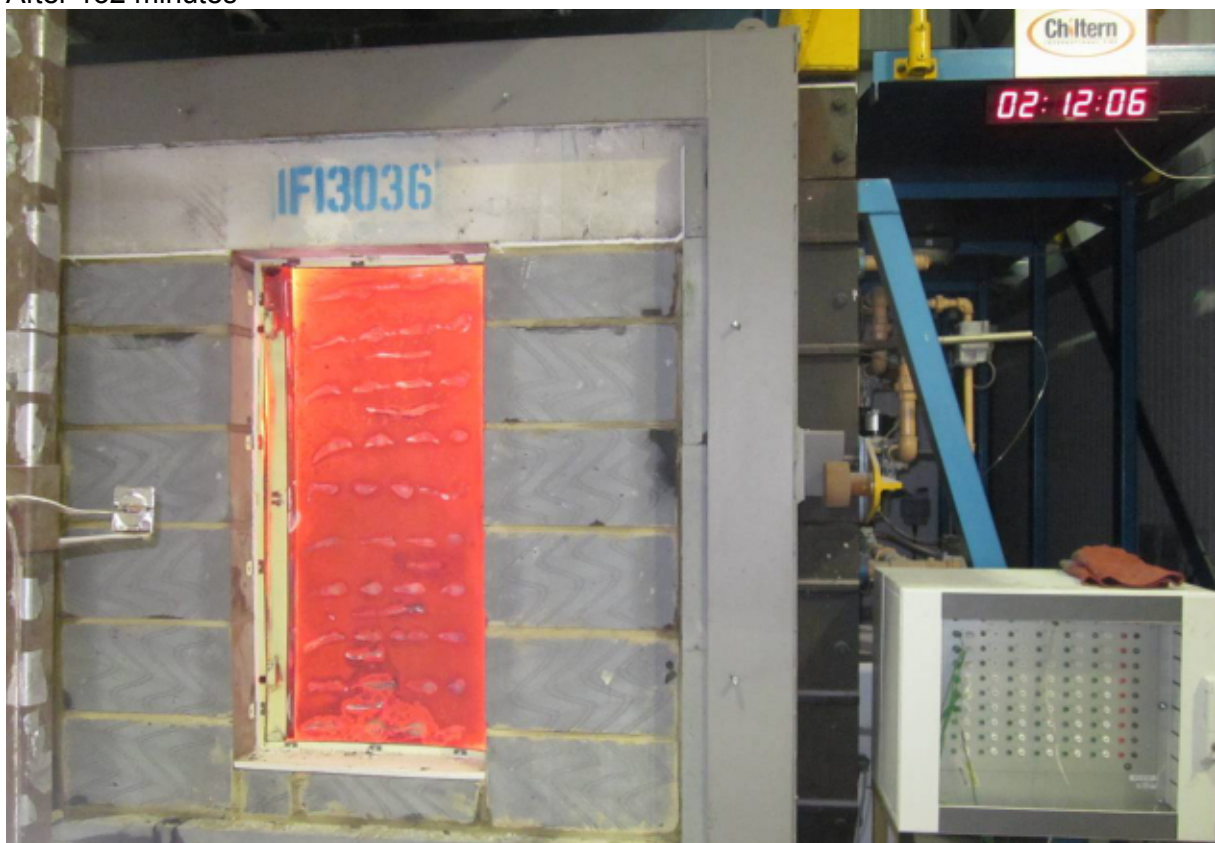
After 132 minutes

132.00 Test terminated.
