**Fire resistance test in
accordance with B.S.
476 : Part 22 : 1987 on a
double-leaf access
panel.**

Prepared for:
Fire Proofing services Ltd.,
13 Shilton Road,
Barwell,
Leicestershire,
LE9 8NB

Test report number 248908

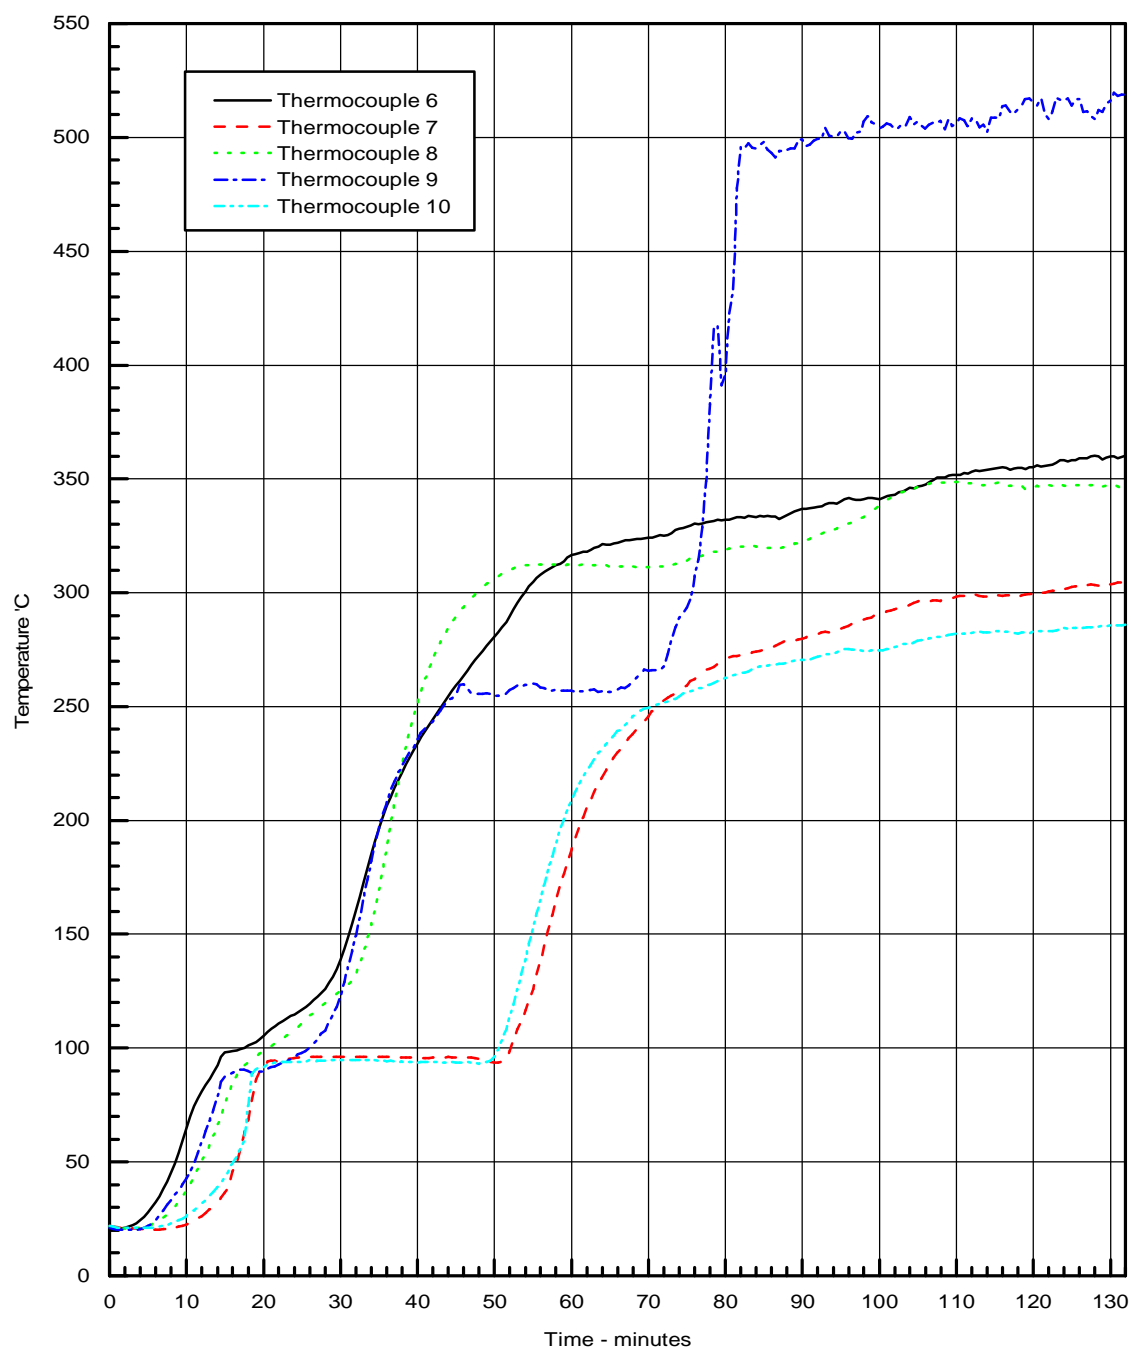
Temperatures recorded on the unexposed face by thermocouples 6 to 10.

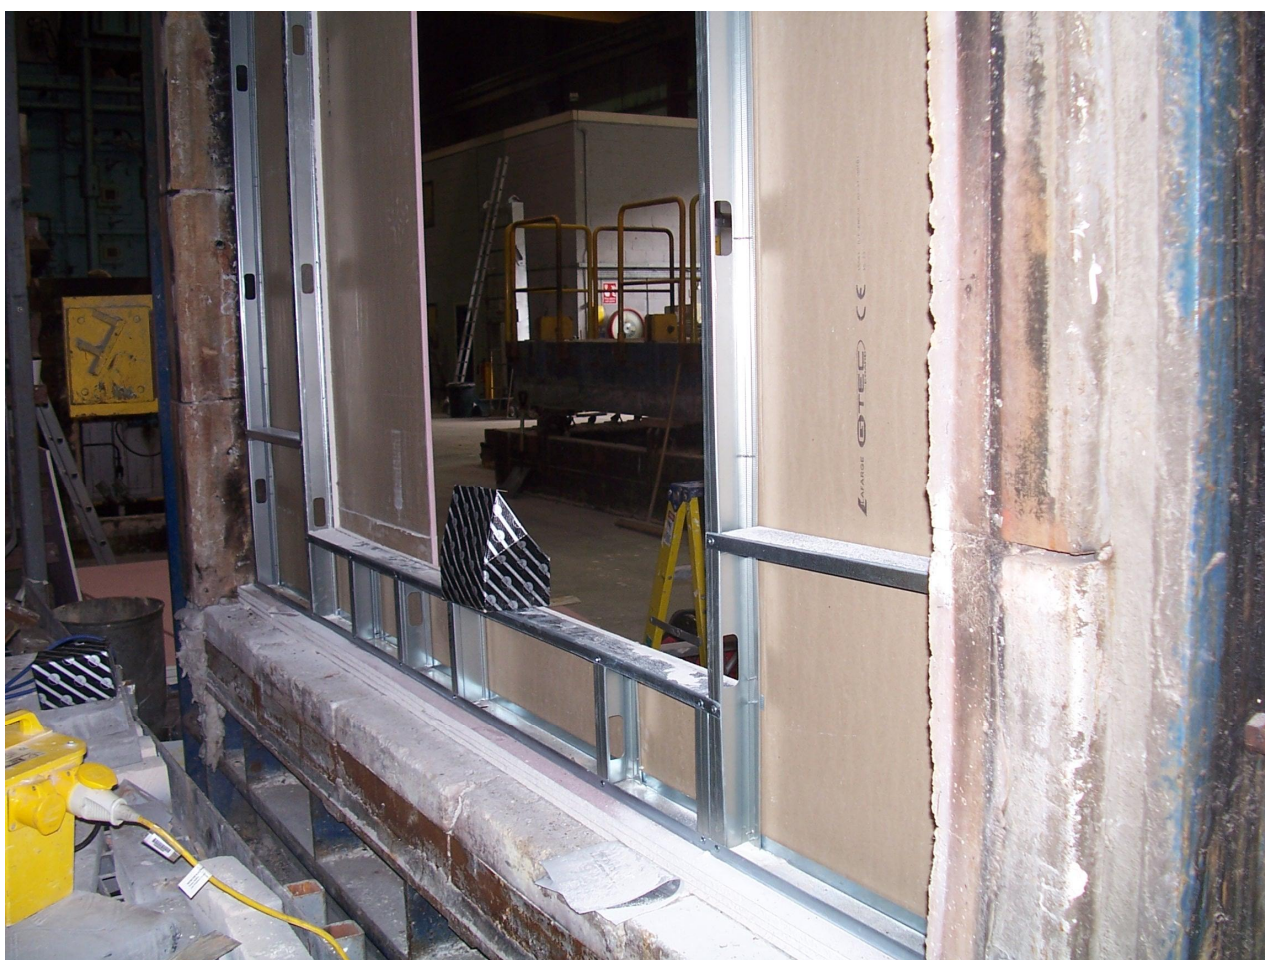
Partition during construction.

Galvanised steel track, 70mm wide x 30mm deep, was secured to the top and bottom of the test frame using M6 x 75mm "Thunderbolts" at nominally 600mm centres. Vertical galvanised steel studs, 70mm wide x 33mm deep, were located nominally 25mm away from each edge of the test frame, with a further two studs nominally 590mm in from each edge. These studs formed the sides of the specimen opening. Two lengths of track were now fitted between these two studs, one 260mm from the top and one 260mm from the bottom of the test frame to form the top and bottom of the opening for the access panel. Four additional vertical studs were then fitted at between 300mm and 600mm centres between the top and bottom tracks and the horizontal tracks forming the opening, as shown in the photographs section of this report. An additional length of track was fitted between the two vertical studs on either side of the partition, at a height of approximately 600mm. One 4.2mm x 13mm wafer head screw was used at each stud / track location.

Each side of the partition was clad with two layers of 15mm Lafarge GTEC plasterboard. All boards were screwed to the studs at nominally 300mm centres using 32mm-long drywall screws on the inside layer of boards, and 42mm-long Drywall screws on the outer layer. The boards were arranged so that the vertical joints in each layer of board on each face were staggered by a minimum of 600mm, relative to vertical joints in the immediately adjacent plasterboard layer.

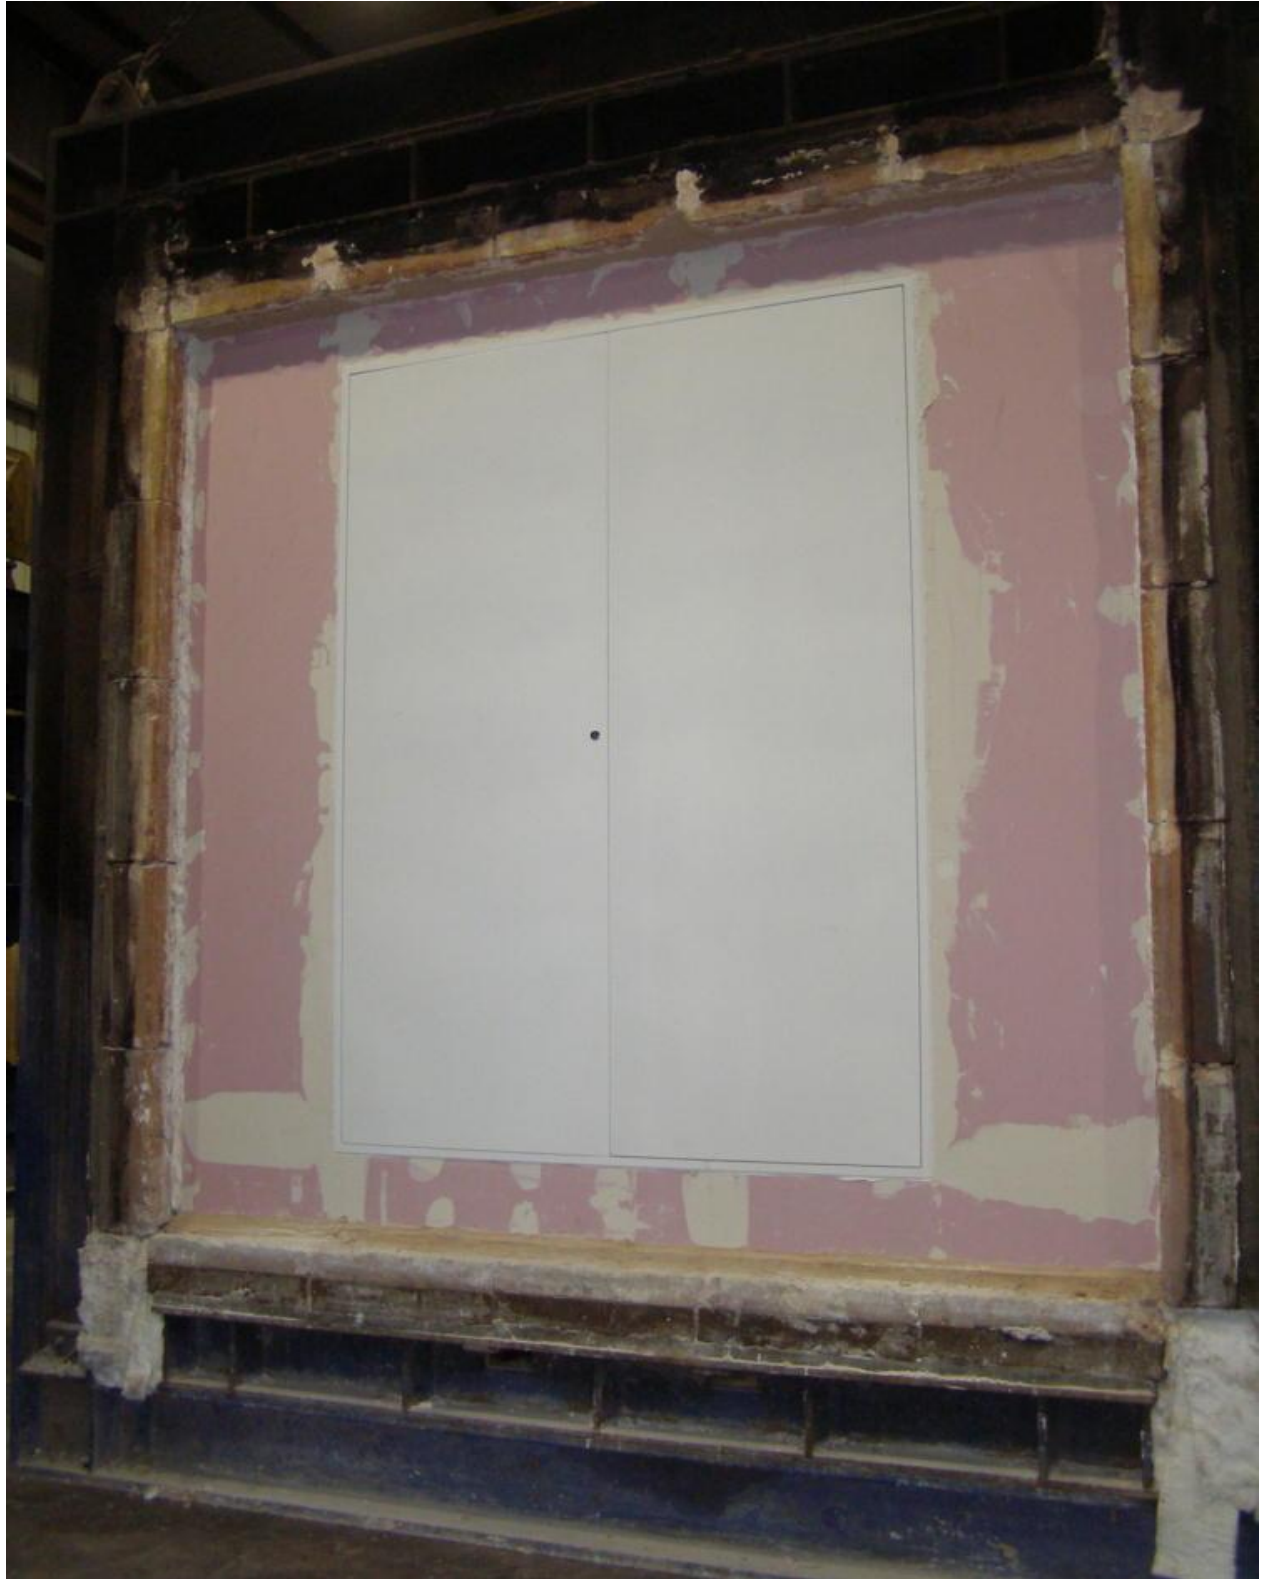
Exposed face of specimen before test.

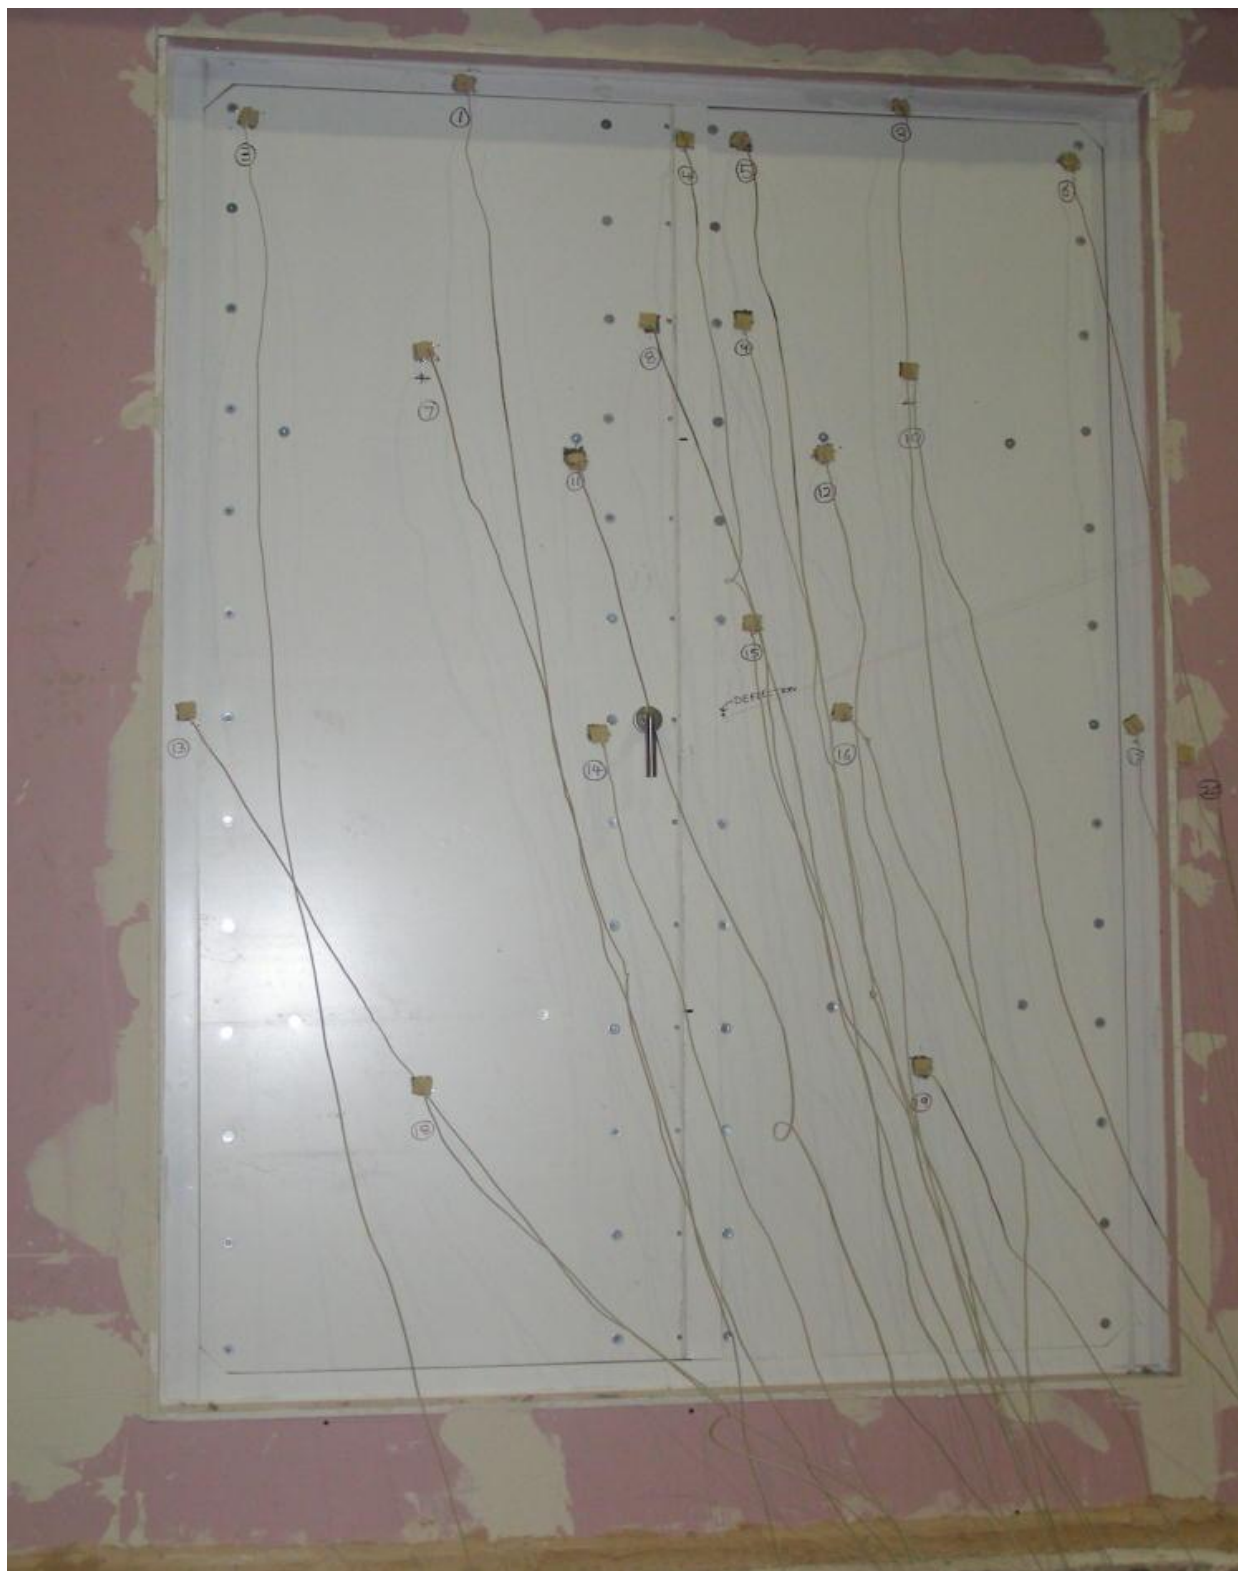
Unexposed face of specimen before test.

The temperature on the unexposed face of the specimen was measured using twenty chromel / alumel (K-type) thermocouples each soldered to a copper disc and covered with an insulating pad, 30mm x 30mm x 2mm thick, as described in B.S. 476 : Part 20 : 1987. The location of the thermocouples is given in following table and is shown in the attached photographs.

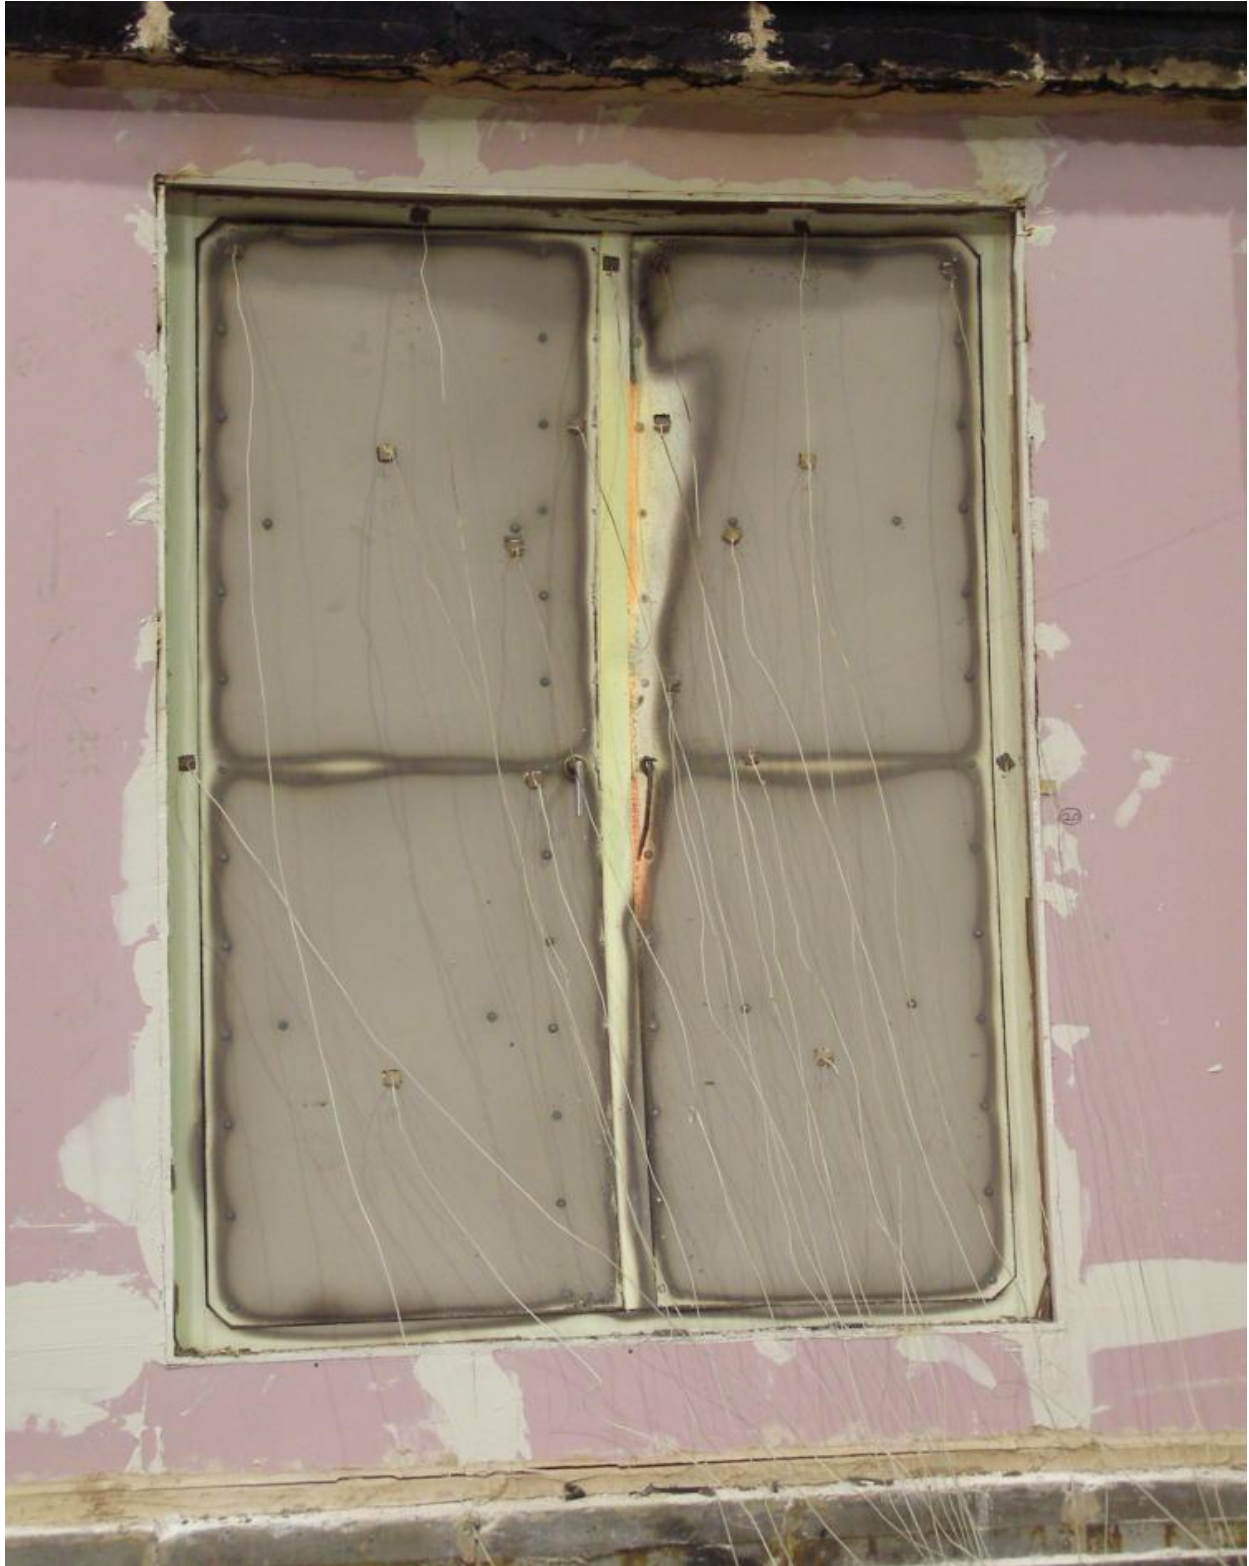
Unexposed face of specimen at end of test.

70	A localised hot area is forming across the leaves at approximately mid height.
98	An approximately 1m length of gasket has now fallen out from between the leaves, above the centre lock location. Both leaves are now darkening as they heat up.
112	Gaps between the door leaves and frame members have filled with intumescent char.
132	Test stopped.

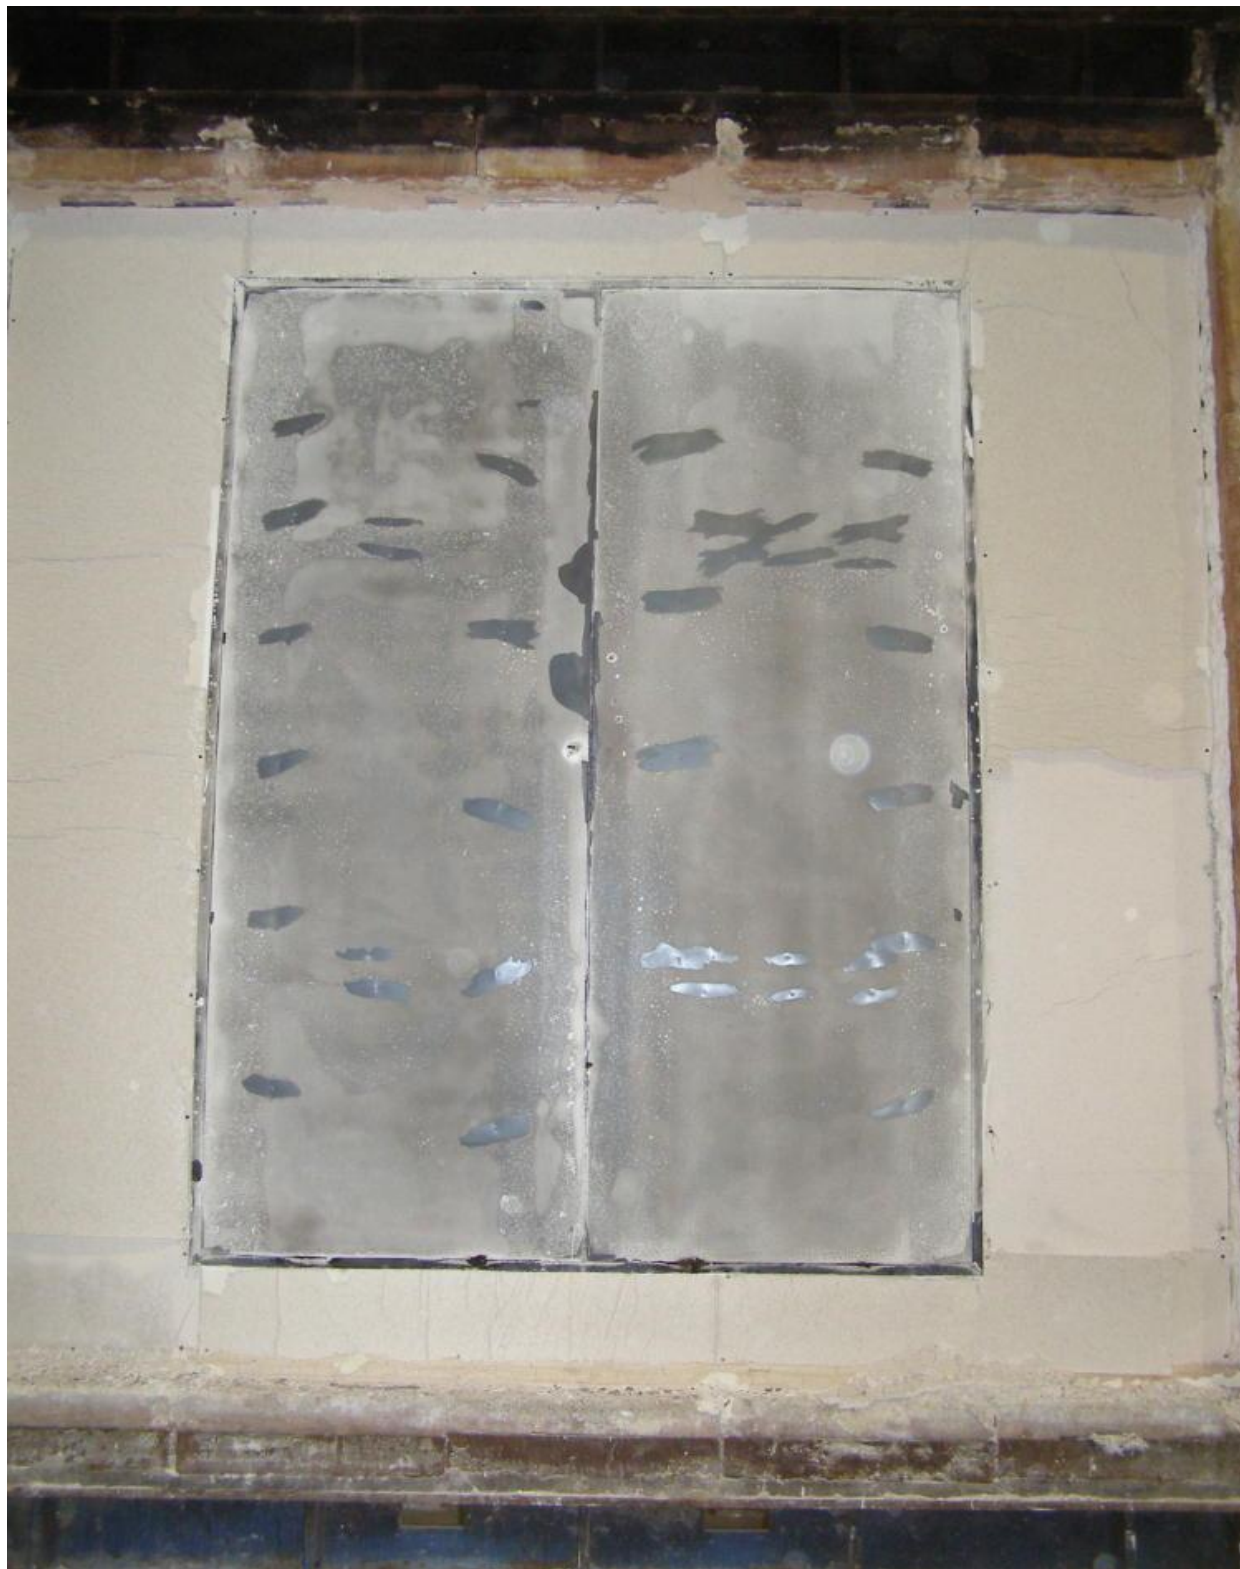
Exposed face of specimen after test.
