**Fire resistance test in
accordance with BS 476
: Part 22 : 1987 on a
single-leaf hinged
access panel in a
plasterboard partition**

Prepared for:
Fire Proofing Services Ltd,
Evolution House
Aston Road
Nuneaton
CV11 5EL

Test report number 232236

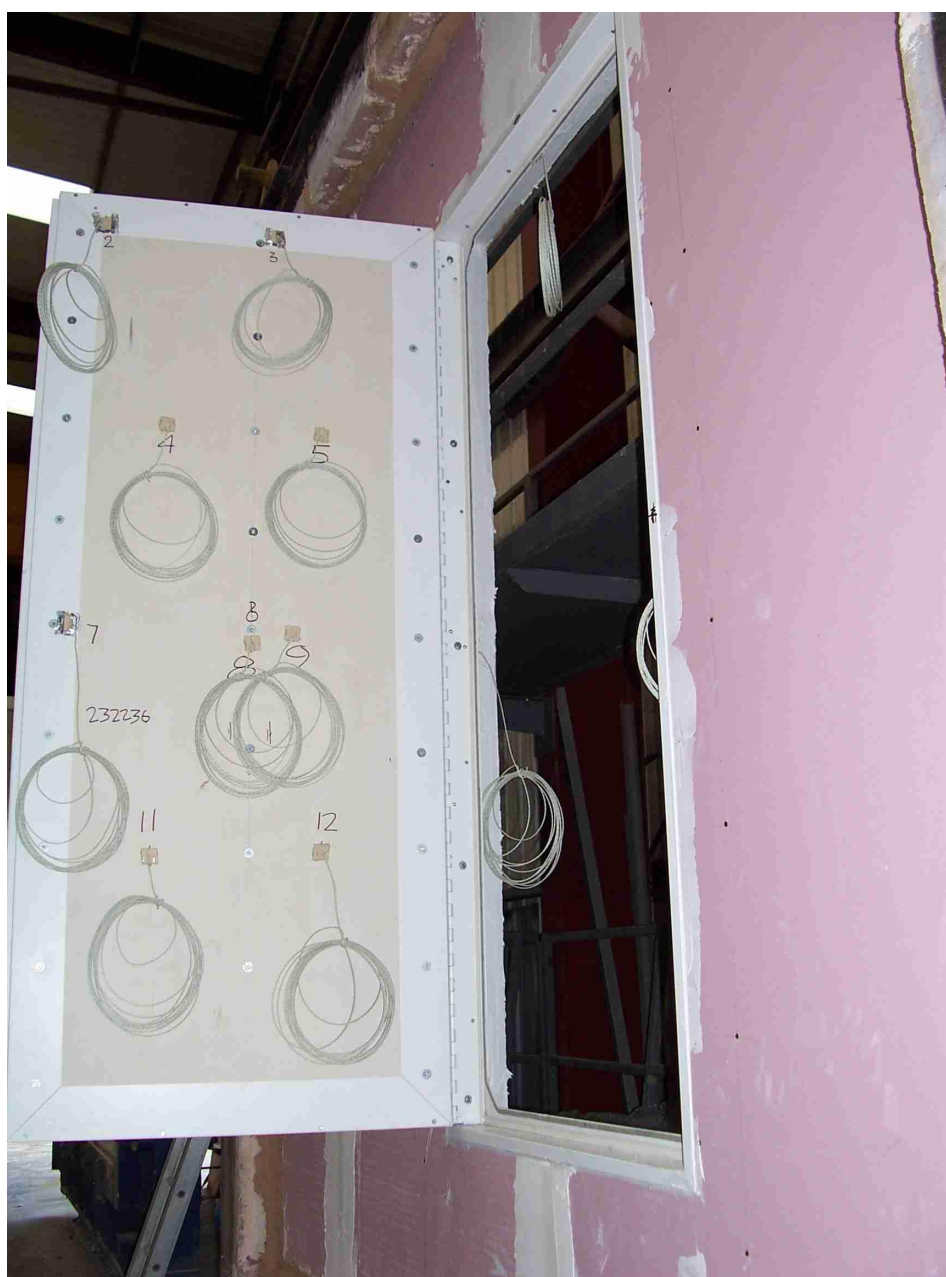
Photo 1 Open access panel before test

The test construction is shown in Figures 1 and 2, and also before test in Photos 1-8. Figure 2 shows one rib on the panel frame behind which the door latch acted, however there were actually two ribs 8mm apart of 1.5mm-thick steel which protruded by 14mm.

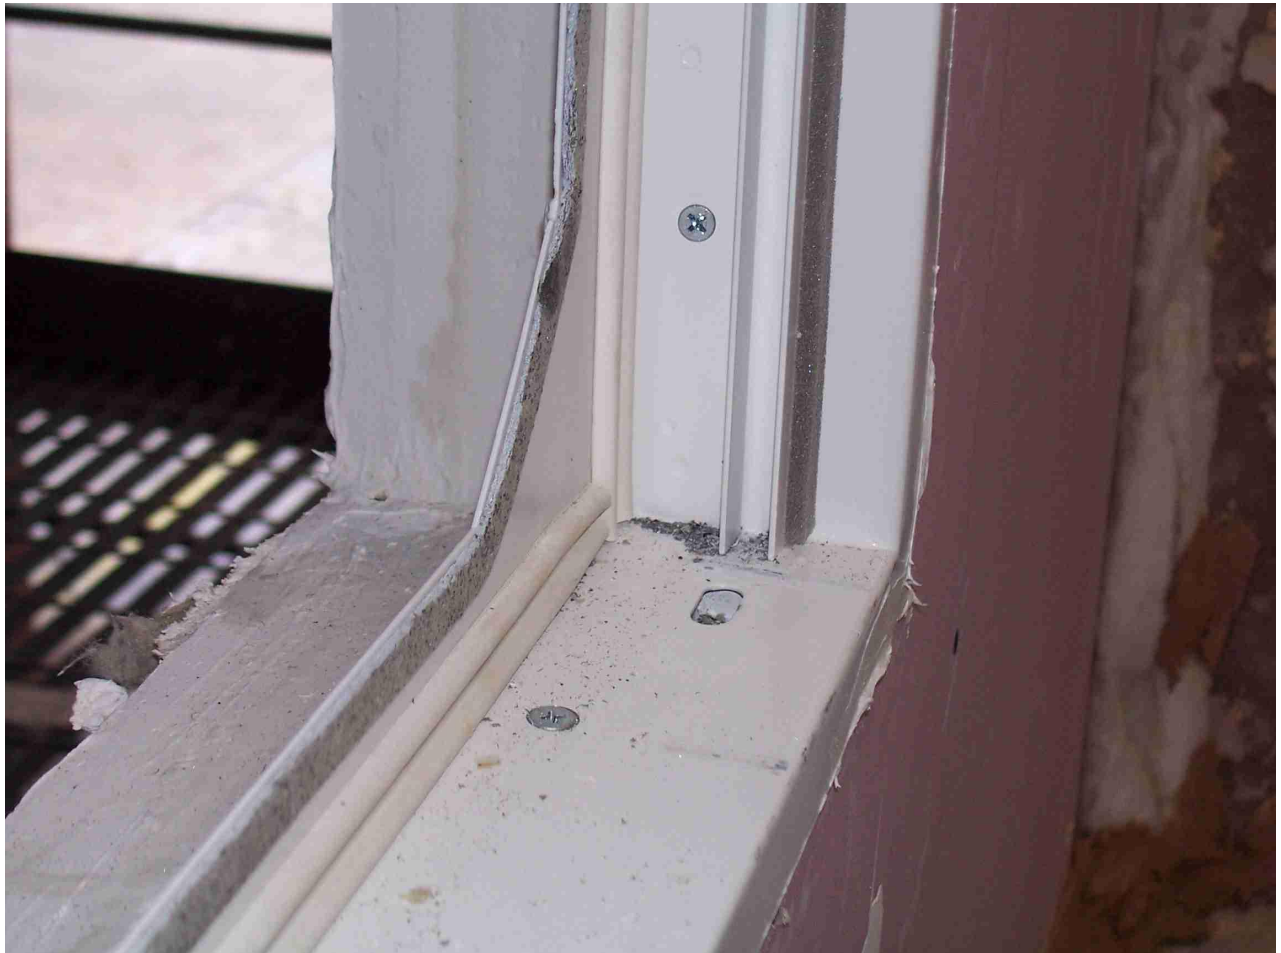
Photo 2Access panel frame before test

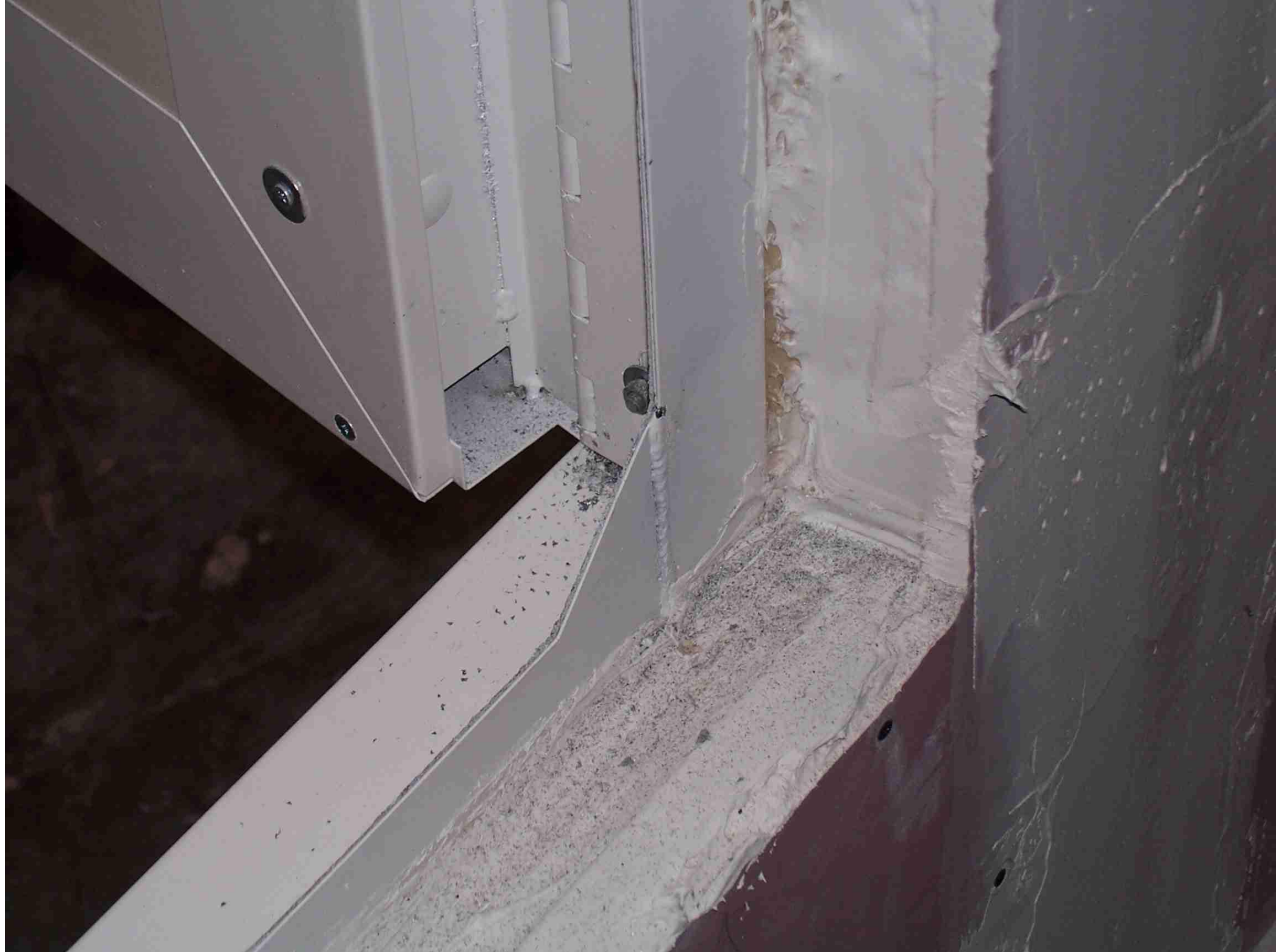
Photo 3 Access panel frame before test

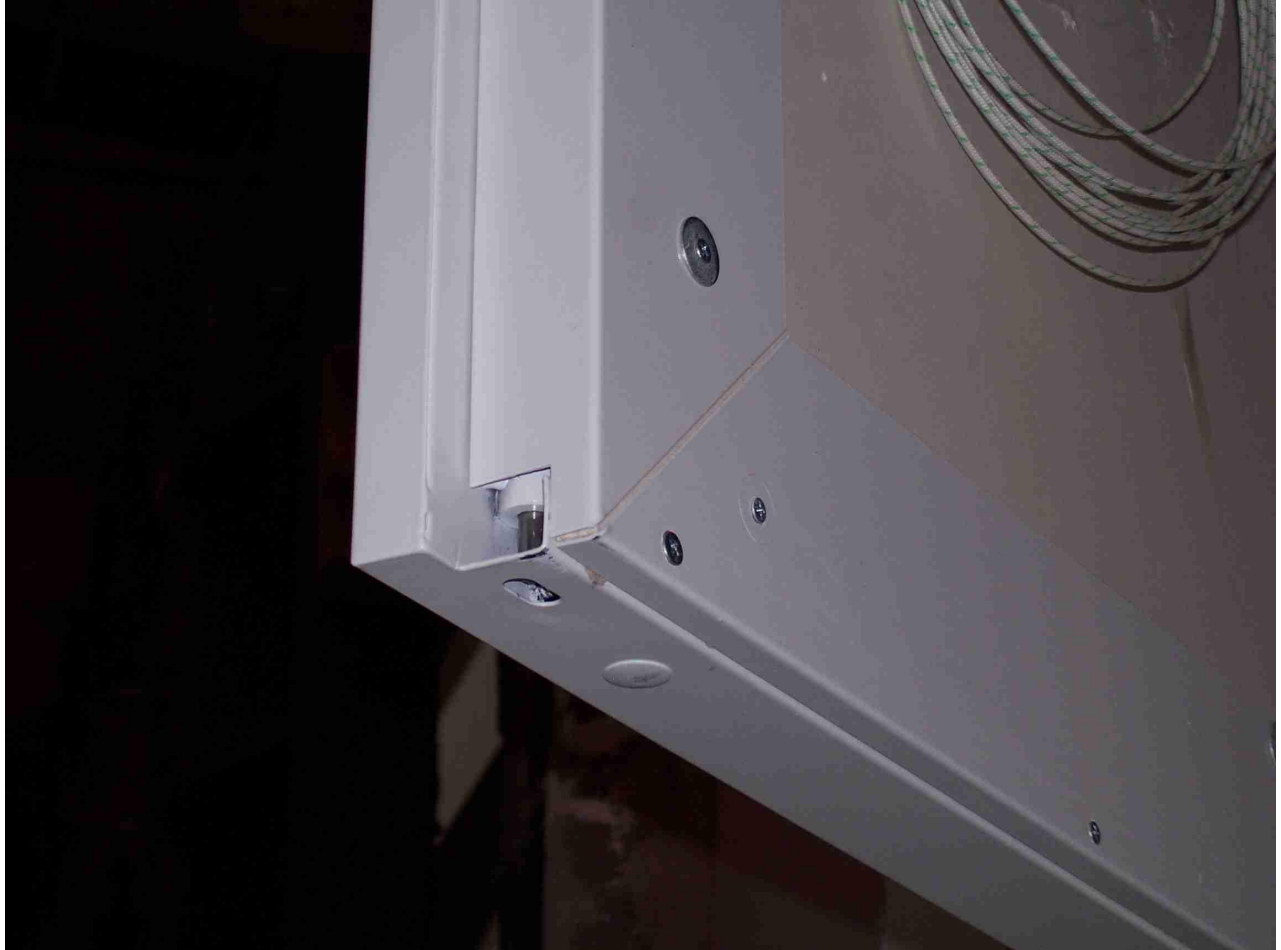
Photo 4 Open access panel leaf before test

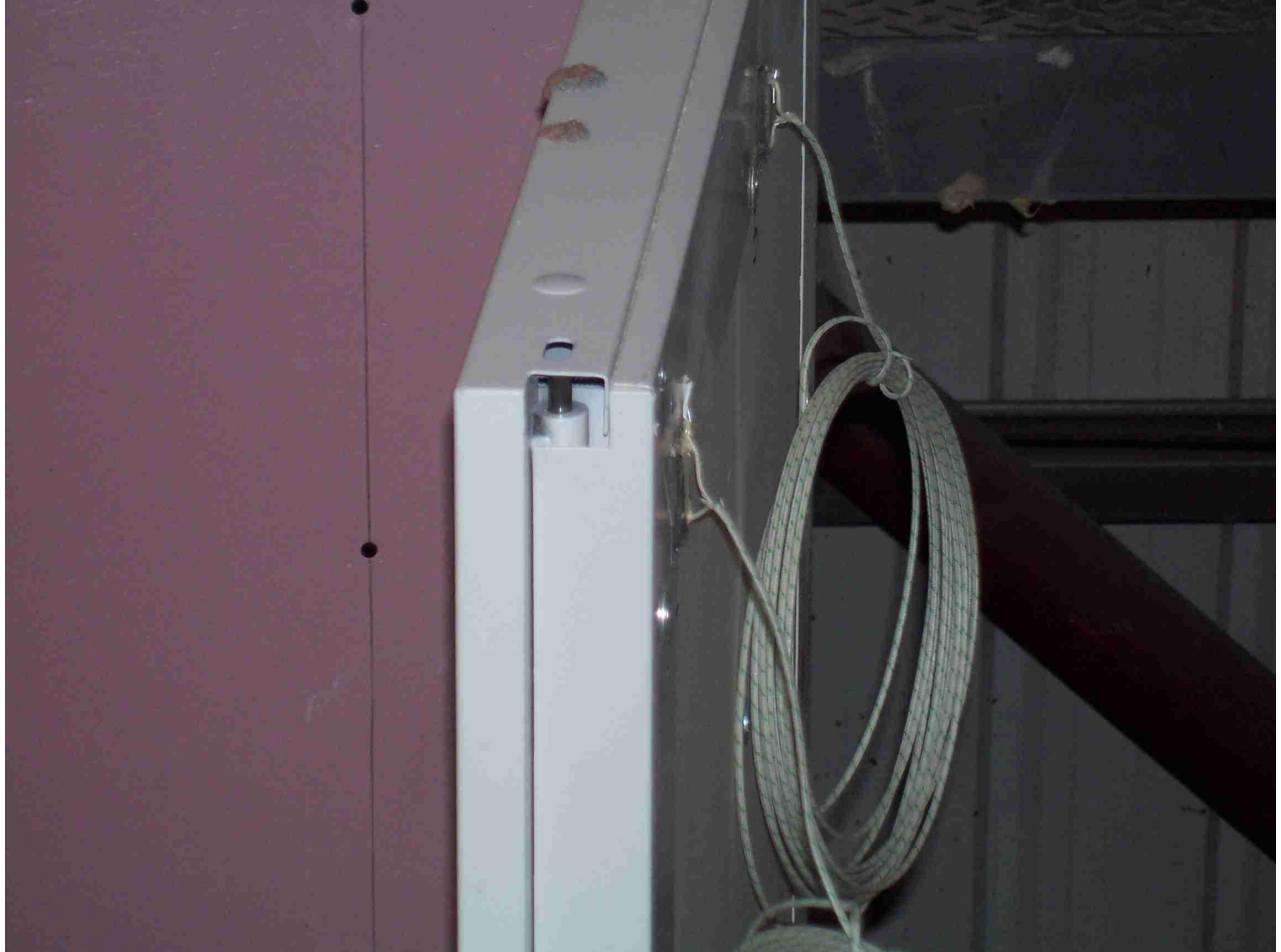
Photo 5 Open access panel leaf before test

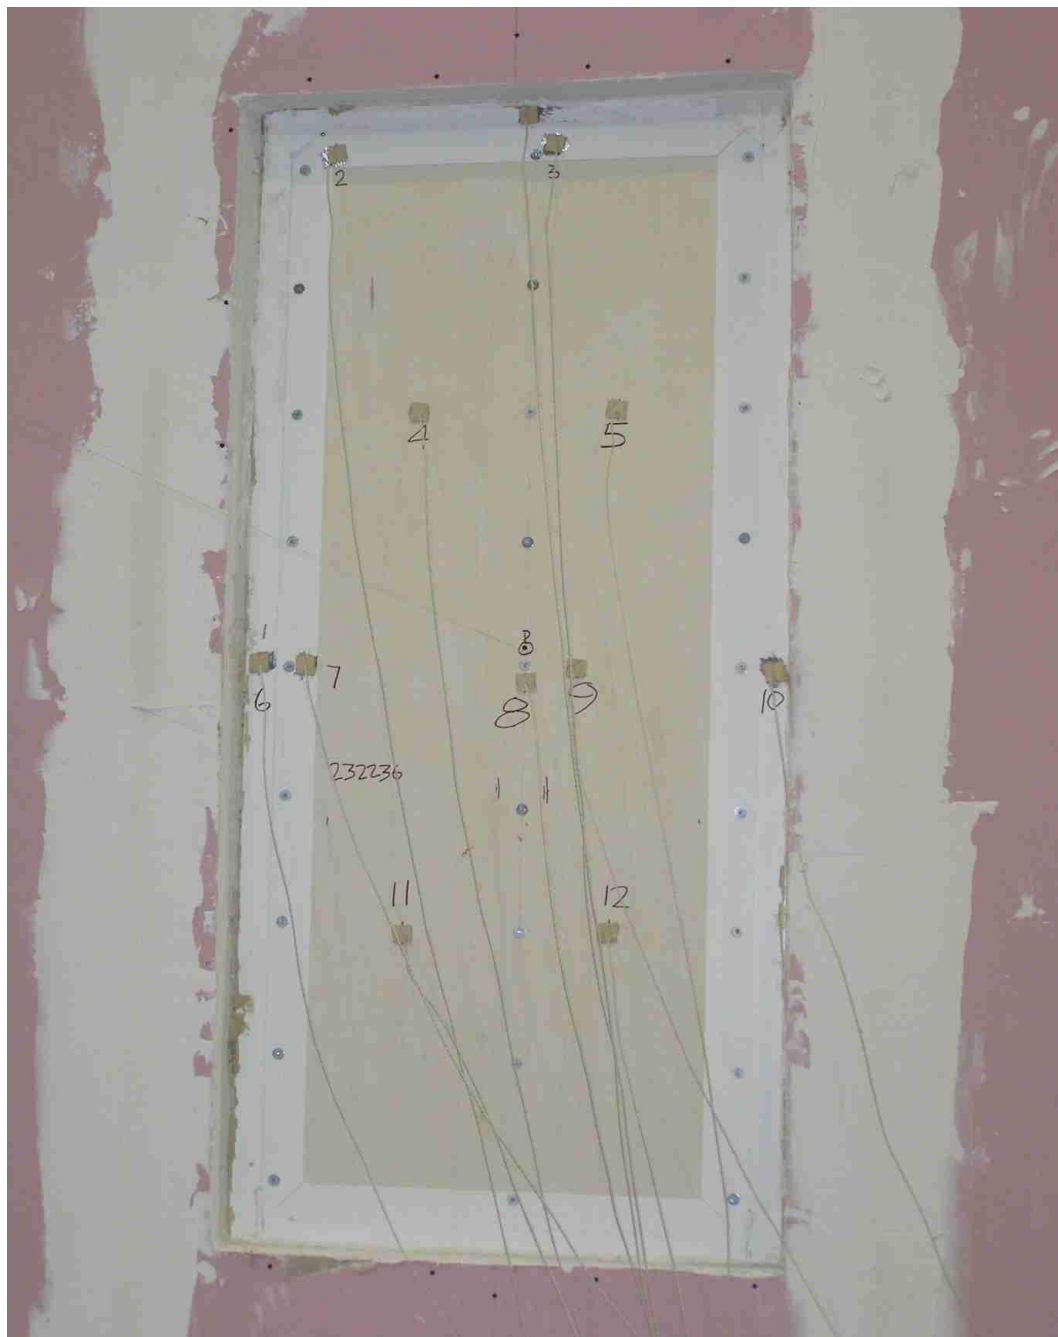
Photo 8 Unexposed face of access panel before test

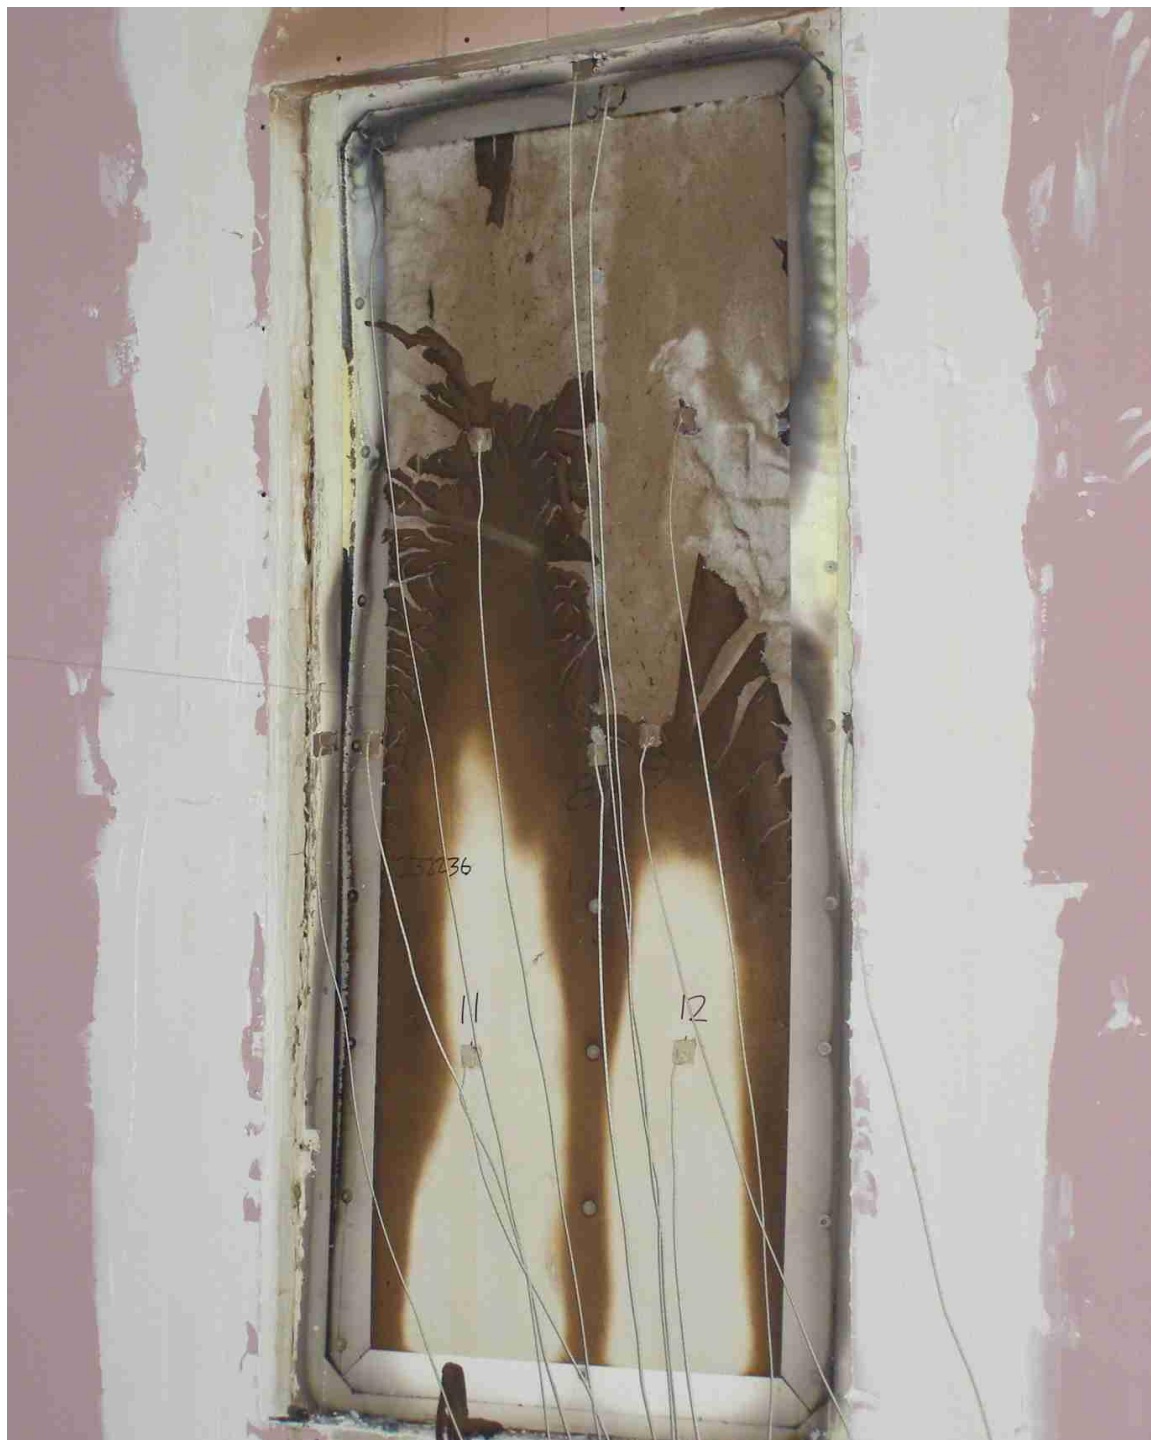
Photo 9 Unexposed face of access panel after test

57	Paper face of plasterboard on rear of leaf charred especially over upper half of leaf
69	Test stopped.

The construction after test is shown in Photos 9 and 10.
