**Fire resistance test in  
accordance with BS 476  
: Part 22 : 1987 on a  
single-leaf hinged  
access panel in a small  
plasterboard partition**

Prepared for:  
Fire Proofing Services Ltd,  
Evolution House  
Aston Road  
Nuneaton  
CV11 5EL

Test report number 232237

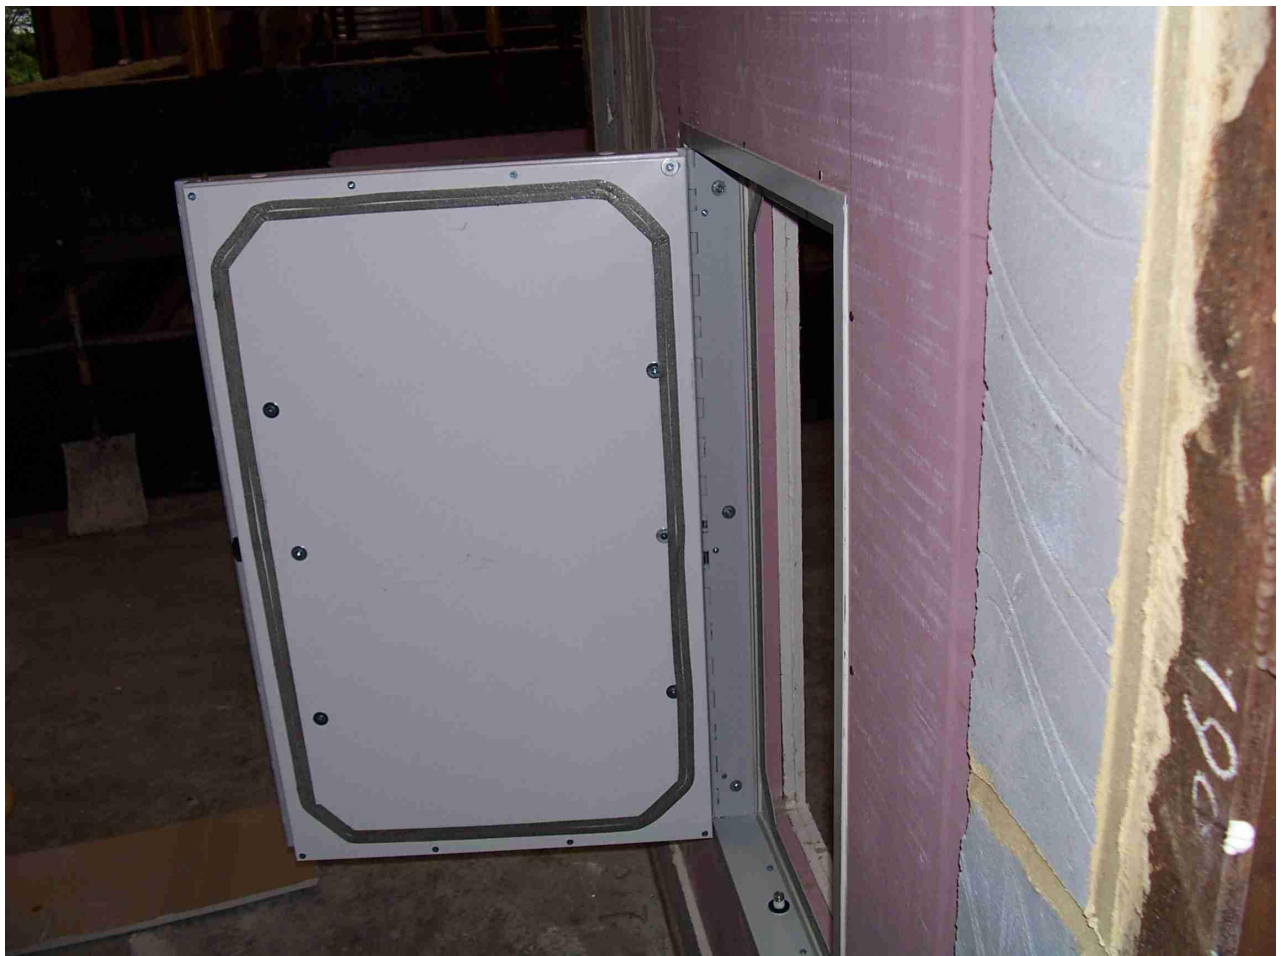
**Photo 1** Open access panel before test

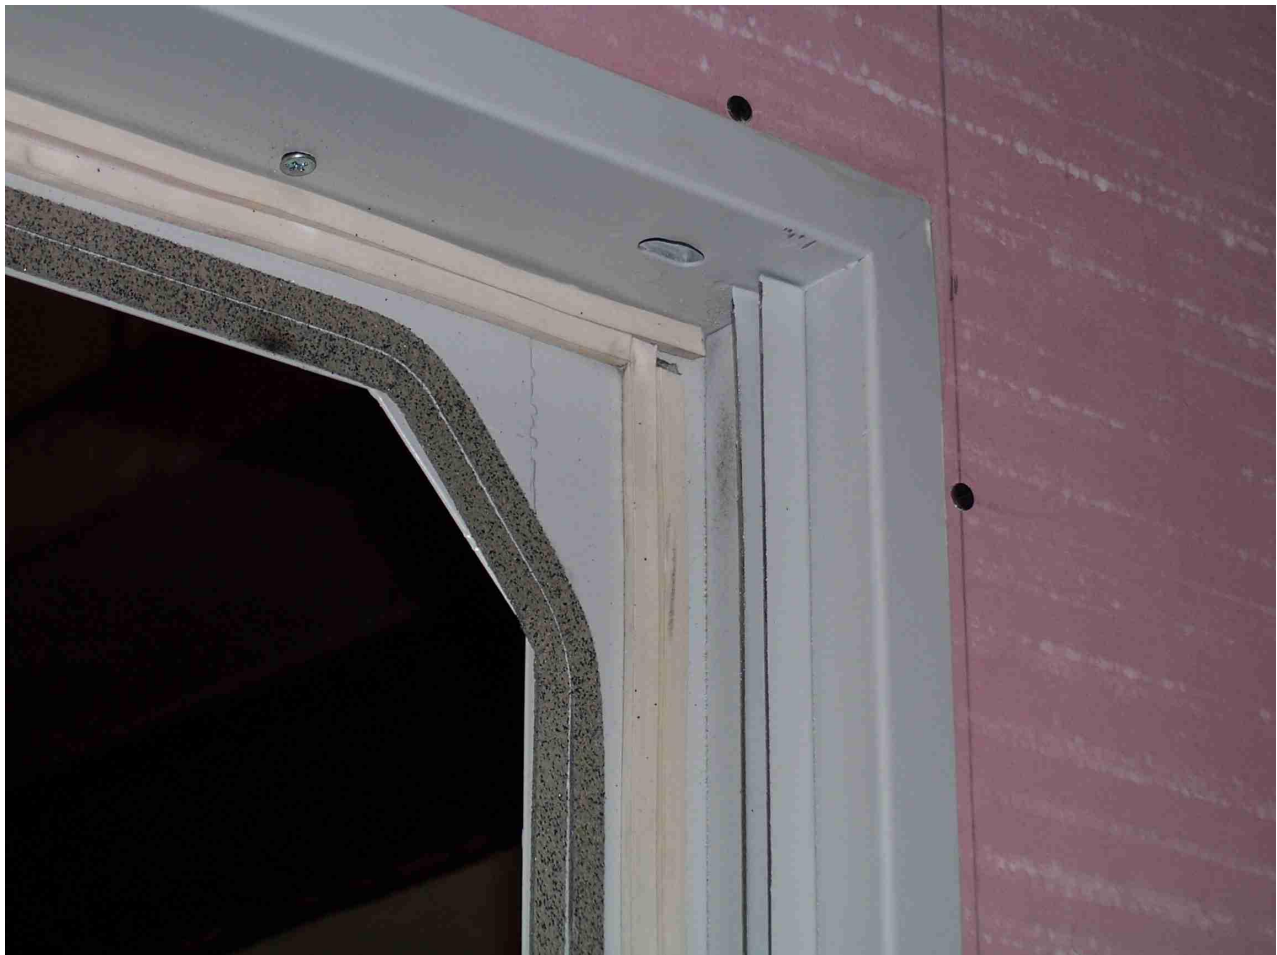
**Photo 2** Access panel frame before test

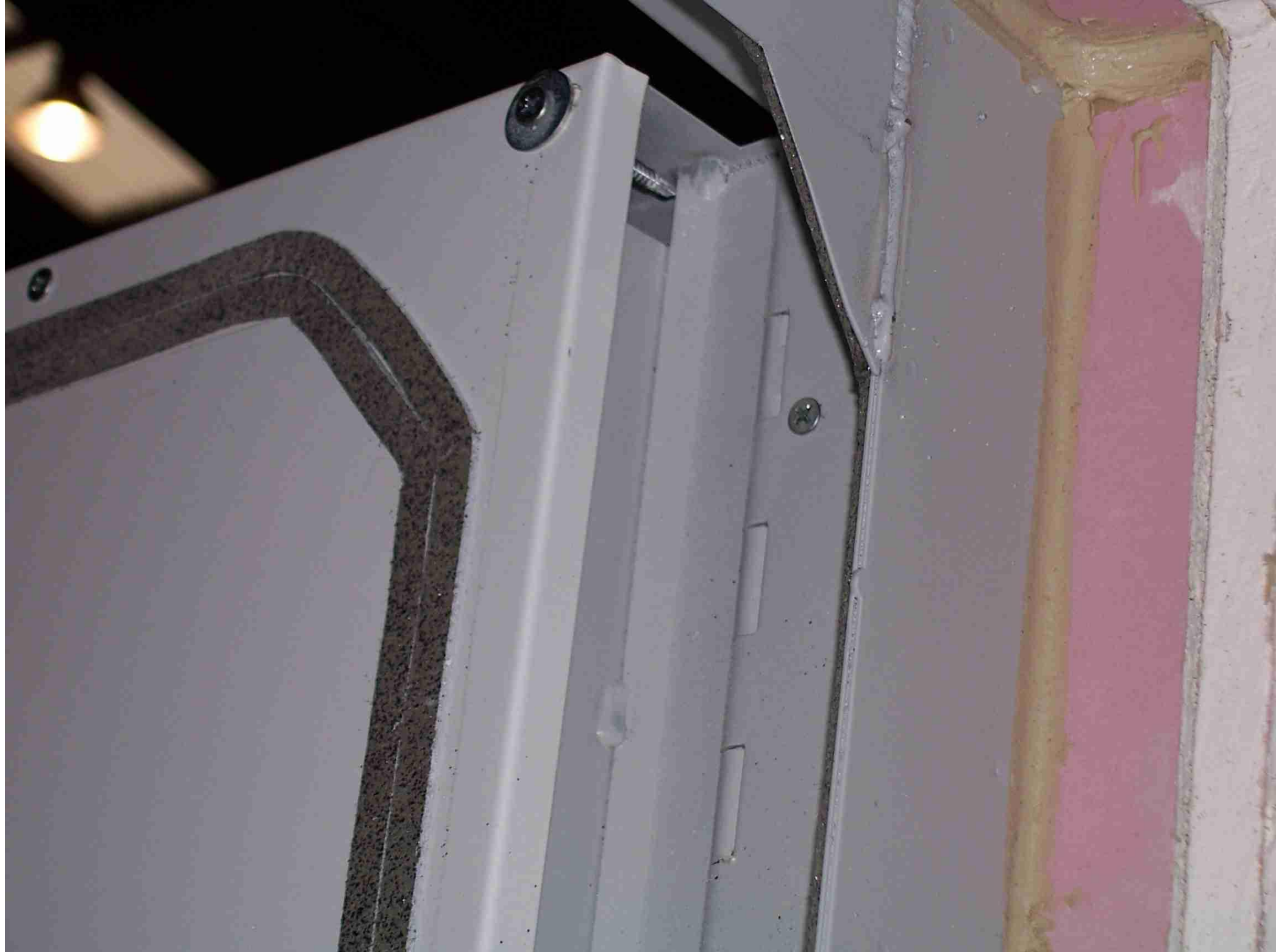
**Photo 3** Access panel frame before test

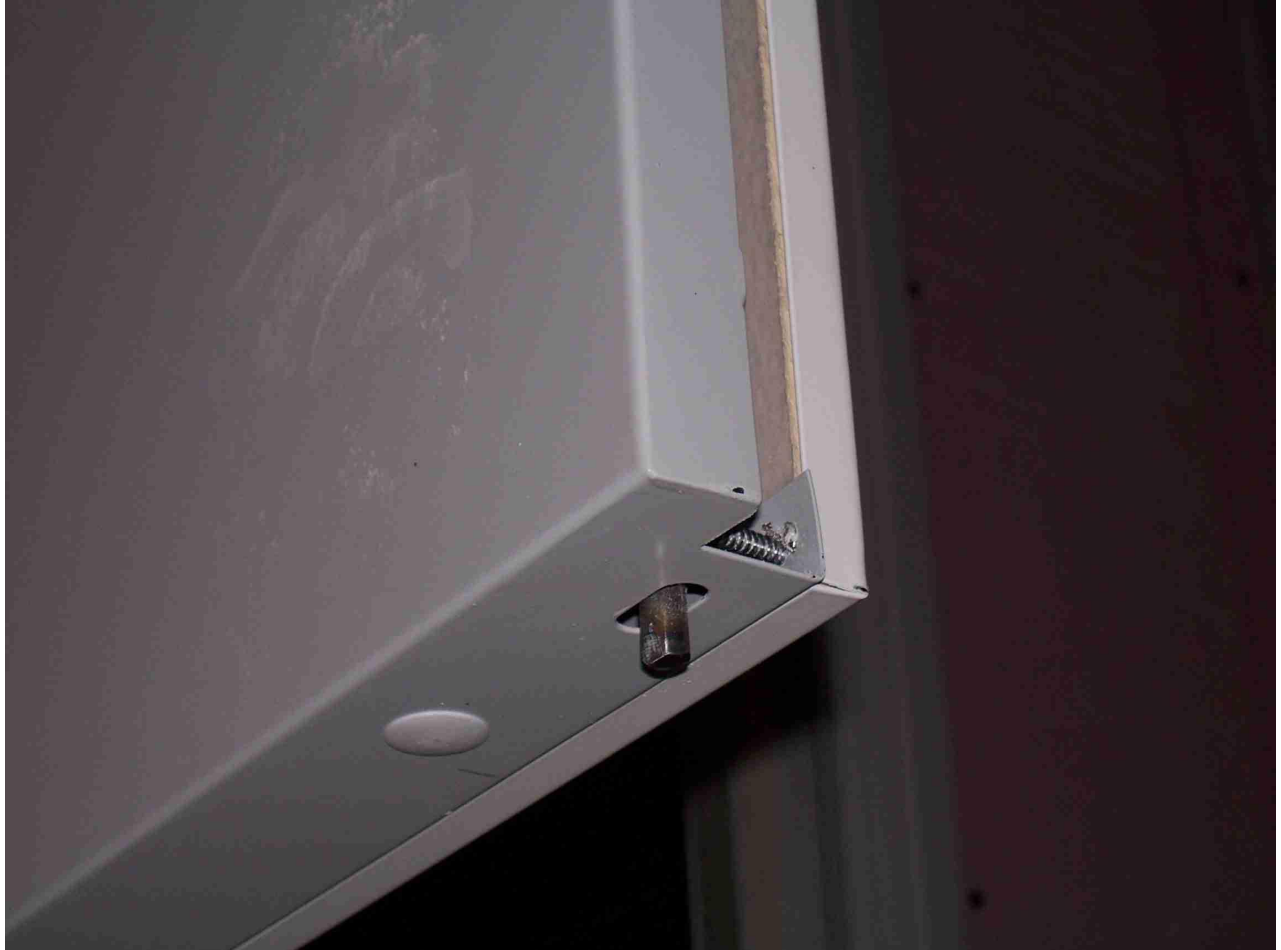
**Photo 4** Open access panel leaf before test

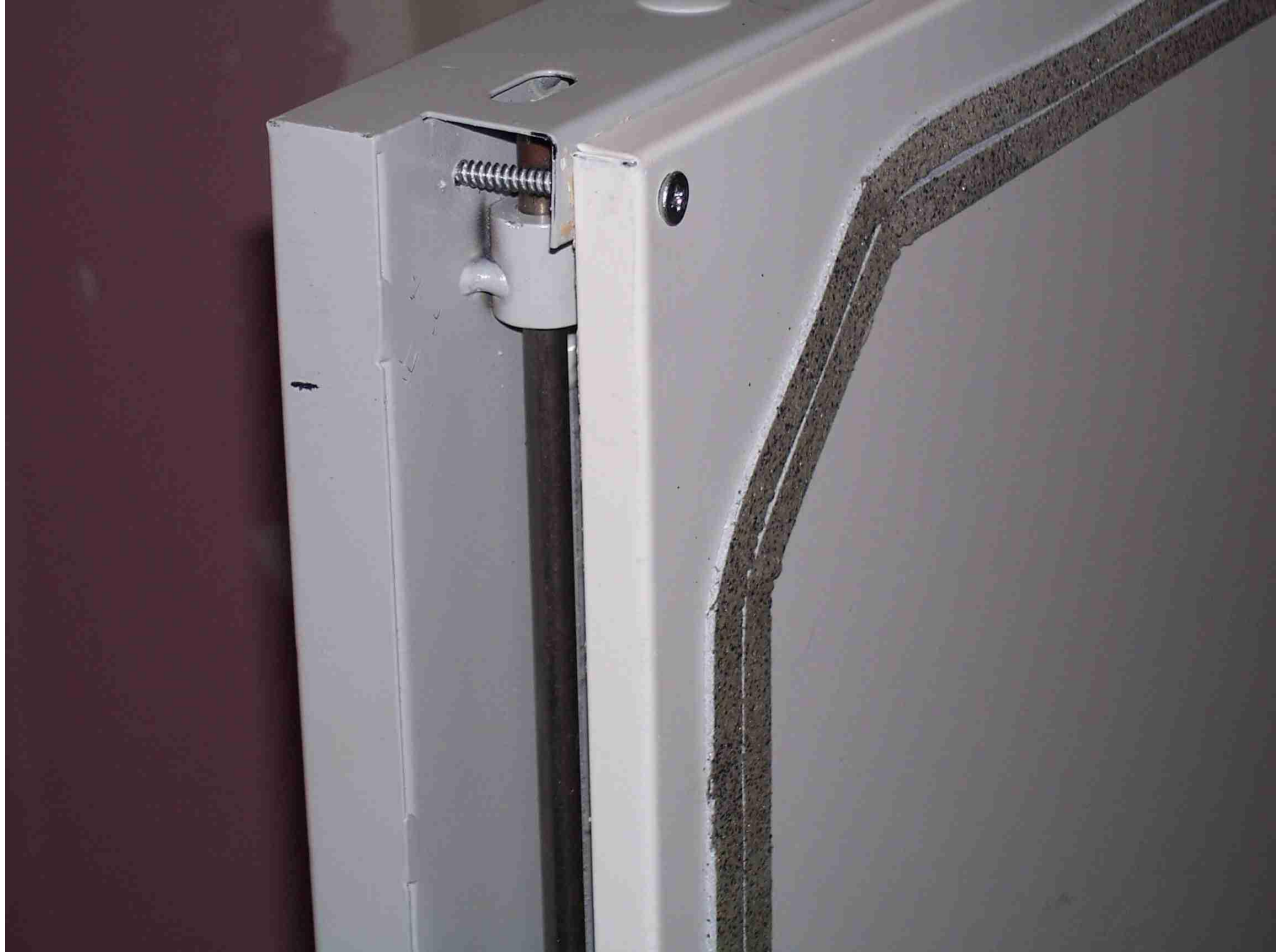
**Photo 5** Open access panel leaf before test

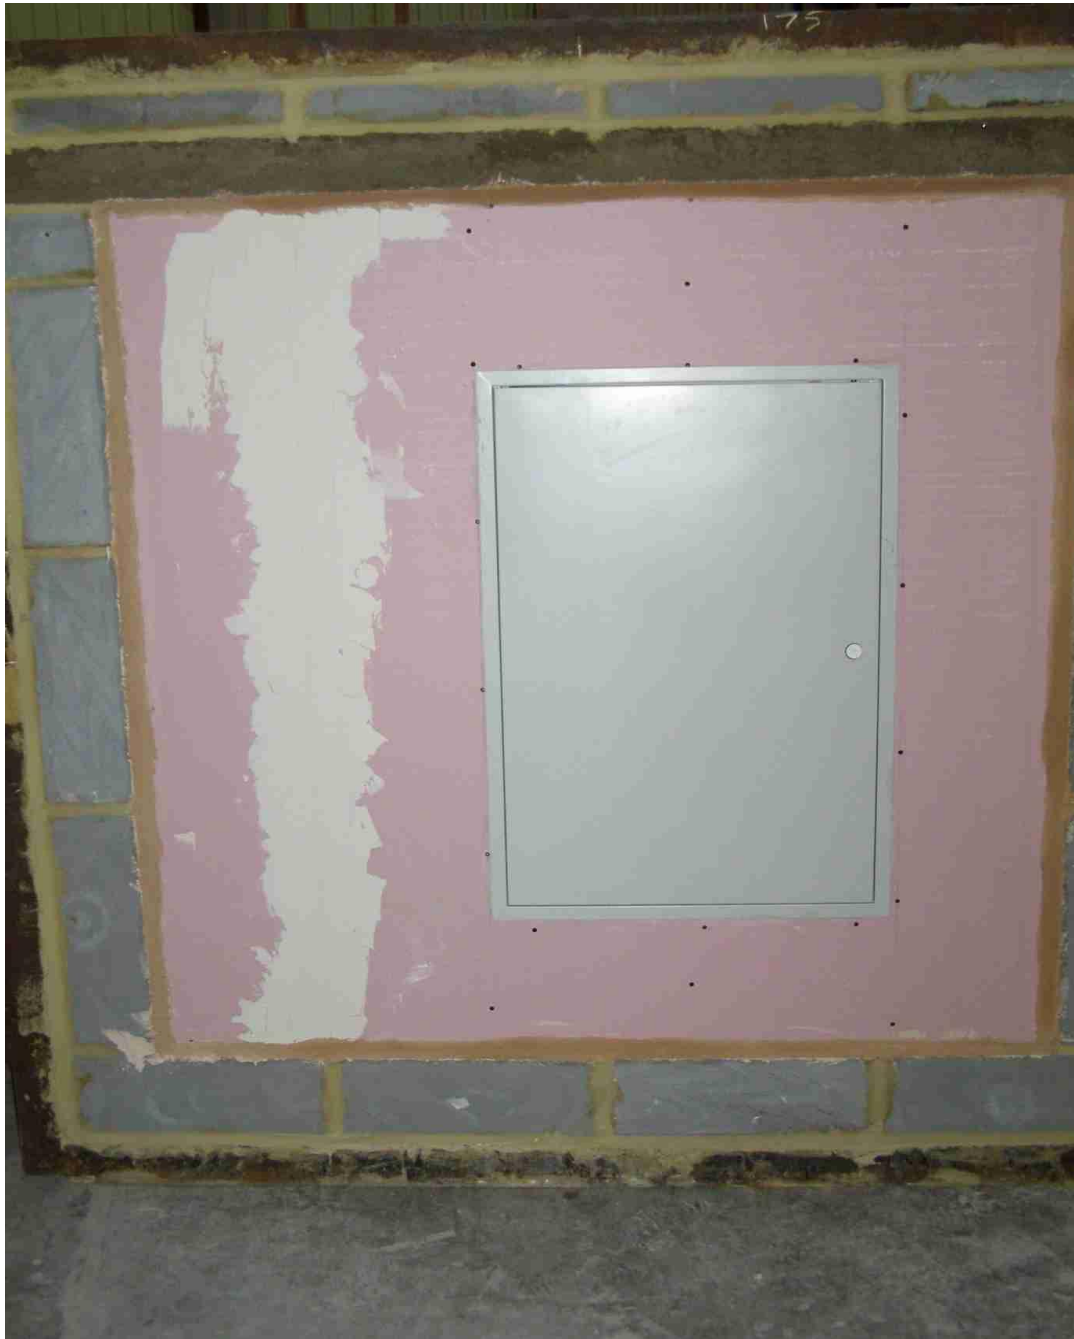
**Photo 6** Exposed face of test construction before test

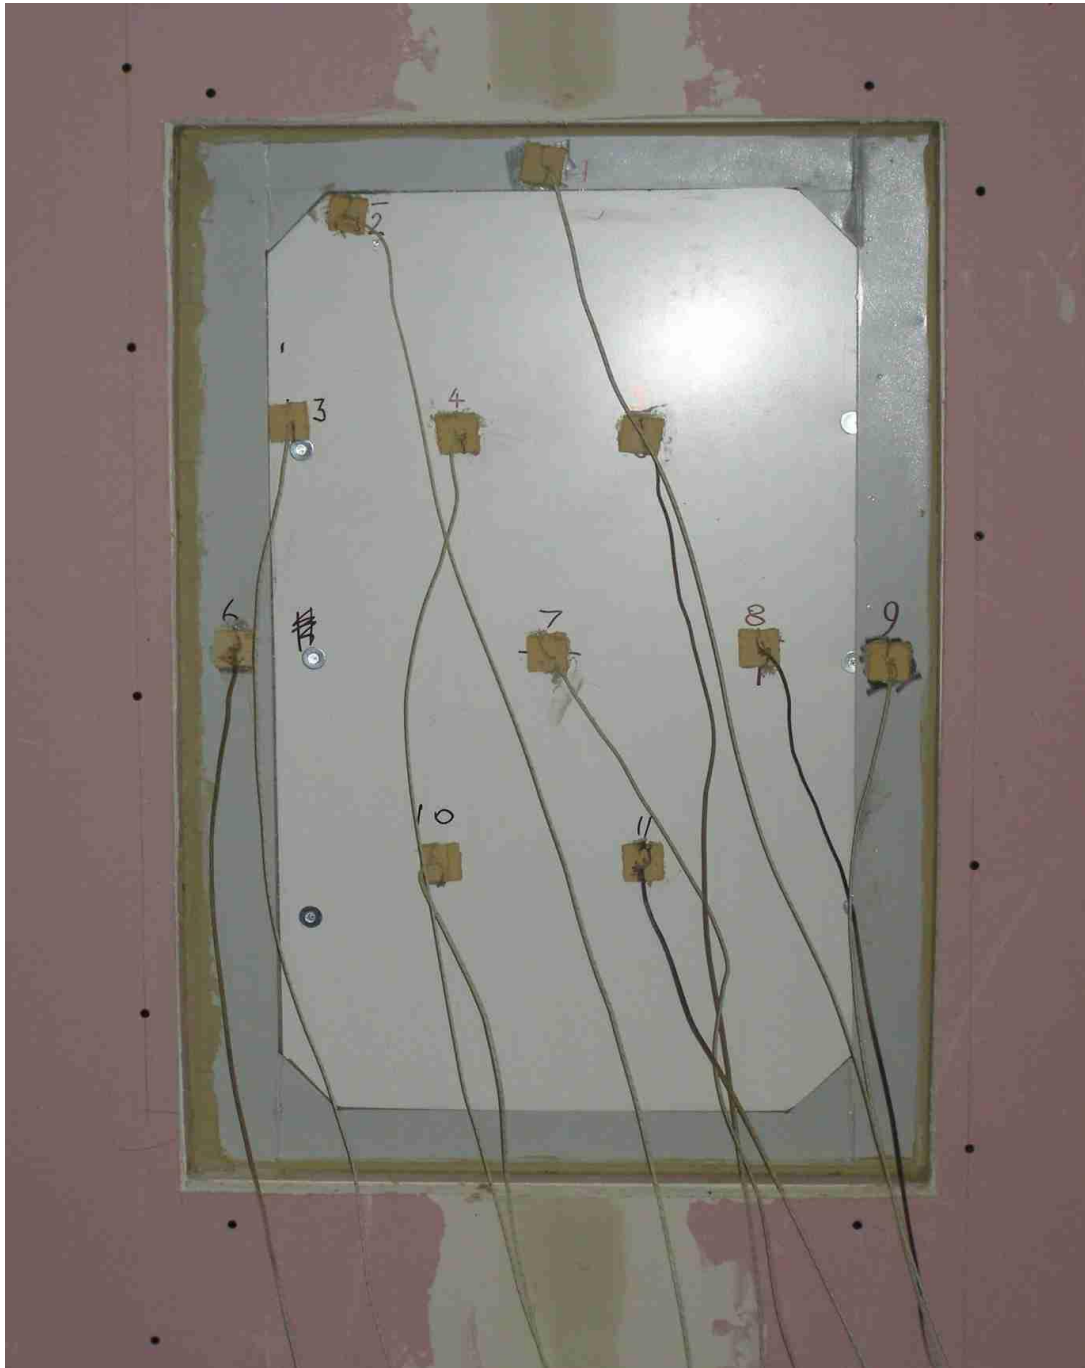
**Photo 8** Unexposed face of access panel before test

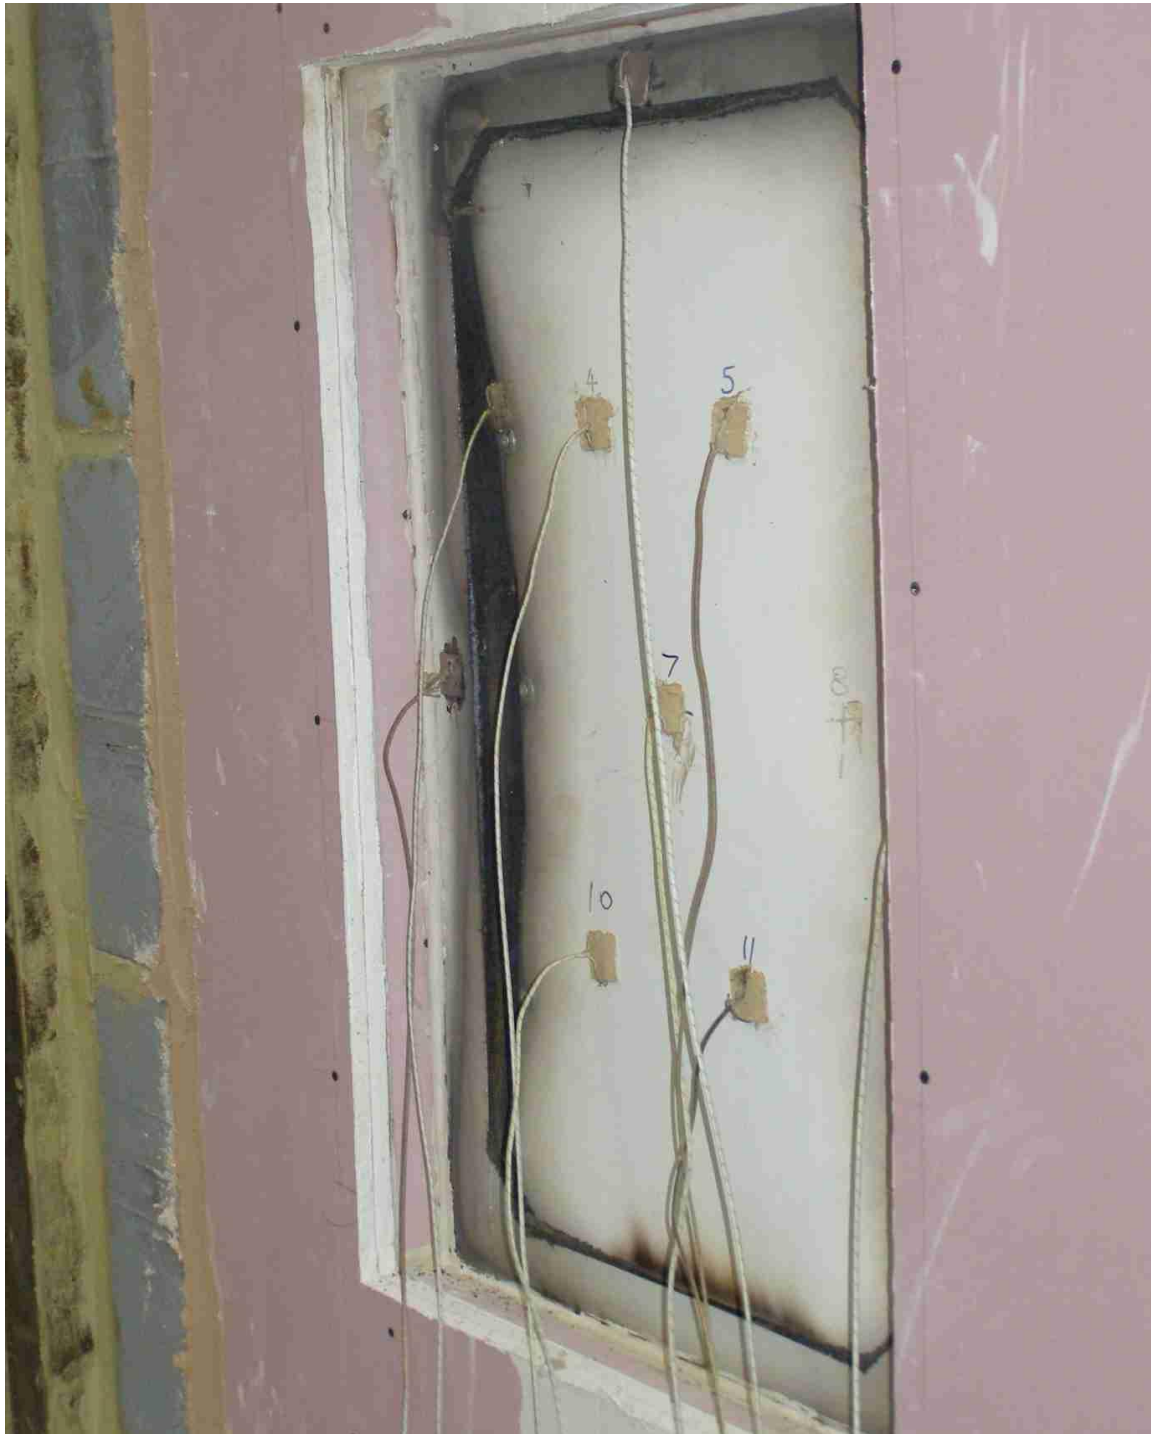
**Photo 9** Unexposed face of access panel after test

Time min	Observations
0	Test started
5	Smoke beginning to issue from inside face of plasterboard aperture perimeter
34	Smoke issuing from leaf/frame interface at bottom edge of panel
35	Leaf bowed at sides increasing leaf/frame interface separation at sides up to approx. 8mm
37	Bow in right-hand side of leaf become an uneven ripple
89	Leaf/frame separation at sides increased up to approx. 25mm at mid height. Intumesced seal had sealed the gap, but now deteriorating resulting in a 5mm-wide gap developed through one side of the seal.
120	Maximum leaf/frame separation measured to be 27mm at mid-height of left-hand side (see photo)
120	Test stopped

The construction after test is shown in Photos 9 and 10.

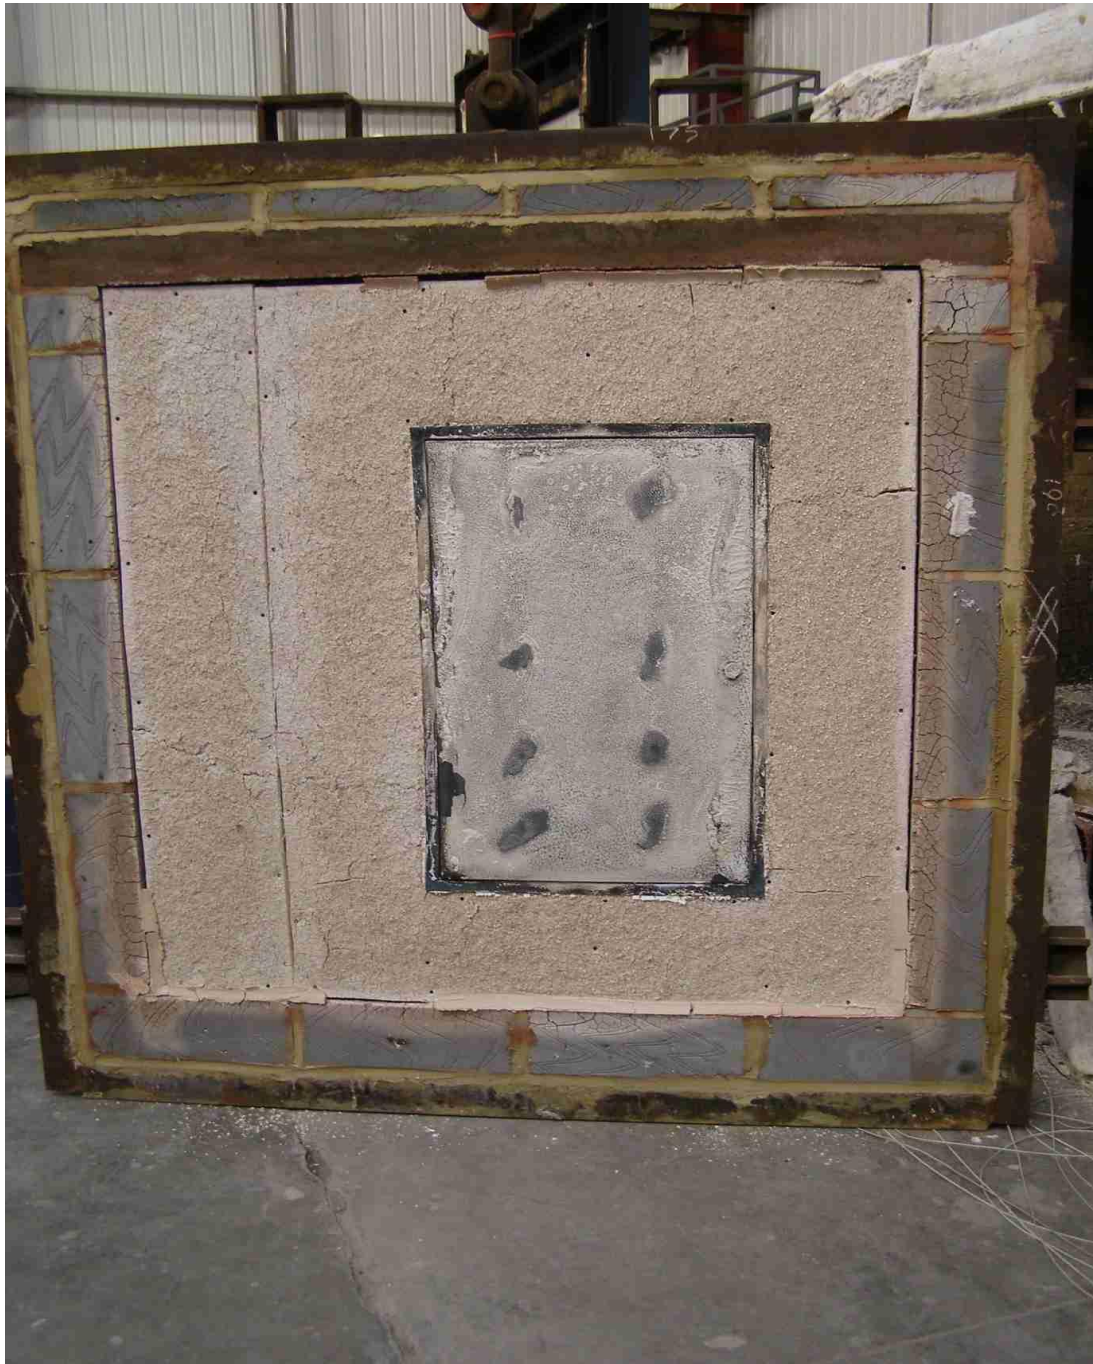
**Photo 10** Exposed face of access panel after test
