**Fire resistance test in
accordance with BS 476
Part 22:1987 on a twin-
leaf access panel door
within a plasterboard
partition.**

Exitile Ltd
49-61 Jodrell Street
Nuneaton
Warwickshire
CV11 5EG

Test report number 225286

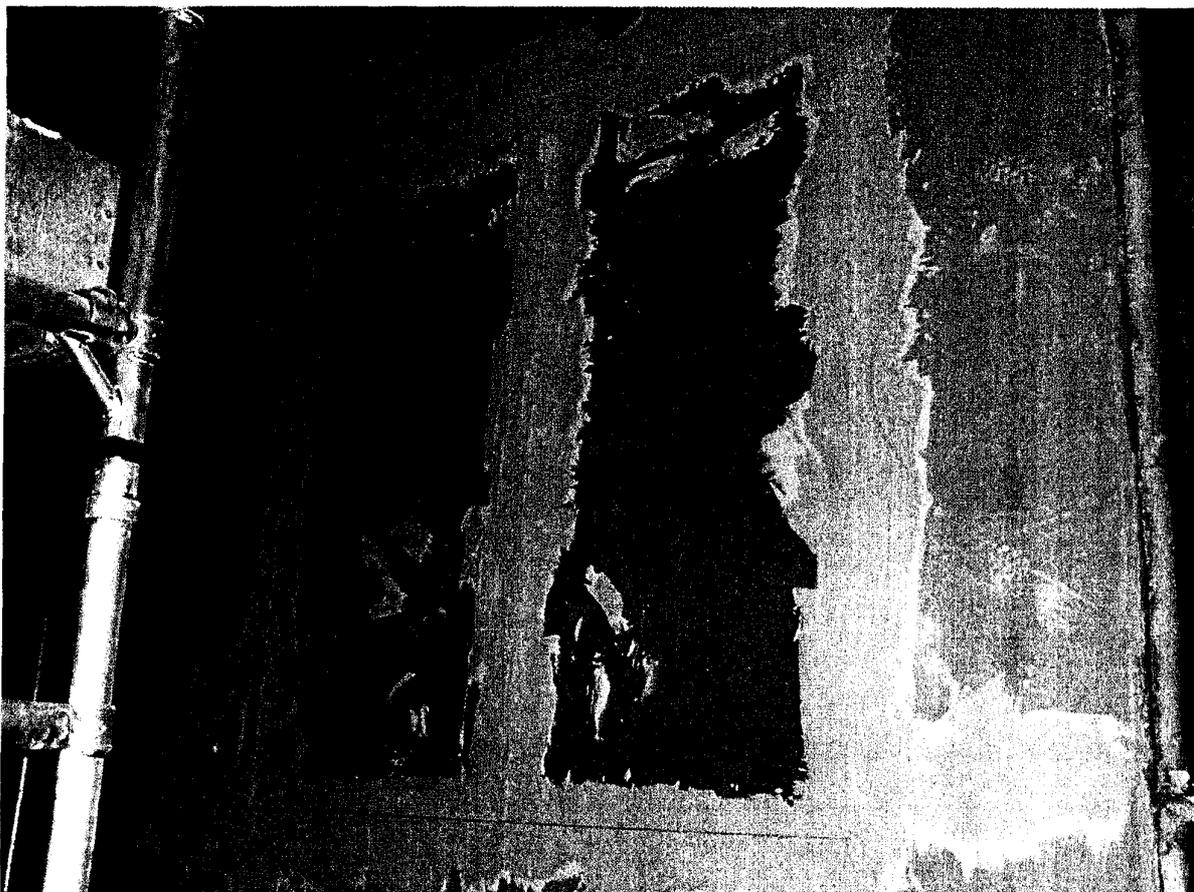
Photograph 1 Showing the exposed face of the access panel door prior to the test.

The twin-leaf access panel door and supporting construction (fire rated plasterboard wall) were installed into the aperture, nominally 3050mm high x 3050mm wide, of a heavily-reinforced concrete test frame, on Thursday 22nd September 2005. The access panel door and supporting construction are shown in Figures 1 and 7 and before the test in Photographs 1, 2 and 3.

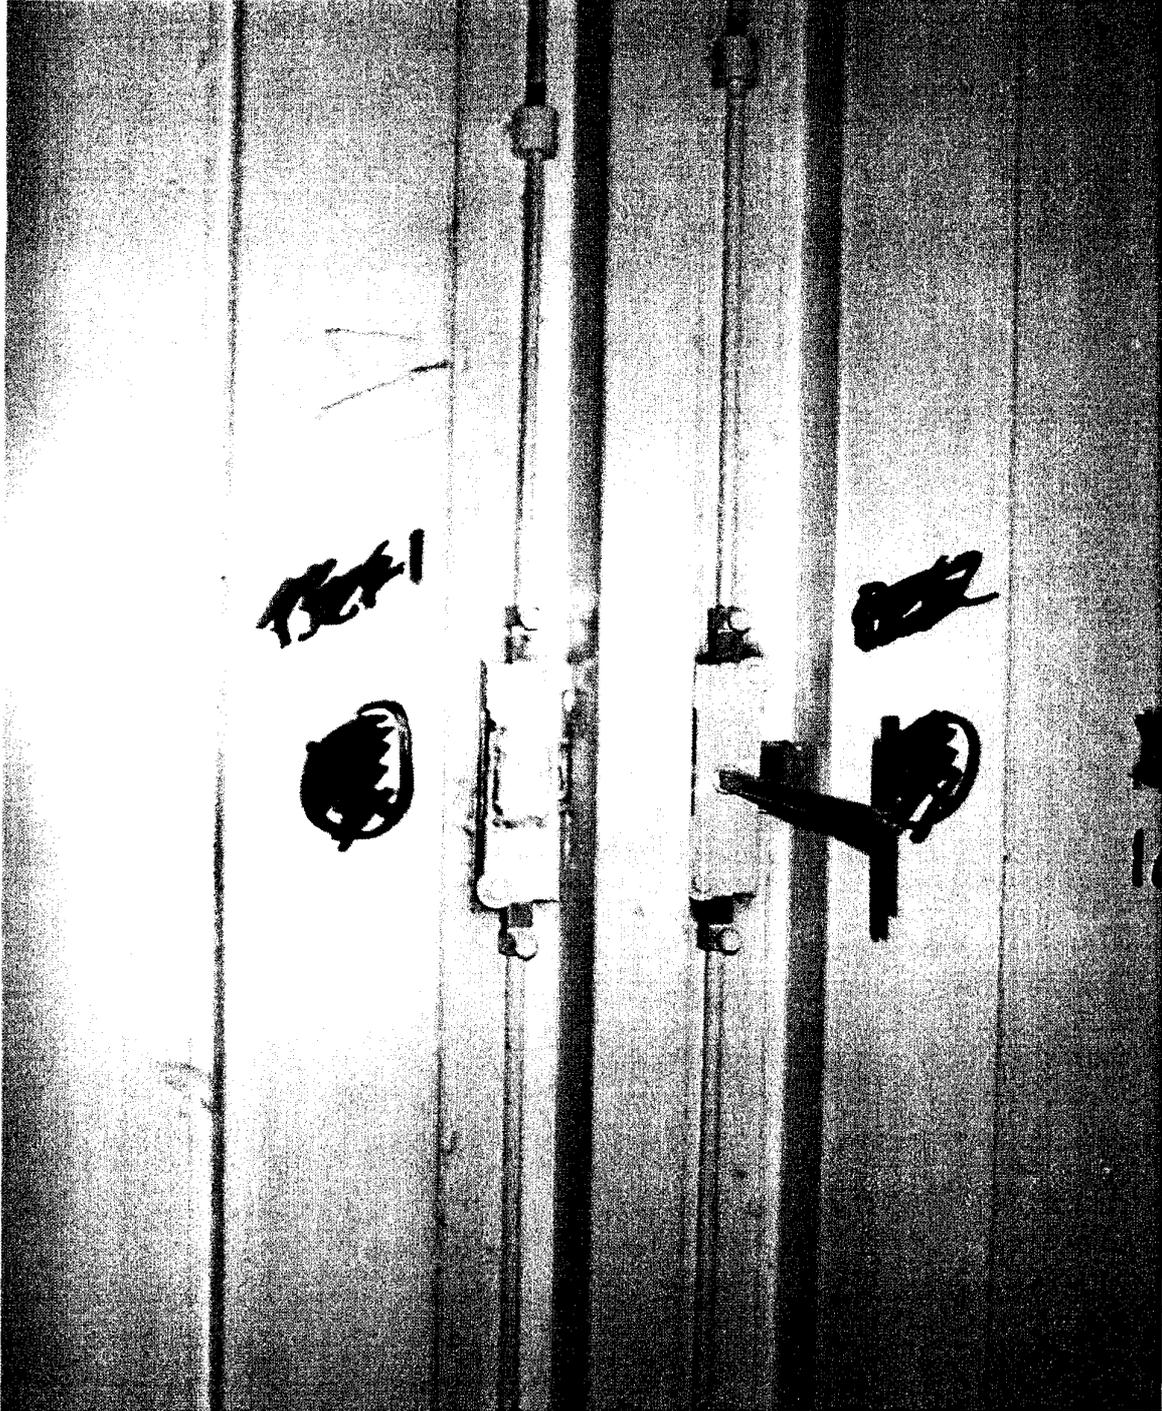
Photograph 3 Showing the two point and three point locking mechanisms used on the access panel door.

The left side leaf (when viewed from the unexposed face) incorporated a three-point locking mechanism comprising 8mmØ rods (see Photograph 3) which extended and engaged into the frame at the top and bottom, by 12mm, and a central latch which engaged at mid height into a locking angle, welded to the right side door (see Figure 2). The 8mmØ rods were retained to the unexposed side of the leaf skin using 20mm-long steel tubes welded at nominally 400mm centre to the steel skin (see Figure 6 and Photograph 3). The left side mechanism could only be operated from the exposed face with a square ended T-section key. A 16mmØ metal screw bung was inserted into the front locking hole at the end of assembly.
