**Fire endurance and hose
stream test in
accordance with UL 10B
on two single-leaf
access panels.**

Prepared for:
Fire Proofing services Ltd.
Evolution House,
Aston Road,
Nuneaton.
CV11 5EL

Test report number 242658

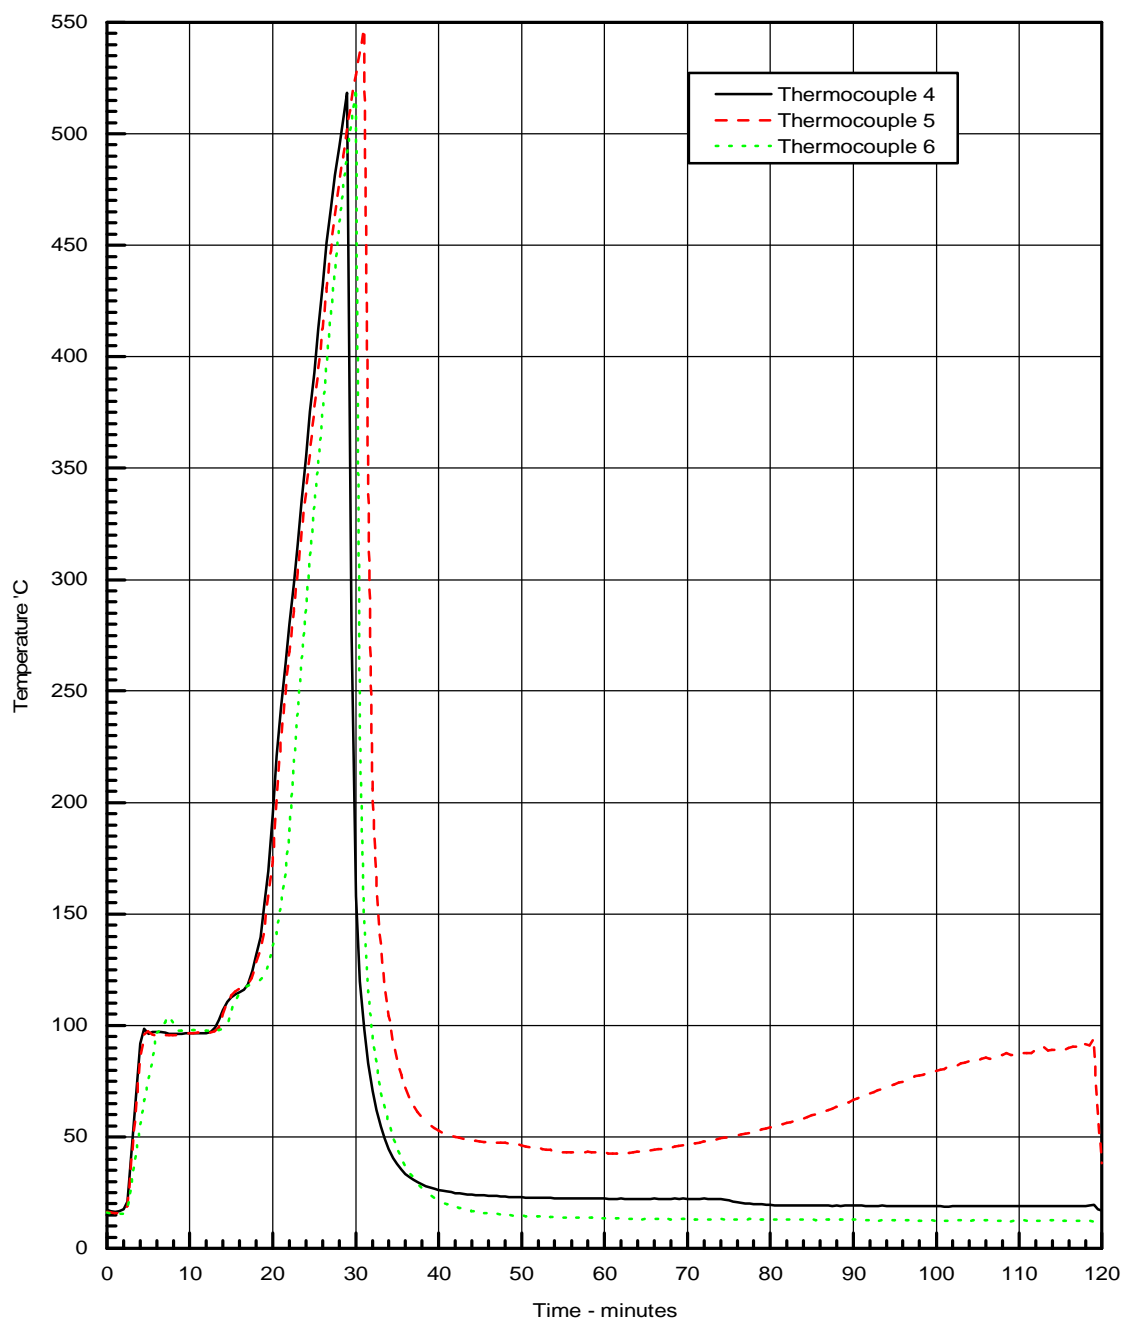
Unexposed face temperatures recorded on access door leaf B.

Note: The thermocouples became detached from the specimen after approximately 30 minutes.
