Fire resistance test in accordance with B.S. 476 : Part 22 : 1987 on a plasterboard ceiling membrane incorporating a Fire Proofing Services Ltd. double-leaf access panel.

Prepared for:
Fire Proofing Services Ltd.,
Evolution House,
Aston Road,
Nuneaton.
CV11 5EL

30th October 2009

Test report number 252171

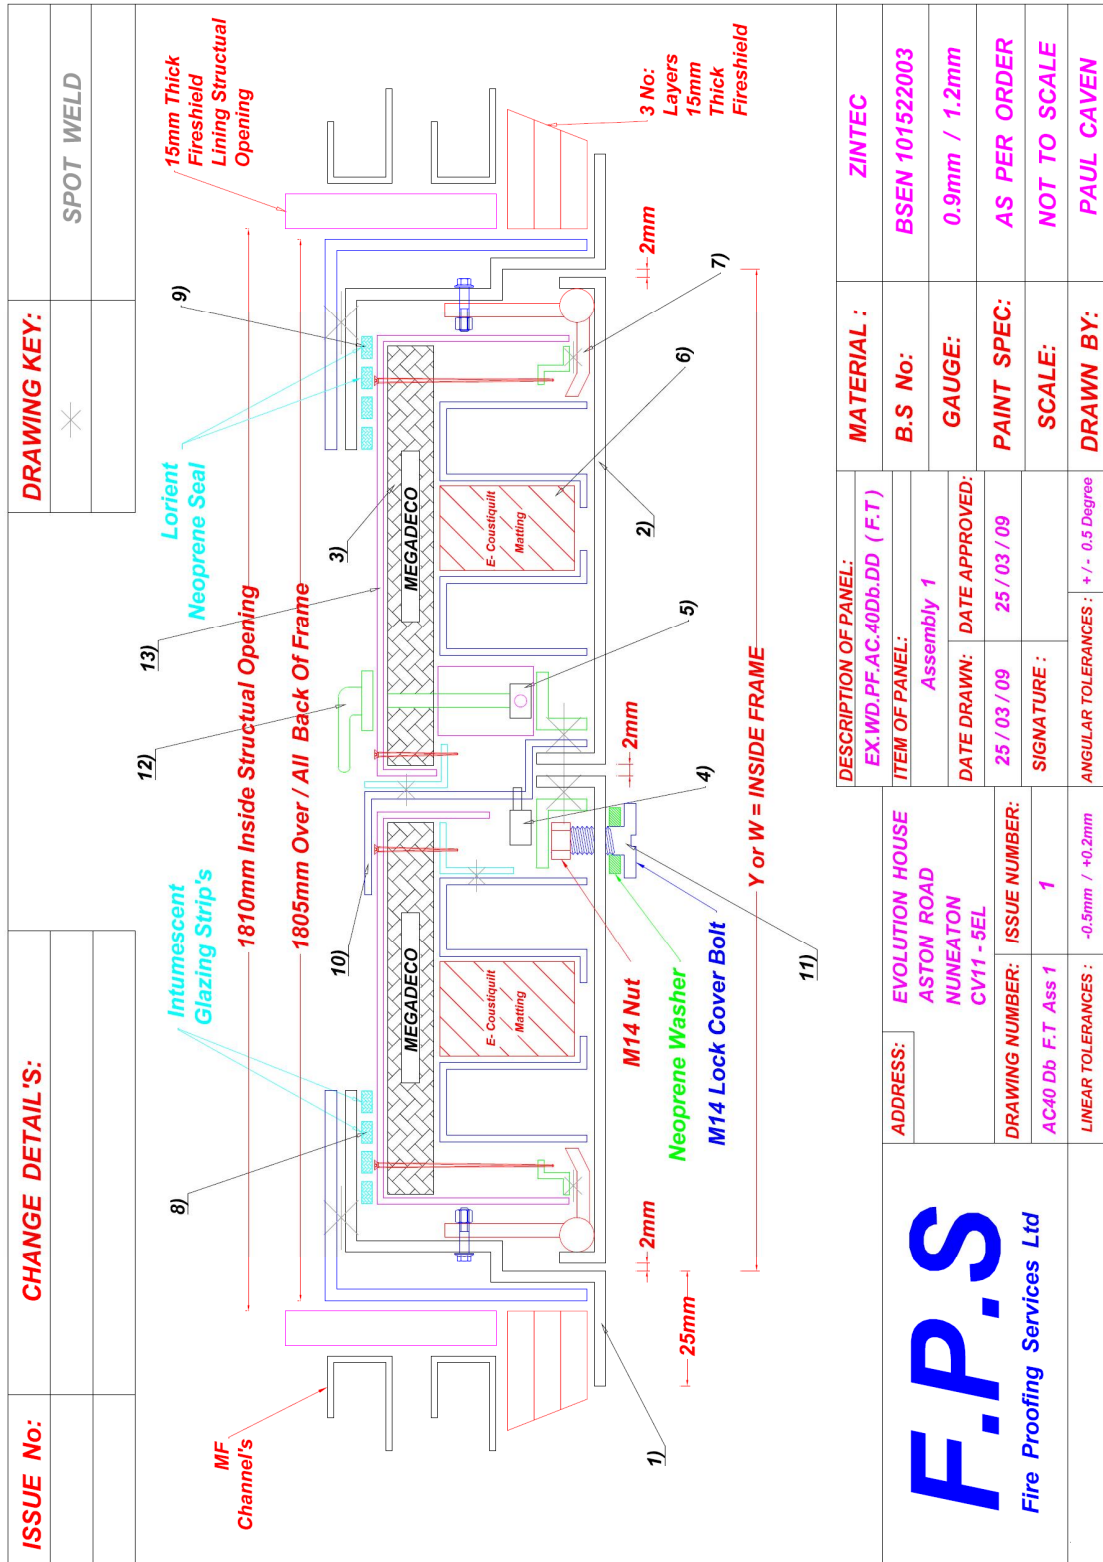
Access panel details (for key, see next page).

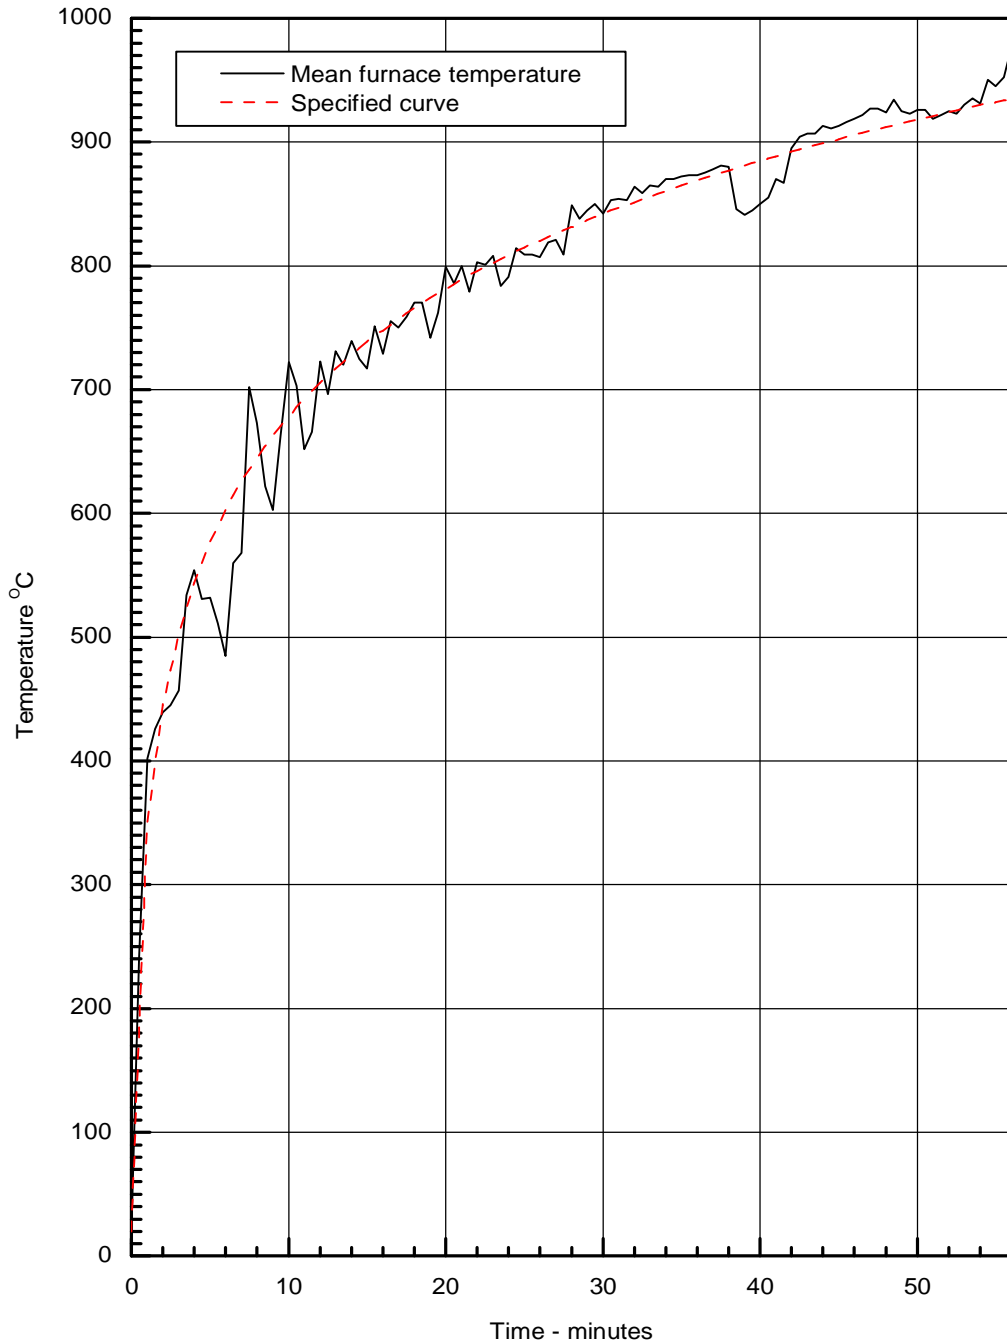
Mean furnace temperature with specified curve for comparison.

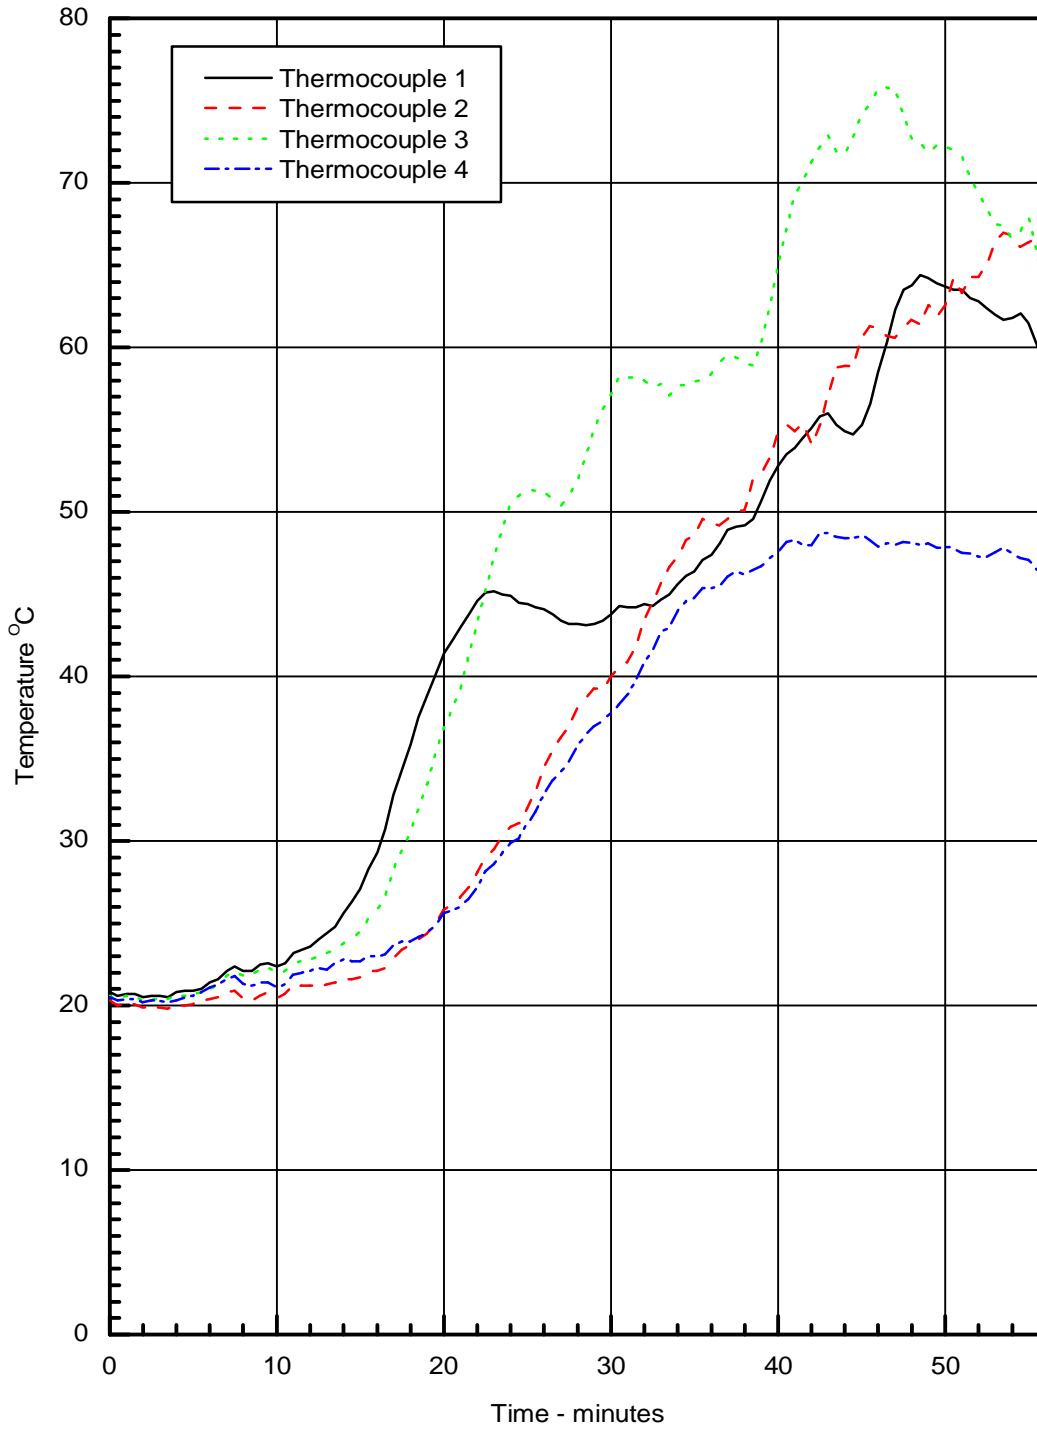
Temperatures recorded on the unexposed face of the ceiling membrane by thermocouples 1 to 4.

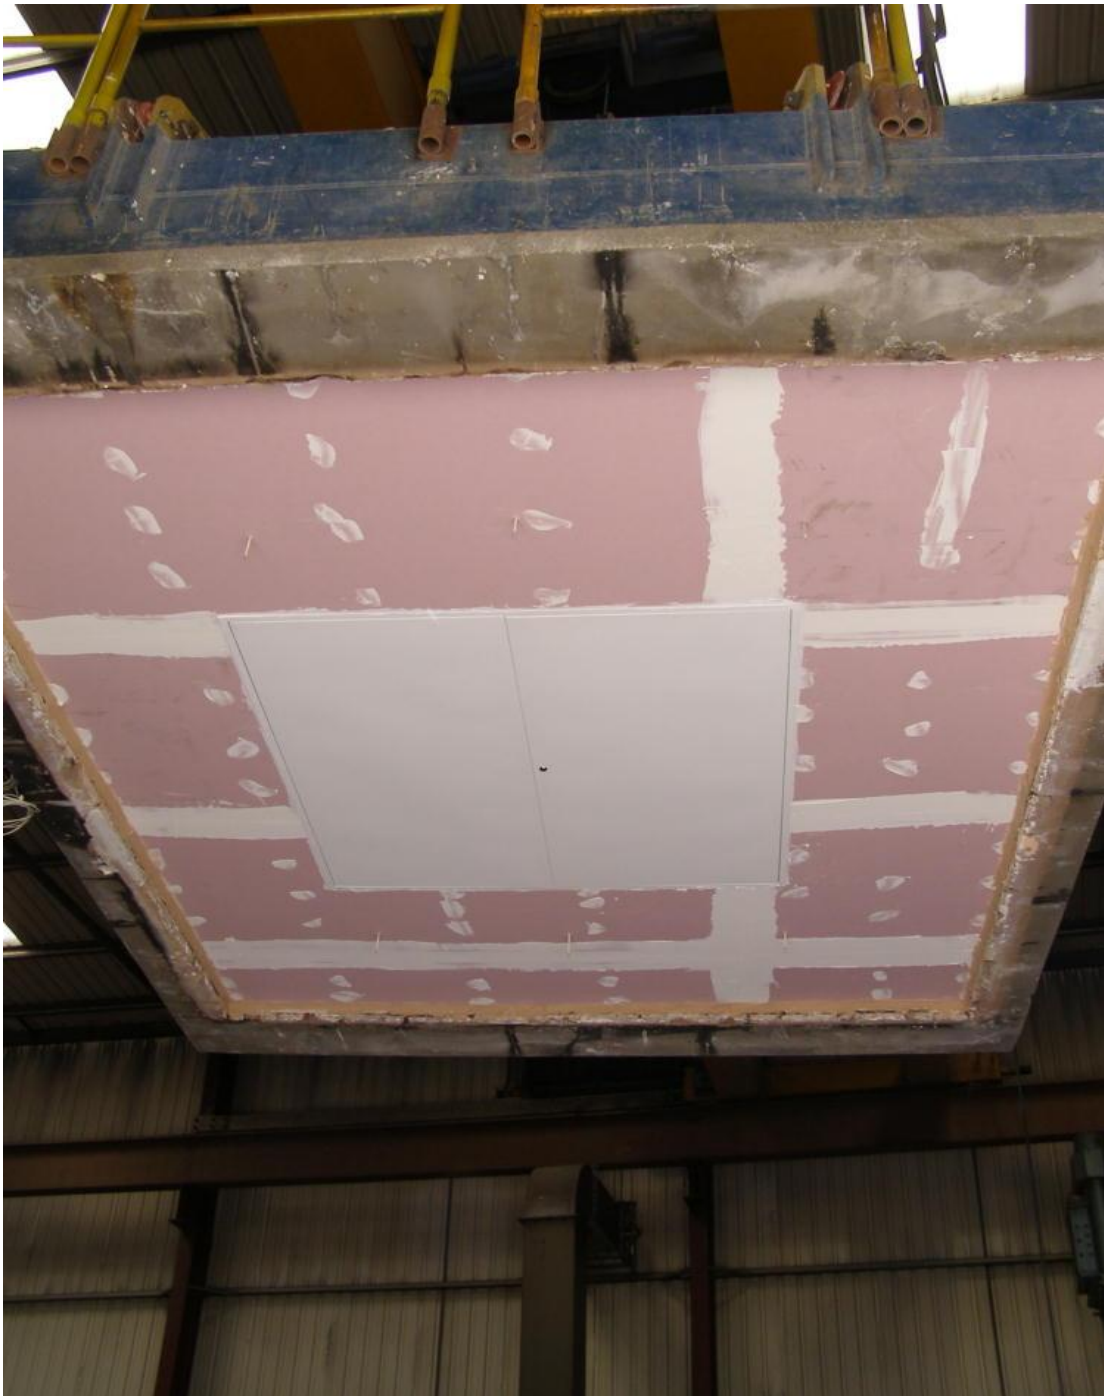
Exposed face of specimen before test.

(Note, four more furnace thermocouples were located in the vicinity of the access panel before the test).

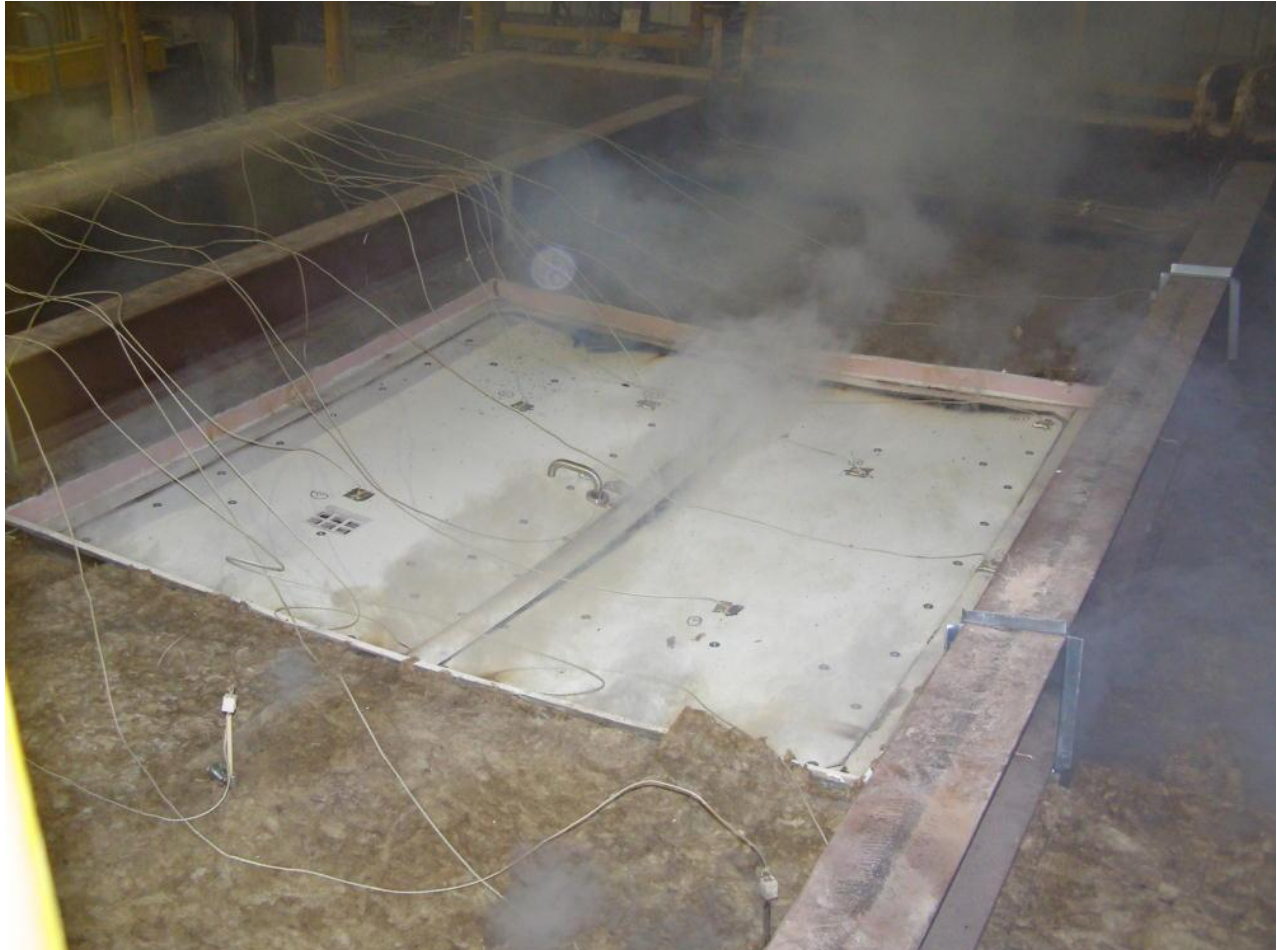
Unexposed face of specimen after 30 minutes.

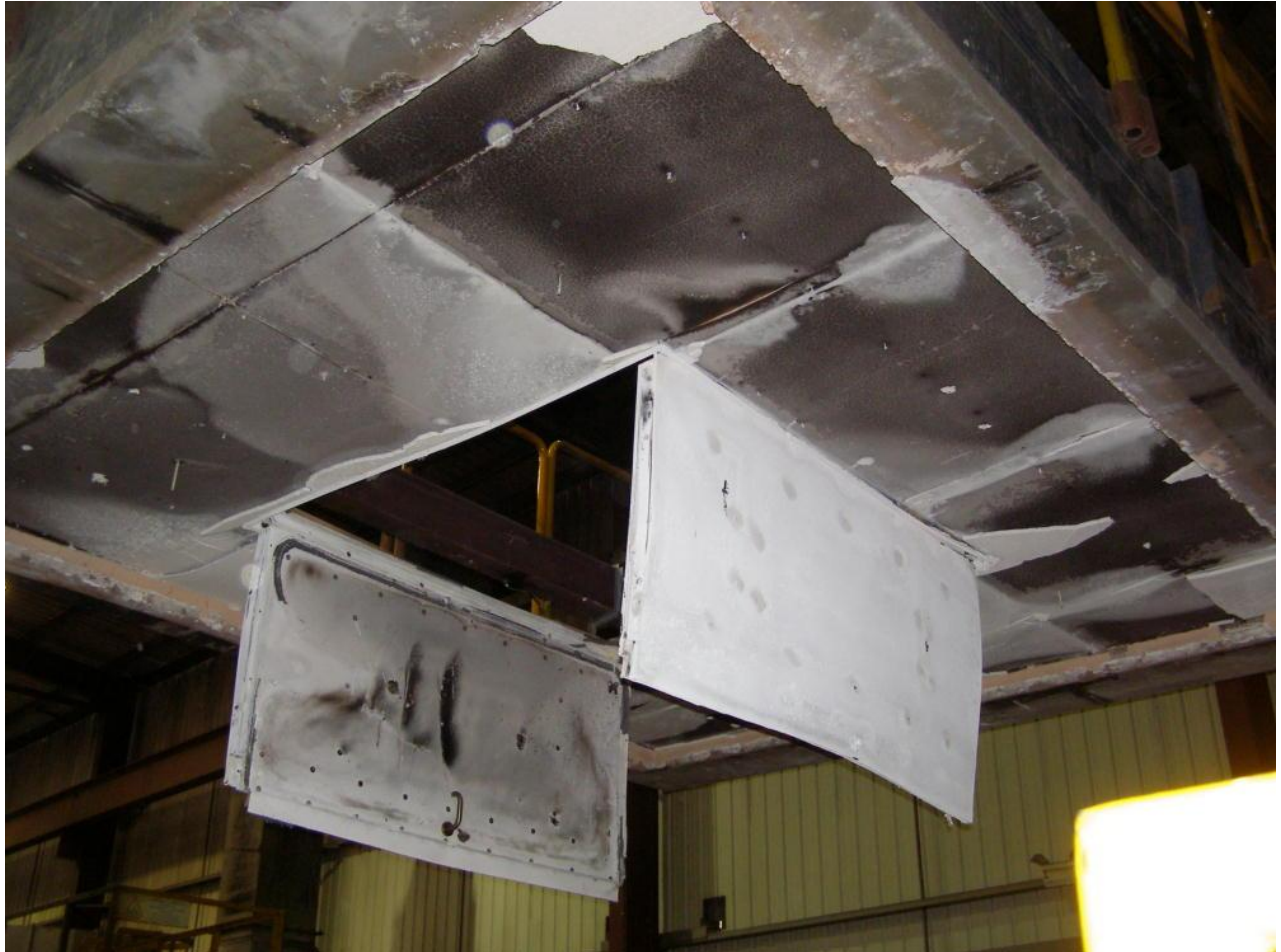
Exposed face after test.
