**Fire resistance test in
accordance with B.S.
476 : Part 22 : 1987 on
an access panel door
installed in a block wall.**

Test report number 226657

Fire resistance test on an access panel door installed in a block wall.

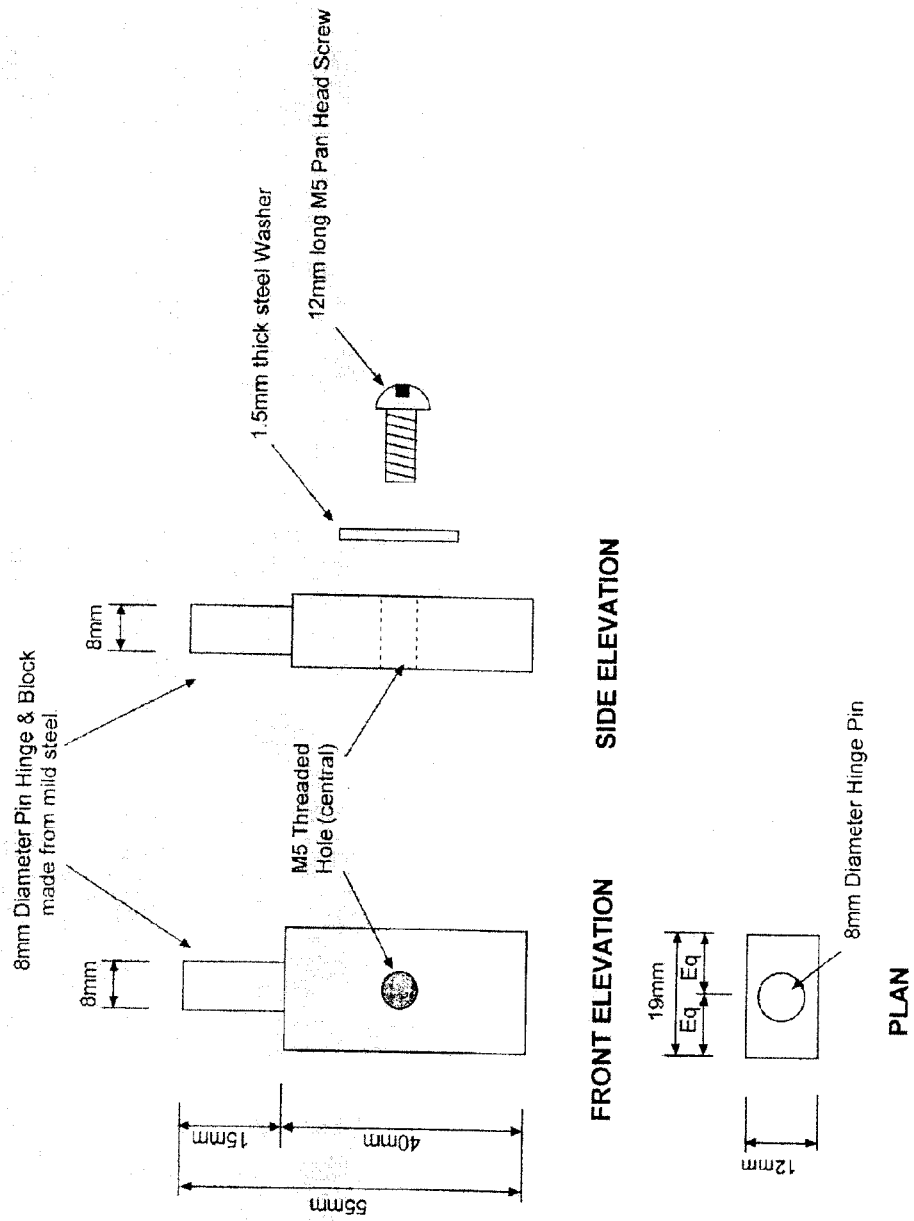
Figure 2 Details of hinge pin arrangement.

The door hinge consisted of an 8mm diameter hinge pin and block fitted top and bottom into a 1.0mm thick top hat steel section welded to the rear of the door tray.

Further details of the specimen construction are shown in Figures 1 and 2, and the specimen is shown before the test in Photo's 1 and 2.

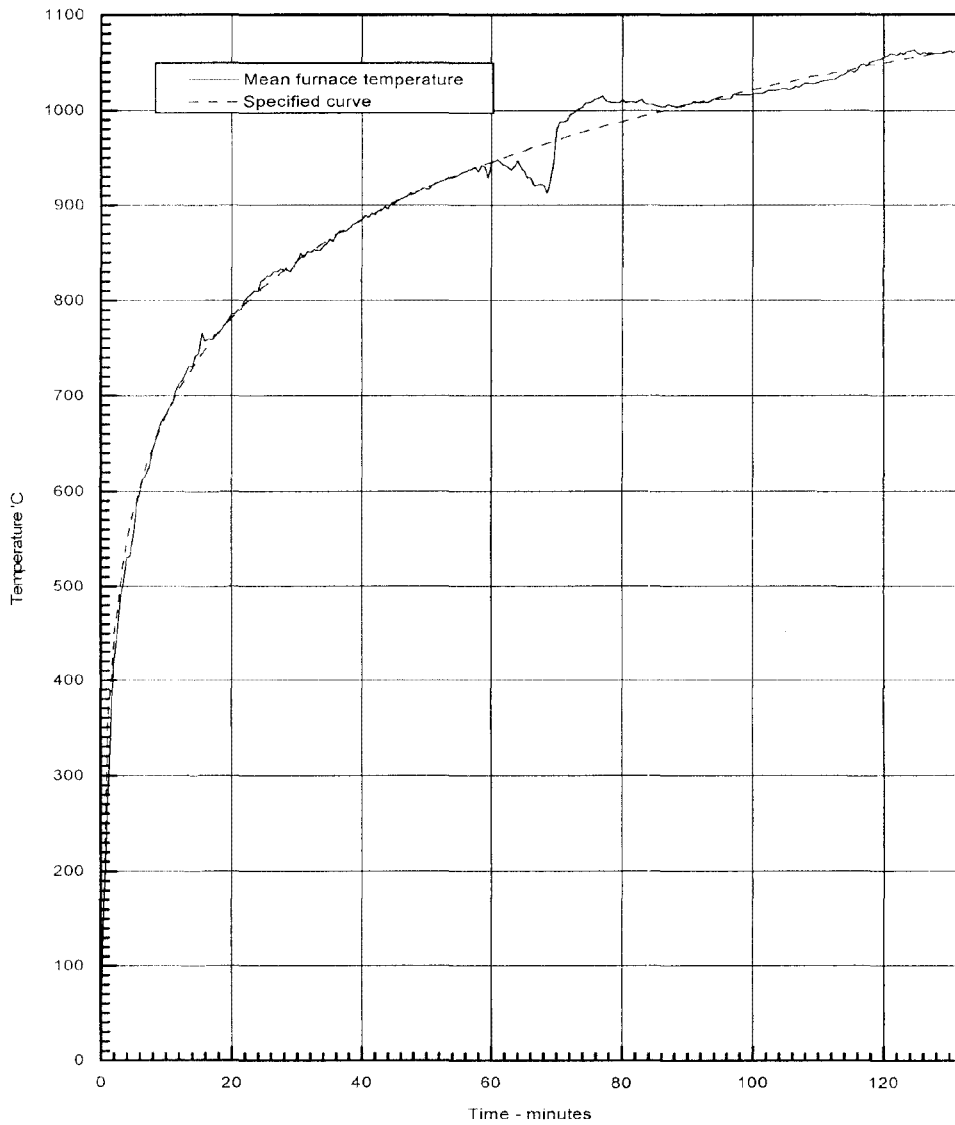
Graph 1 Mean furnace temperature with specified curve for comparison.

The mean furnace temperature is plotted against time in Graph 1 with the specified curve for comparison.

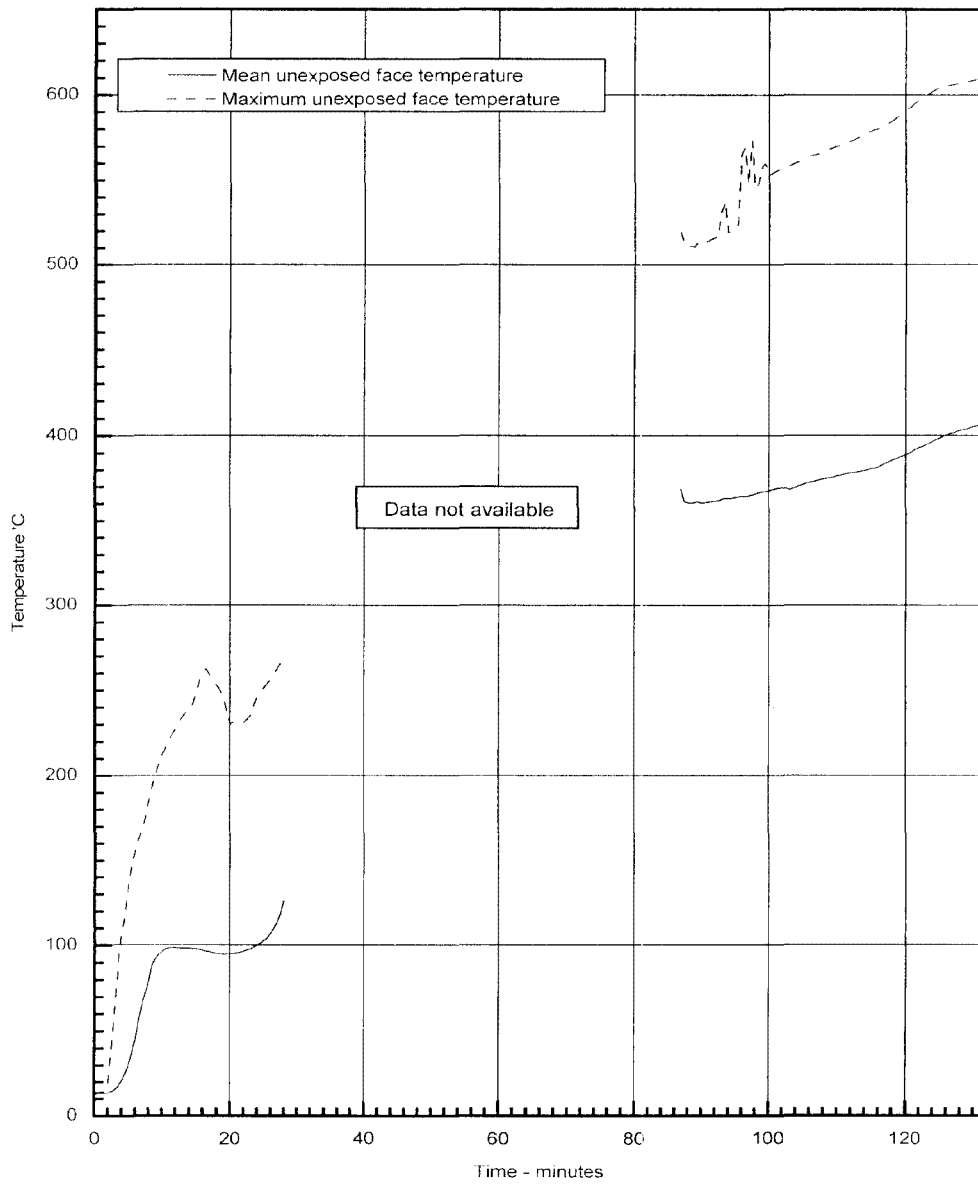
Graph 2 Mean and maximum unexposed face temperatures.

The mean, maximum and individual temperatures recorded on the access panel leaf and frame are plotted against time in Graphs 2 to 4. Due to a technical problem, the data between 28 and 87 minutes became unstable, and is not shown.

The limit for maximum temperature rise (180°C) was first exceeded on the specimen after 8 minutes and the limit for the rise in mean temperature on the access panel leaf was exceeded sometime after 28 minutes, although it is not possible to determine the exact time due to instability of the data.

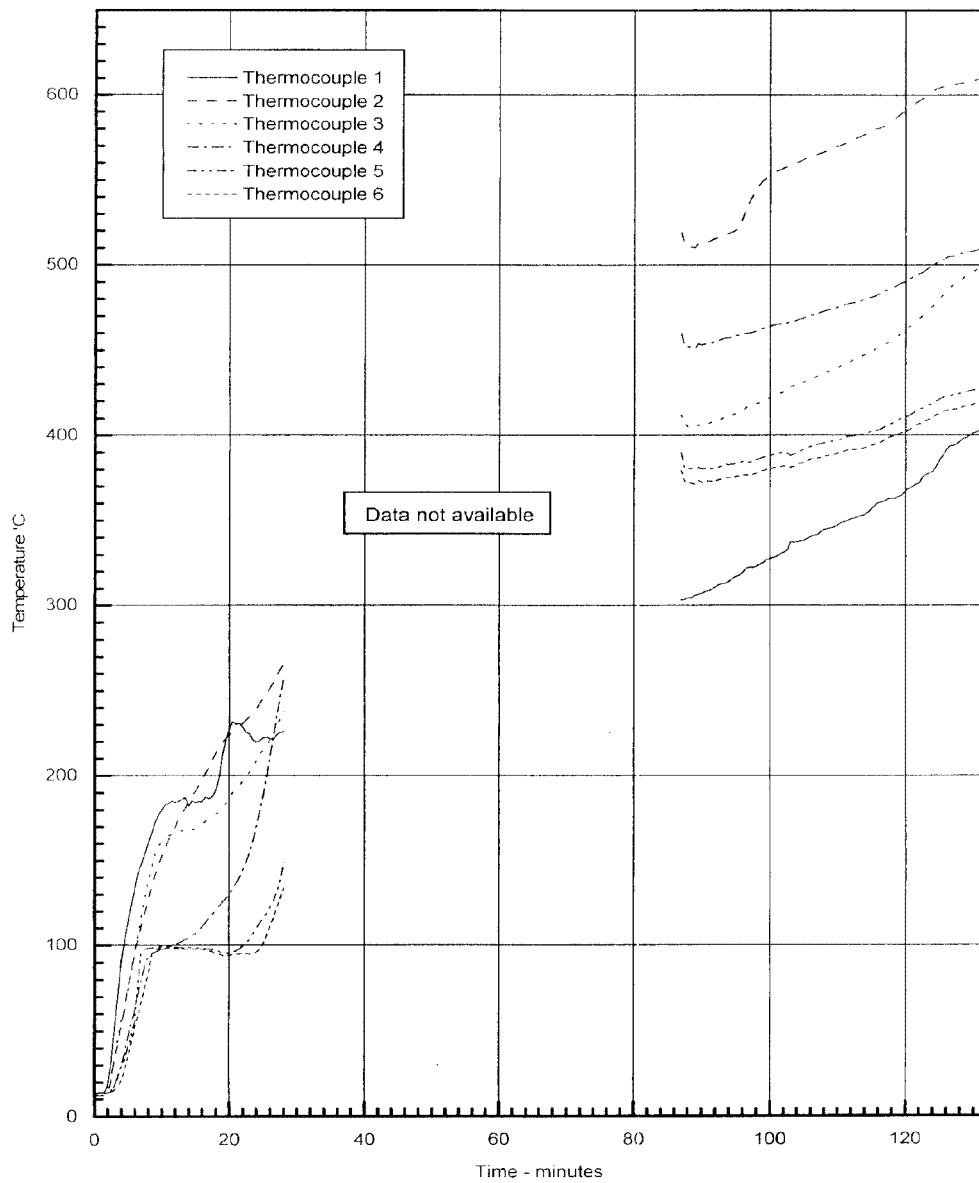
Graph 3 Temperatures recorded on the unexposed face by thermocouples 1 to 6.

Thermocouple	Location
1	On the access panel frame, centrally above the leaf.
2	On the top left-hand corner of the access panel leaf, on a stiffener.
3	At the top of the access panel leaf, at mid width, on a stiffener.
4	At the top right corner of the access panel leaf, adjacent to stiffeners.
5*	In the centre of the top left quarter of the access panel leaf.
6*	In the centre of the top right quarter of the access panel leaf.
7	On the frame at the left-hand side of the access panel, at mid height.
8*	As near as possible to the centre of the access panel (50mm to the right hand side of the central stiffener).
9	On the frame at the right hand side, and mid height.
10*	In the centre of the bottom left quarter of the access panel leaf.
11*	In the centre of the bottom right quarter of the access panel leaf.

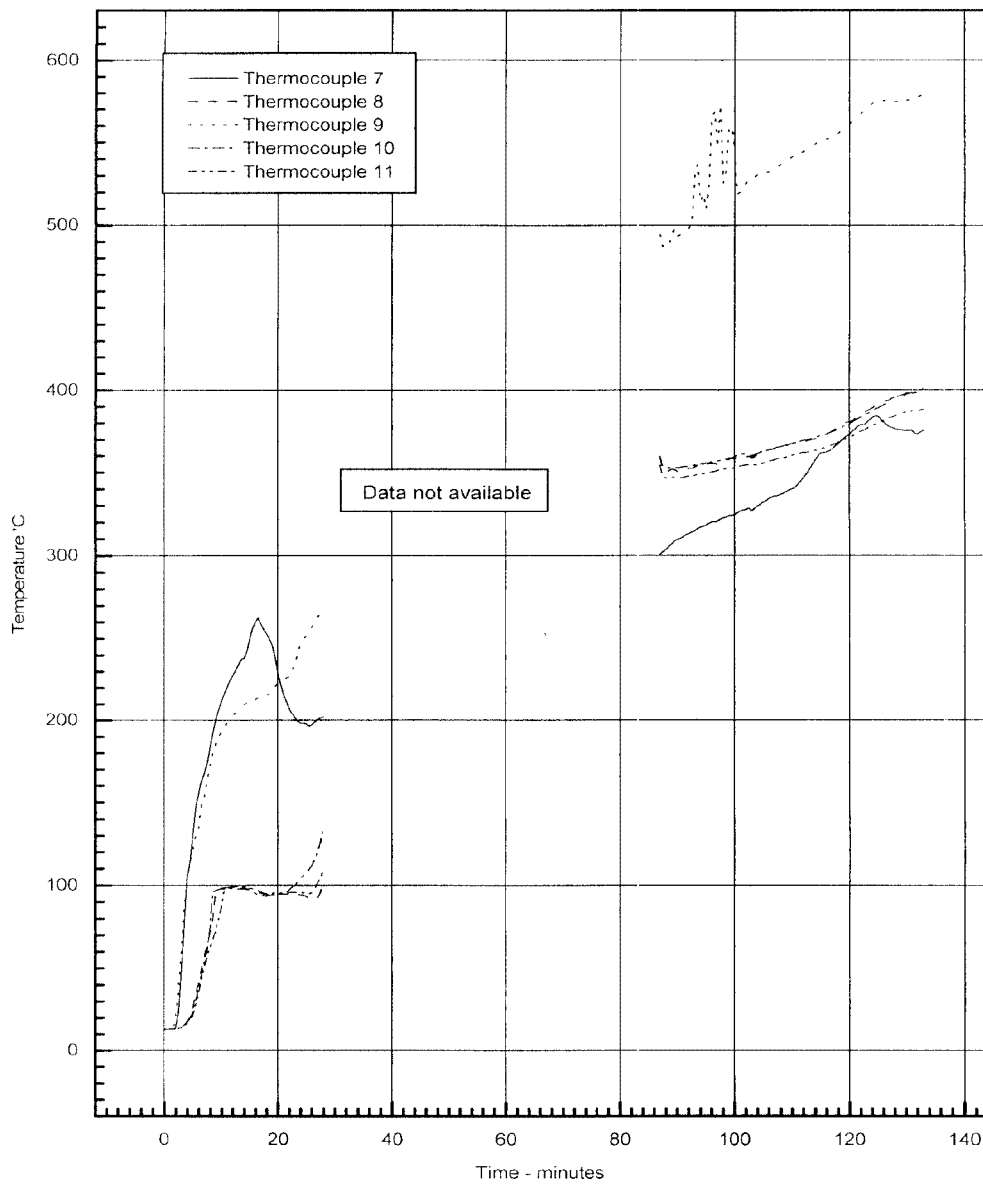
Graph 4 Temperatures recorded on the unexposed face by thermocouples 7 to 11.

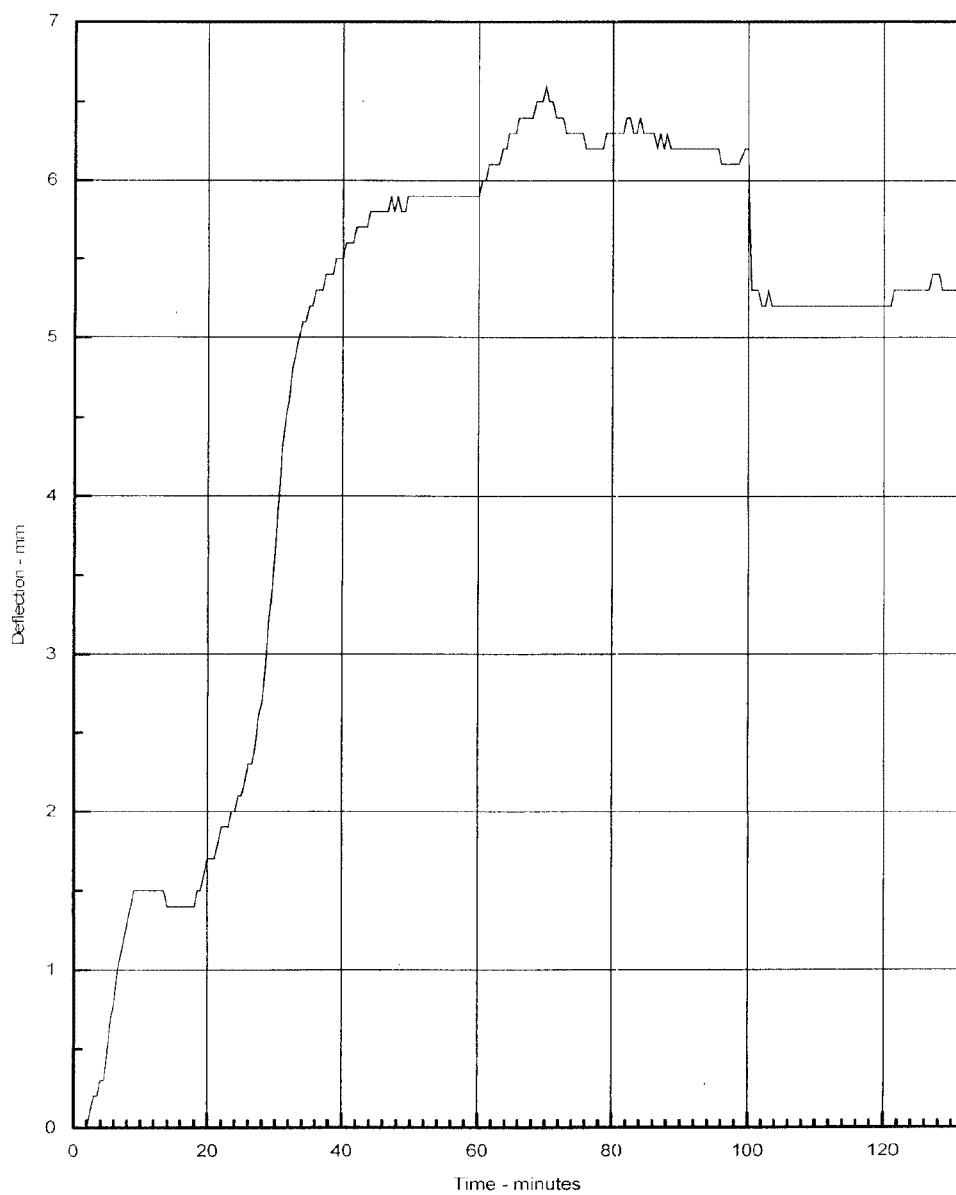
Graph 5 Deflection (towards furnace) recorded at the centre of the access panel leaf.

A transducer activated by a fine taut wire attached at the centre of the access panel leaf was used to continuously monitor deflection of the leaf throughout the test.

The deflection recorded near the centre of the access panel leaf is shown plotted against time in Graph 5.

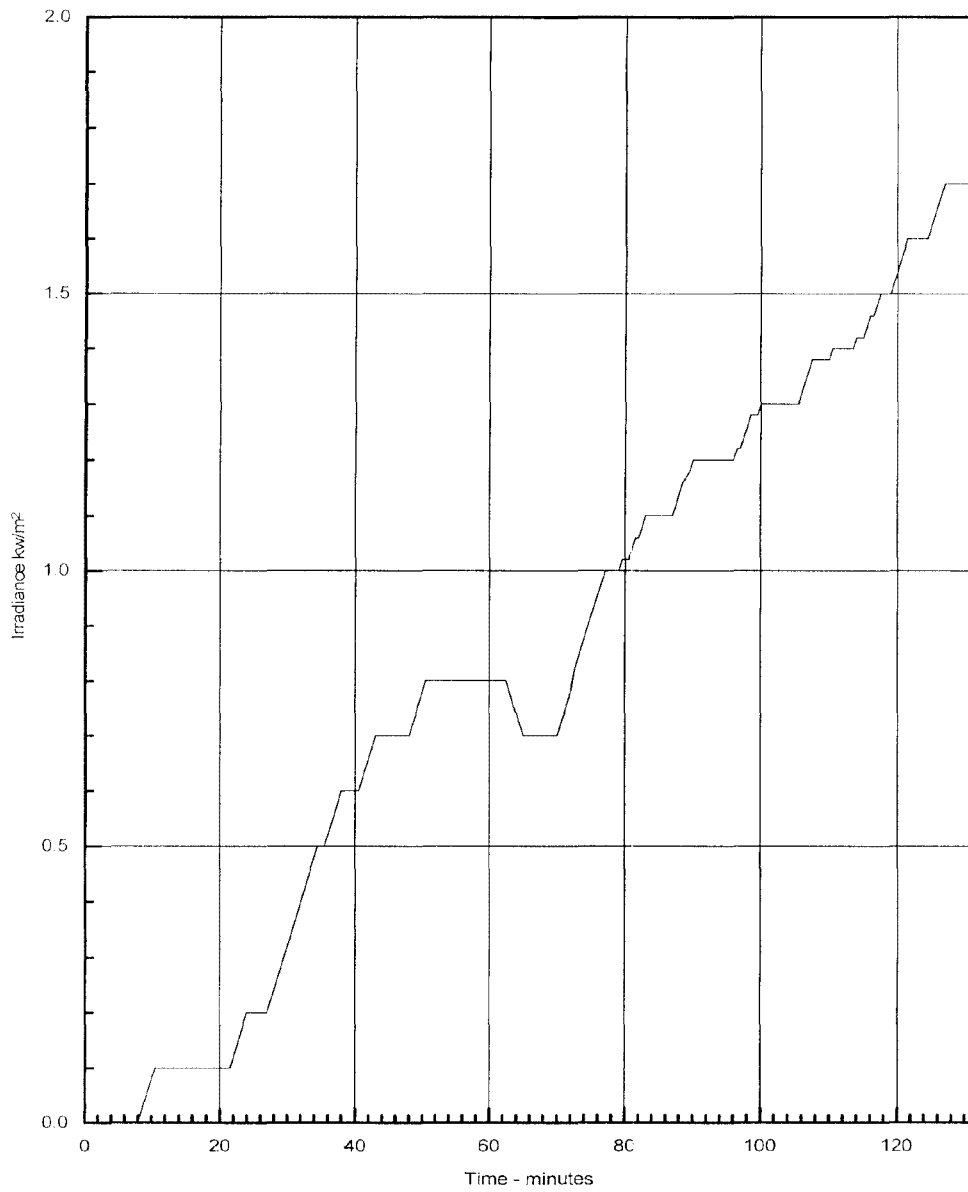
Graph 6 Irradiance recorded 1m from the unexposed face of the specimen.

The irradiance from the access panel leaf was recorded via a radiometer located 1m from the centre of the specimen.

The irradiance recorded 1m from the access panel is given in Graph 6.

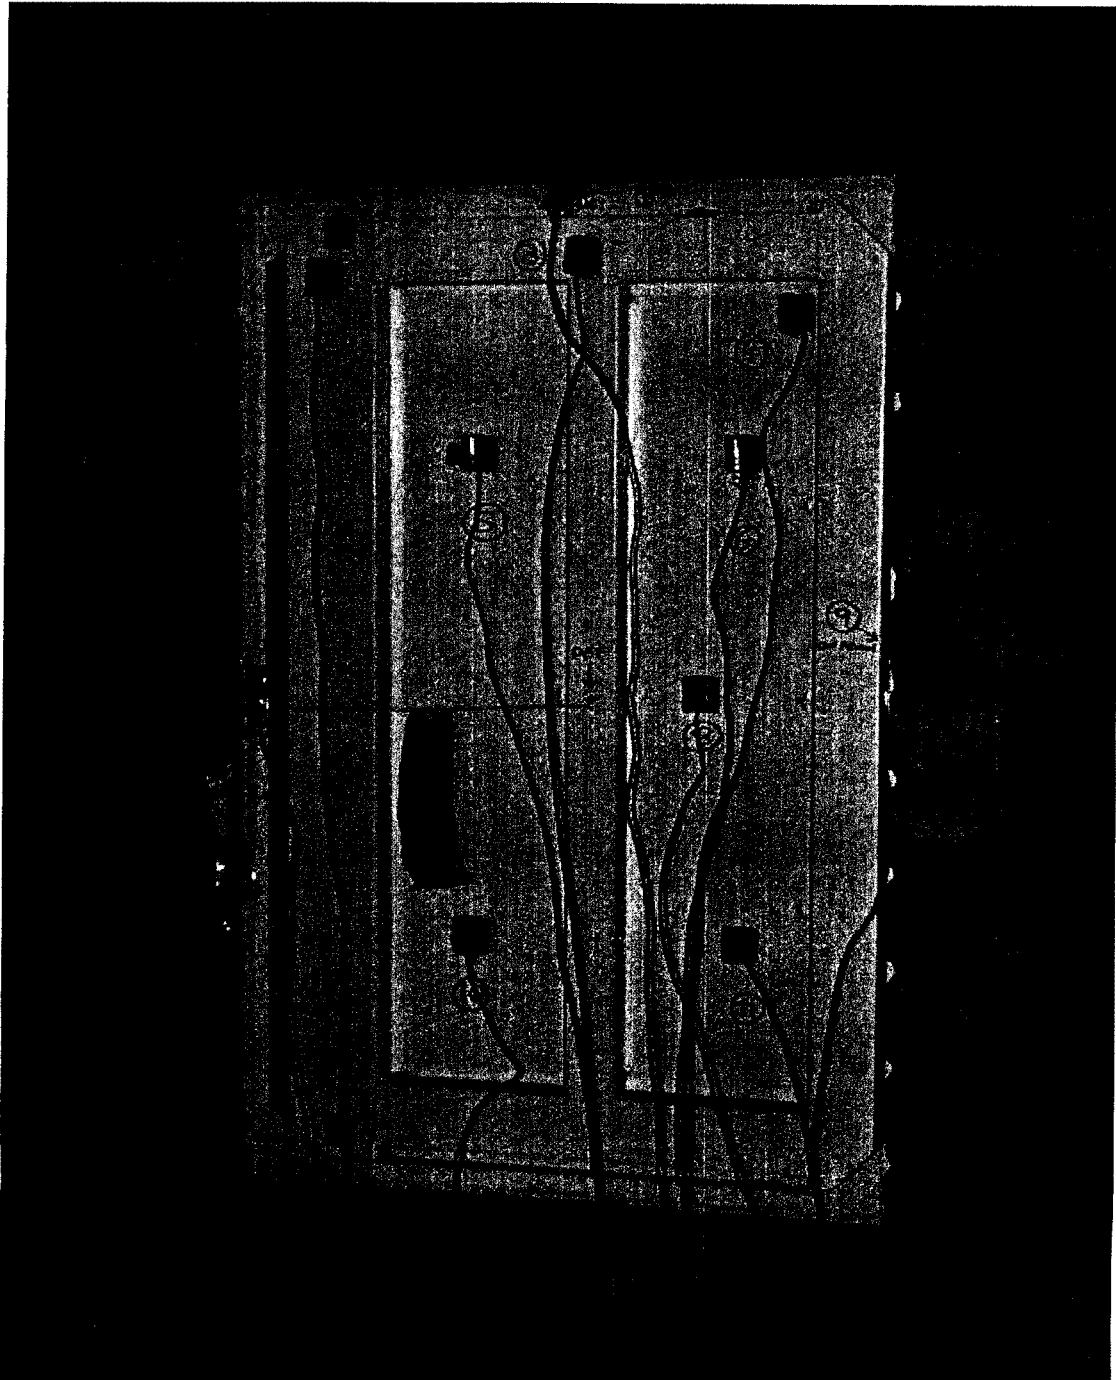
Photo 2 Unexposed face of specimen before test.

The temperature on the unexposed face of the specimen was measured using eleven chromel / alumel (K-type) thermocouples each soldered to a copper disc and covered with an insulating pad, 30mm x 30mm x 2mm thick, as described in B.S. 476 : Part 20 : 1987¹. The location of the thermocouples is given in Table 1 and is shown in Photo 2.

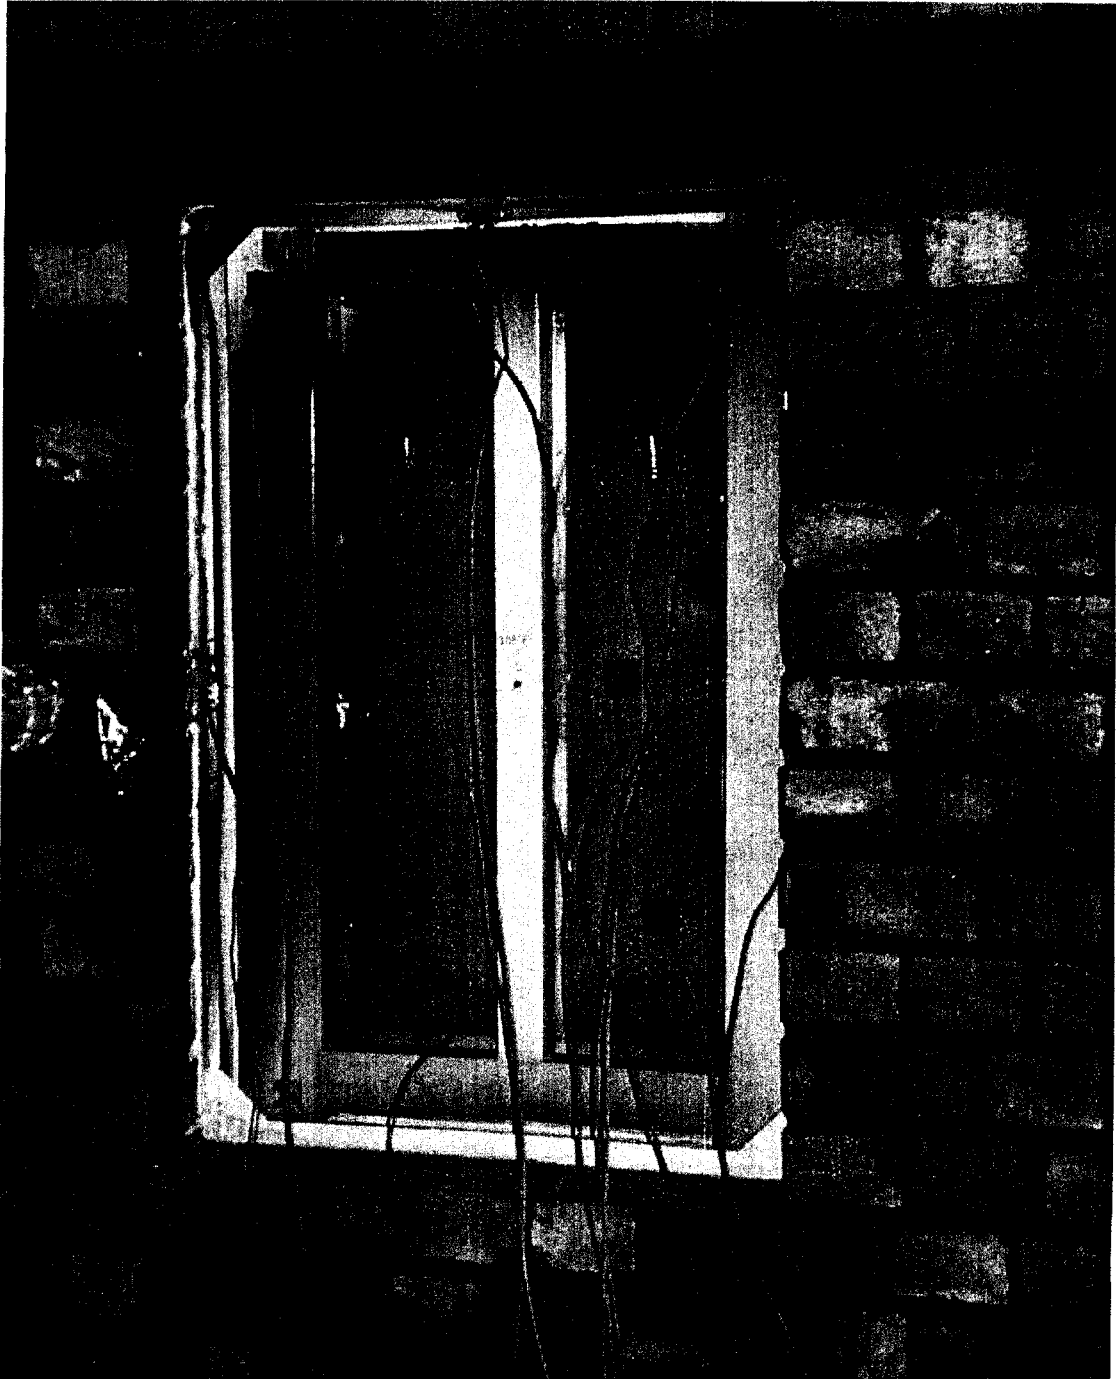
Photo 3 Unexposed face of specimen after 60 minutes.

The specimen is shown after 1 hour, at termination and after the test in Photo's 3 to 5.

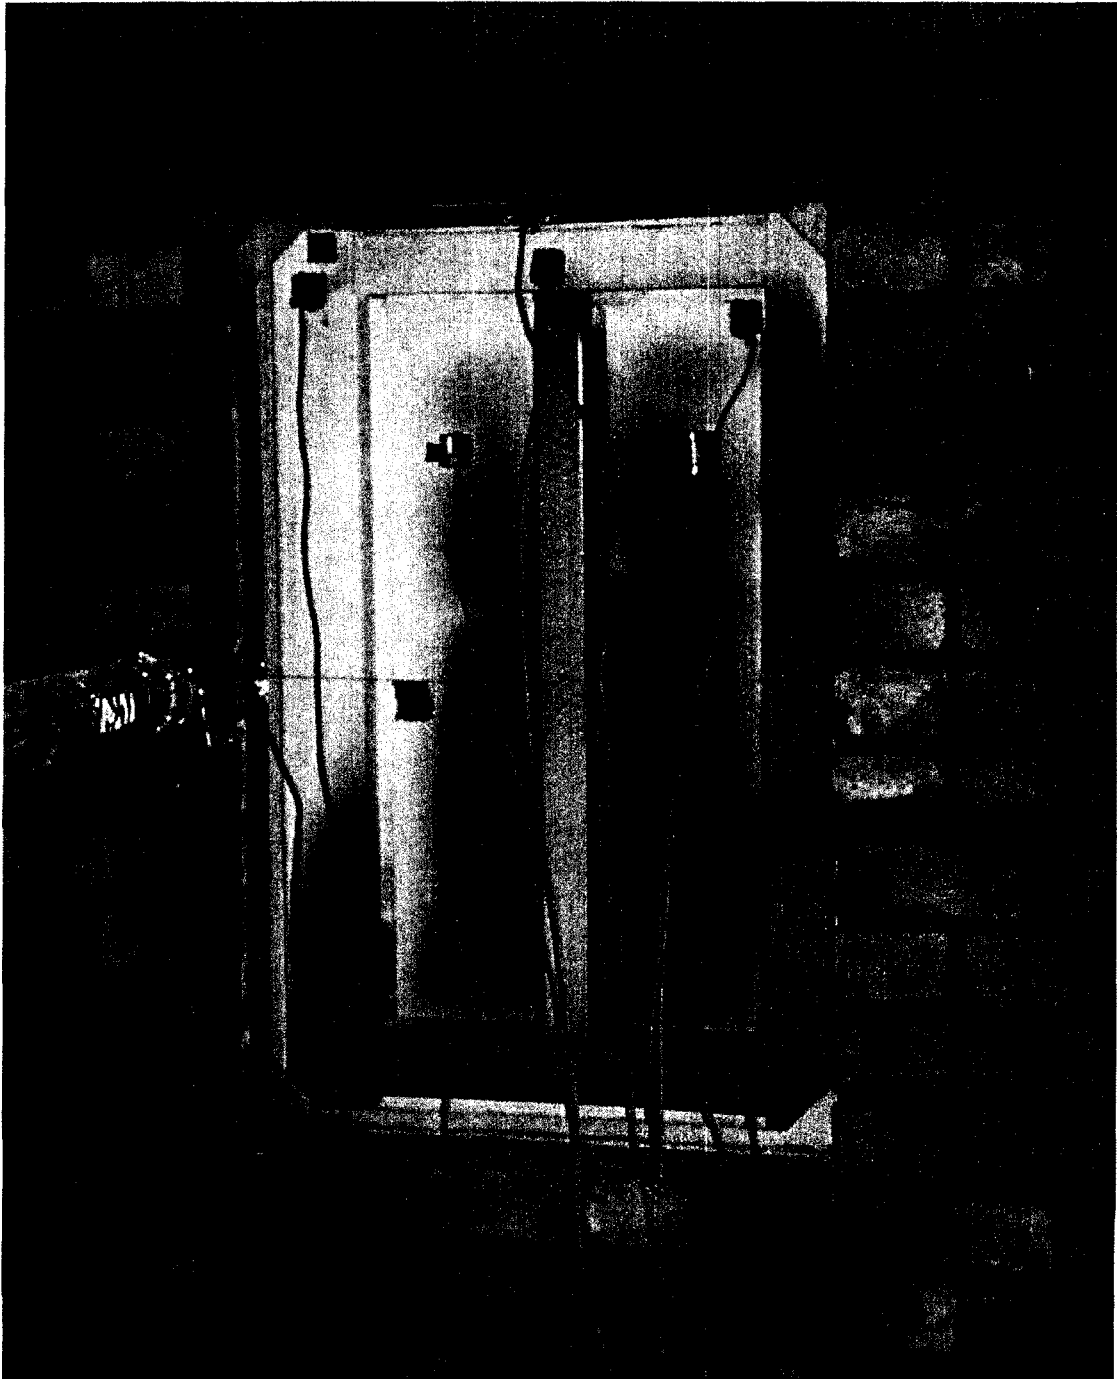
Photo 4 Unexposed face of specimen at termination of test (132 minutes).

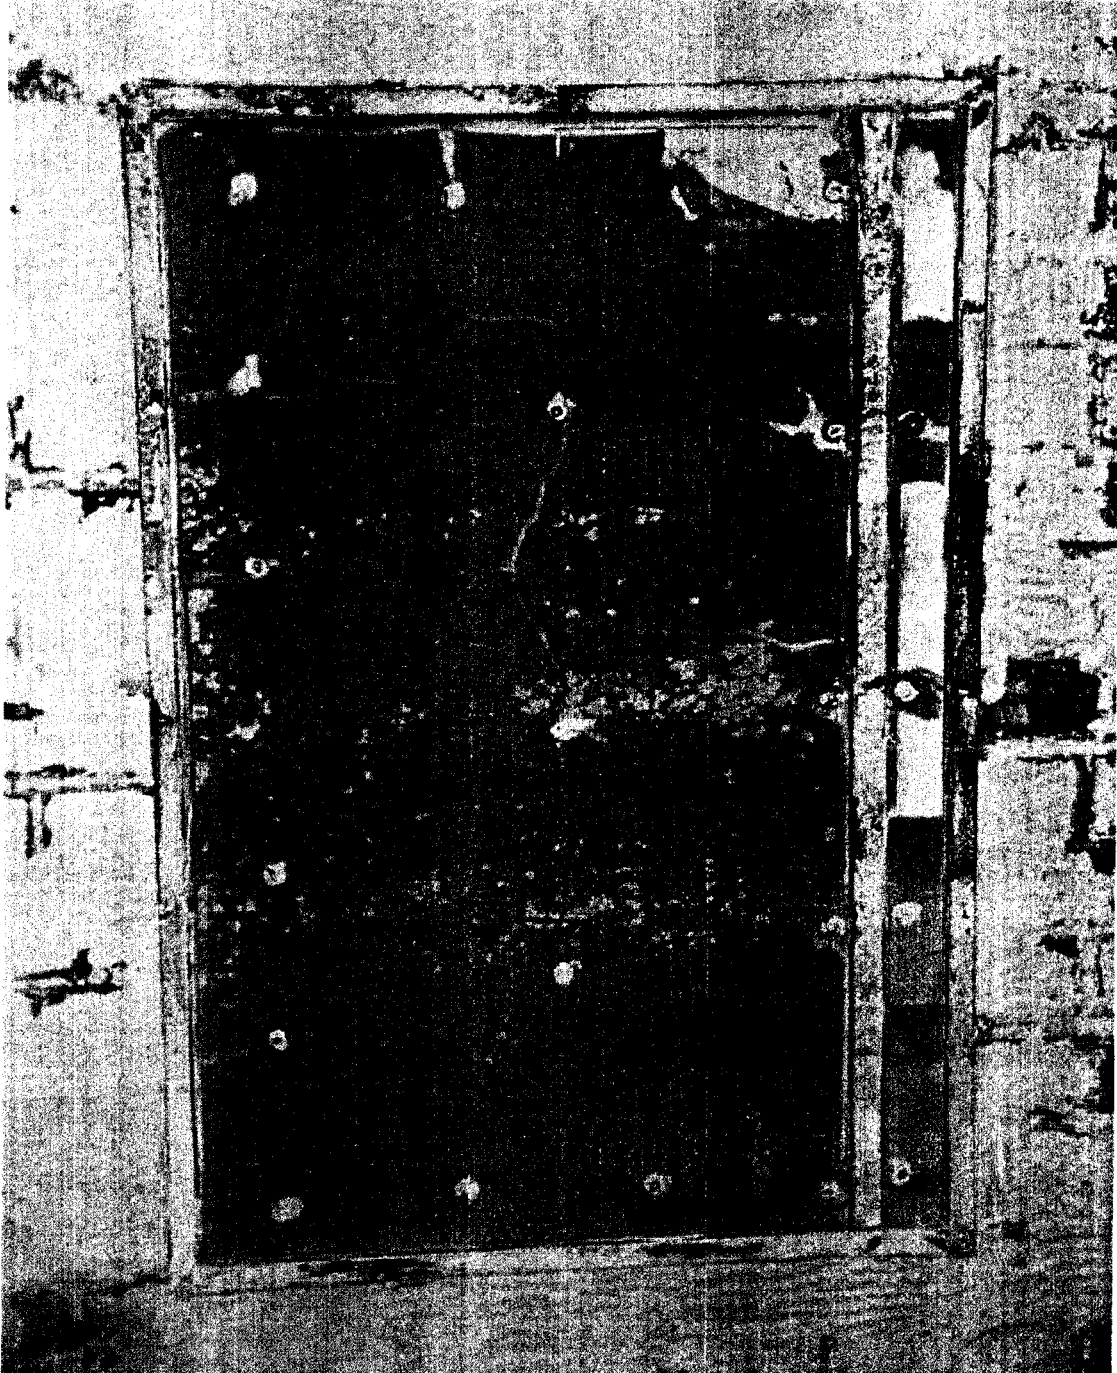
Photo 5 Exposed face of specimen after test.
