Fire resistance test in accordance with B.S. 476 : Part 22 : 1987 on a plasterboard ceiling membrane incorporating two Fire Proofing Services Ltd. single-leaf access panels.

Test report number 254906

Fire resistance test on two Fire Proofing Services Ltd. access panels in a plasterboard ceiling membrane.

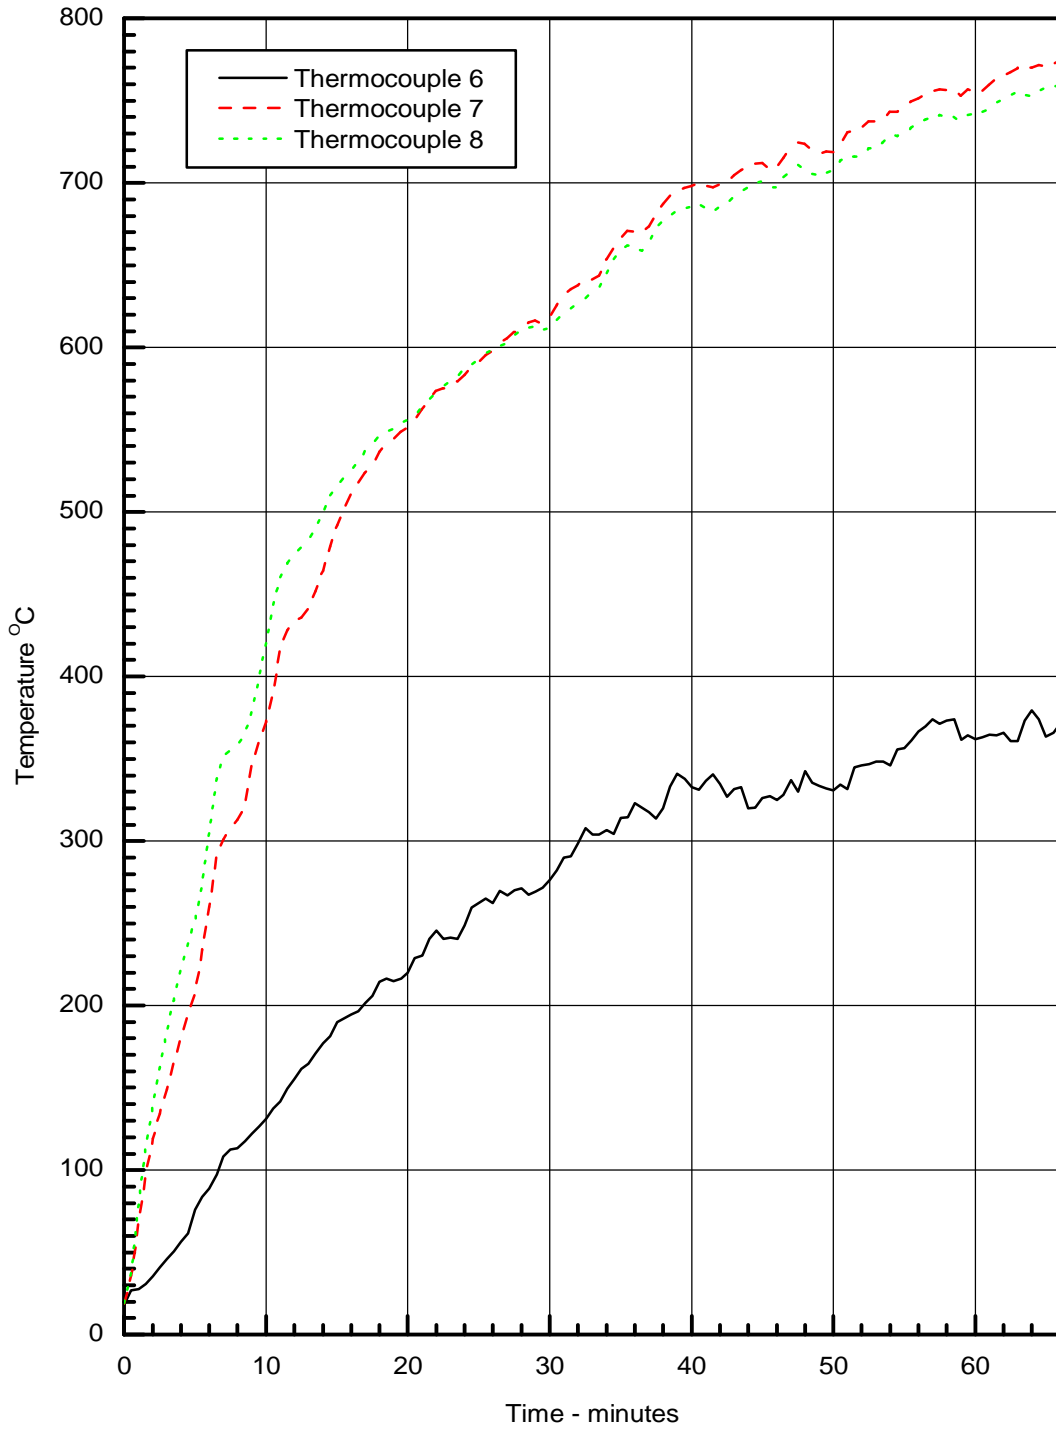
Individual temperatures recorded on the MTFD access panel.

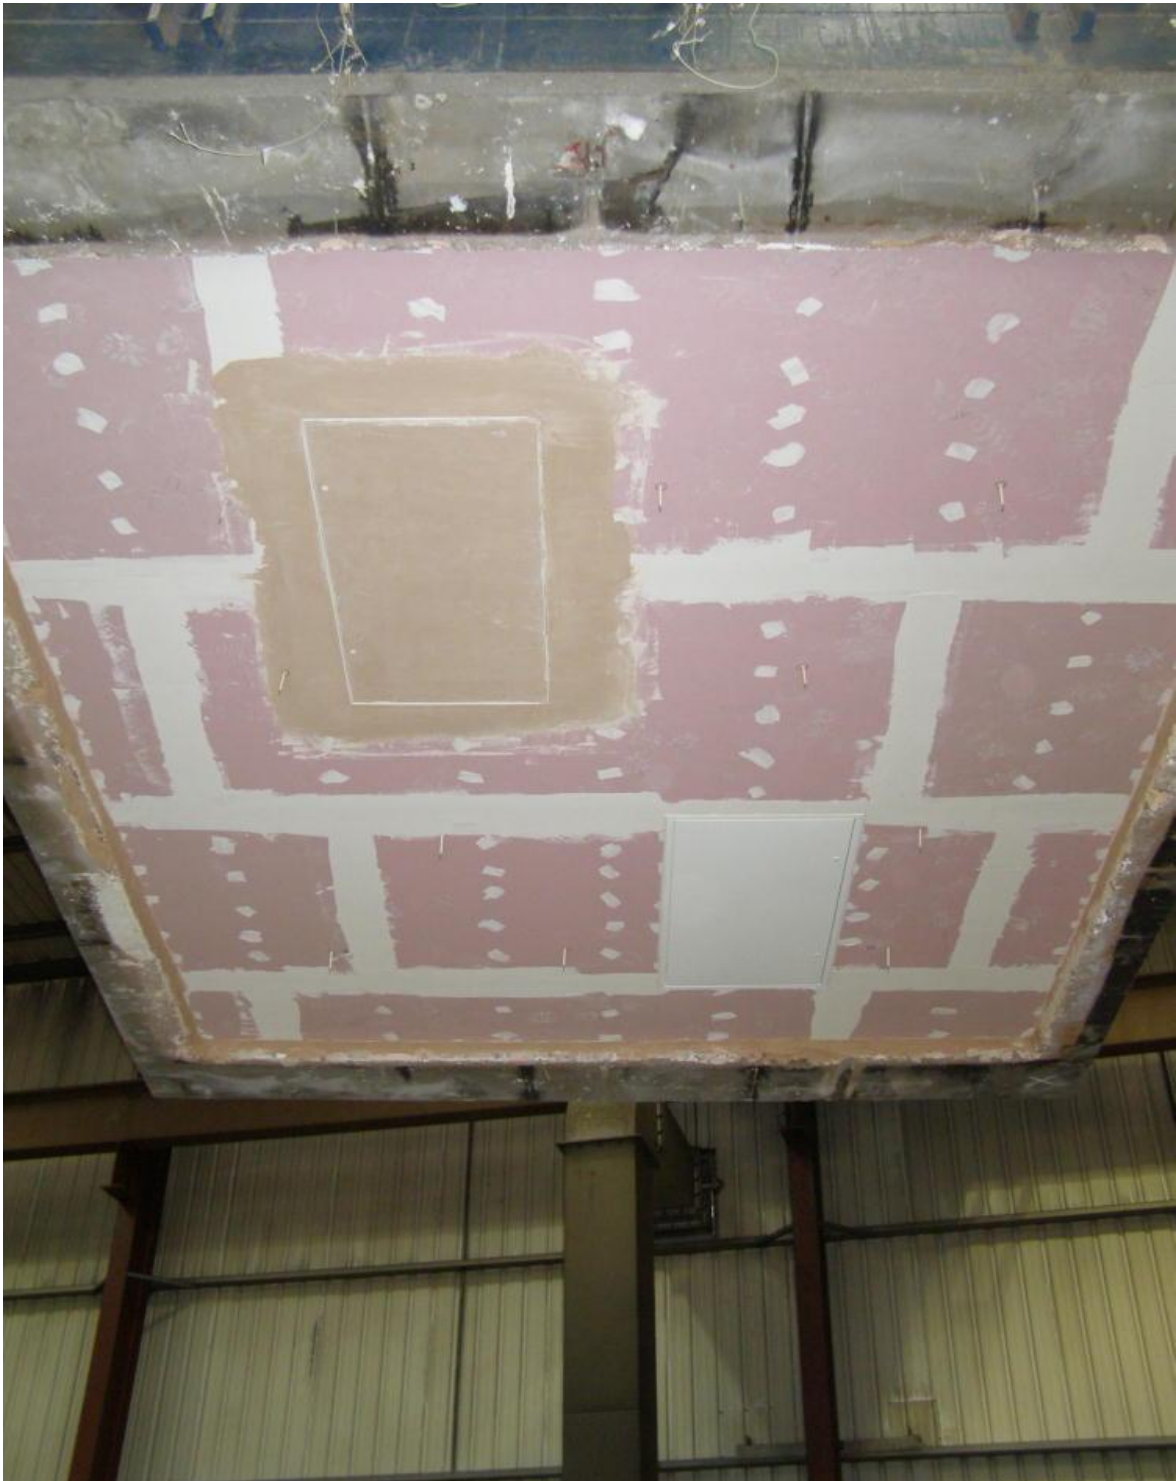
Exposed face of ceiling before test.

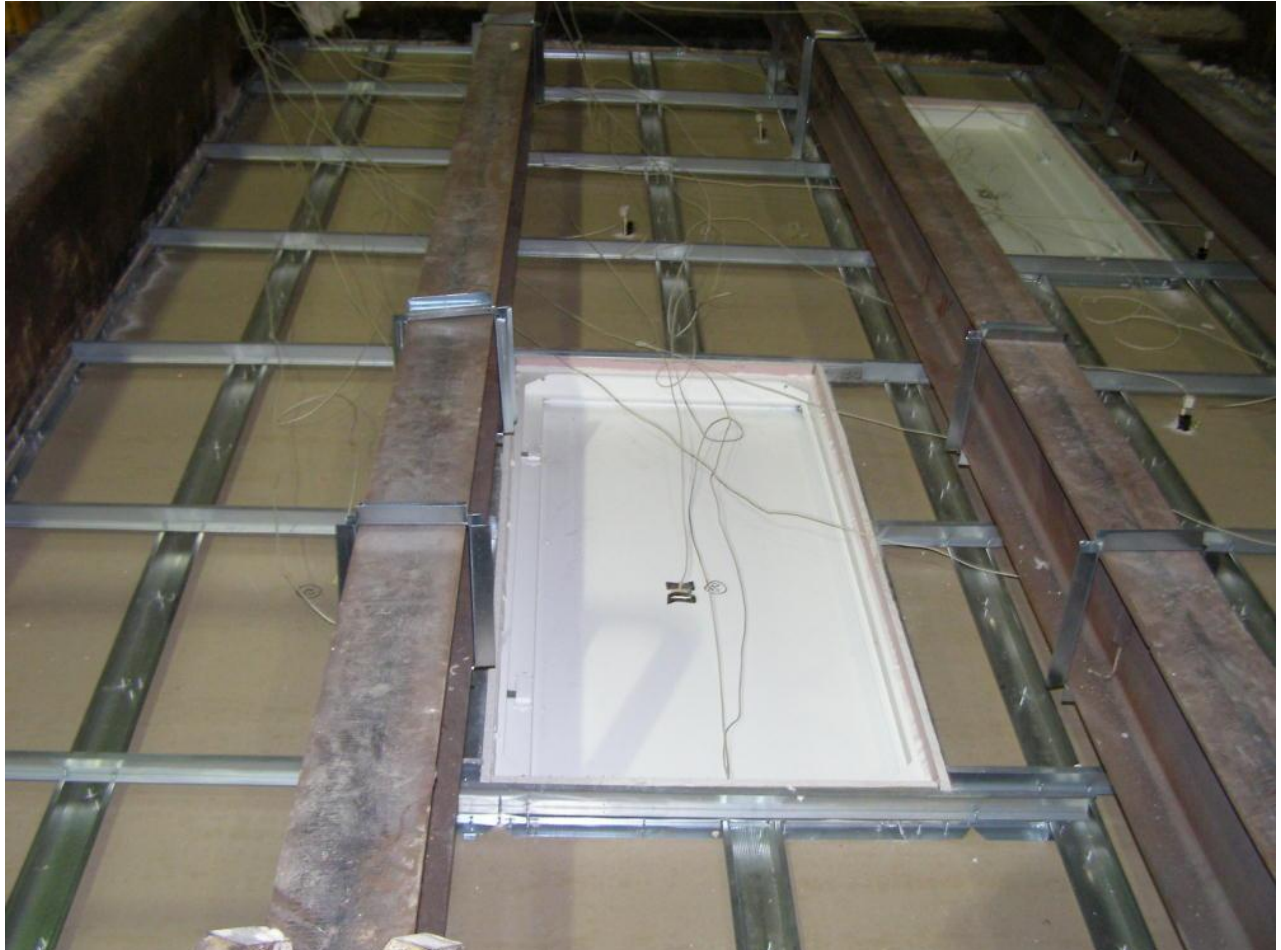
Unexposed face of ceiling showing MTFB access panel before test.

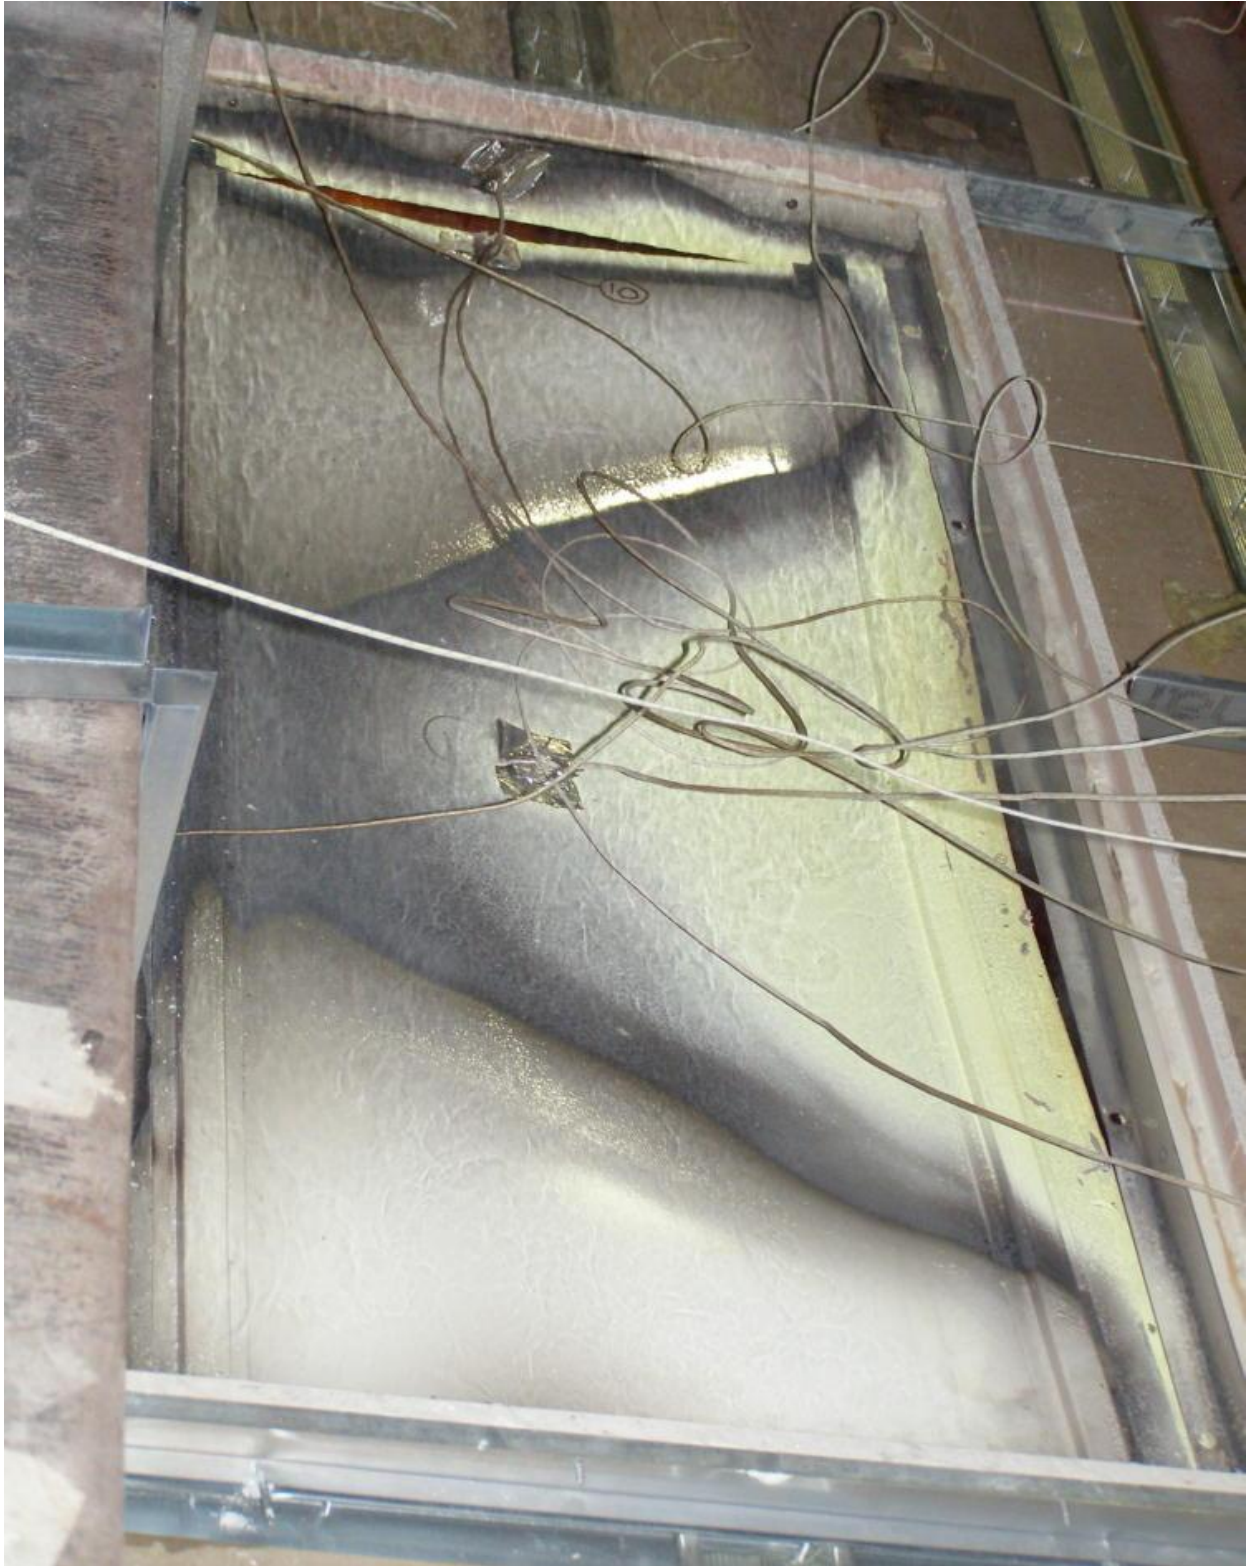
Unexposed face of ceiling showing PFBF access panel after 30 minutes.

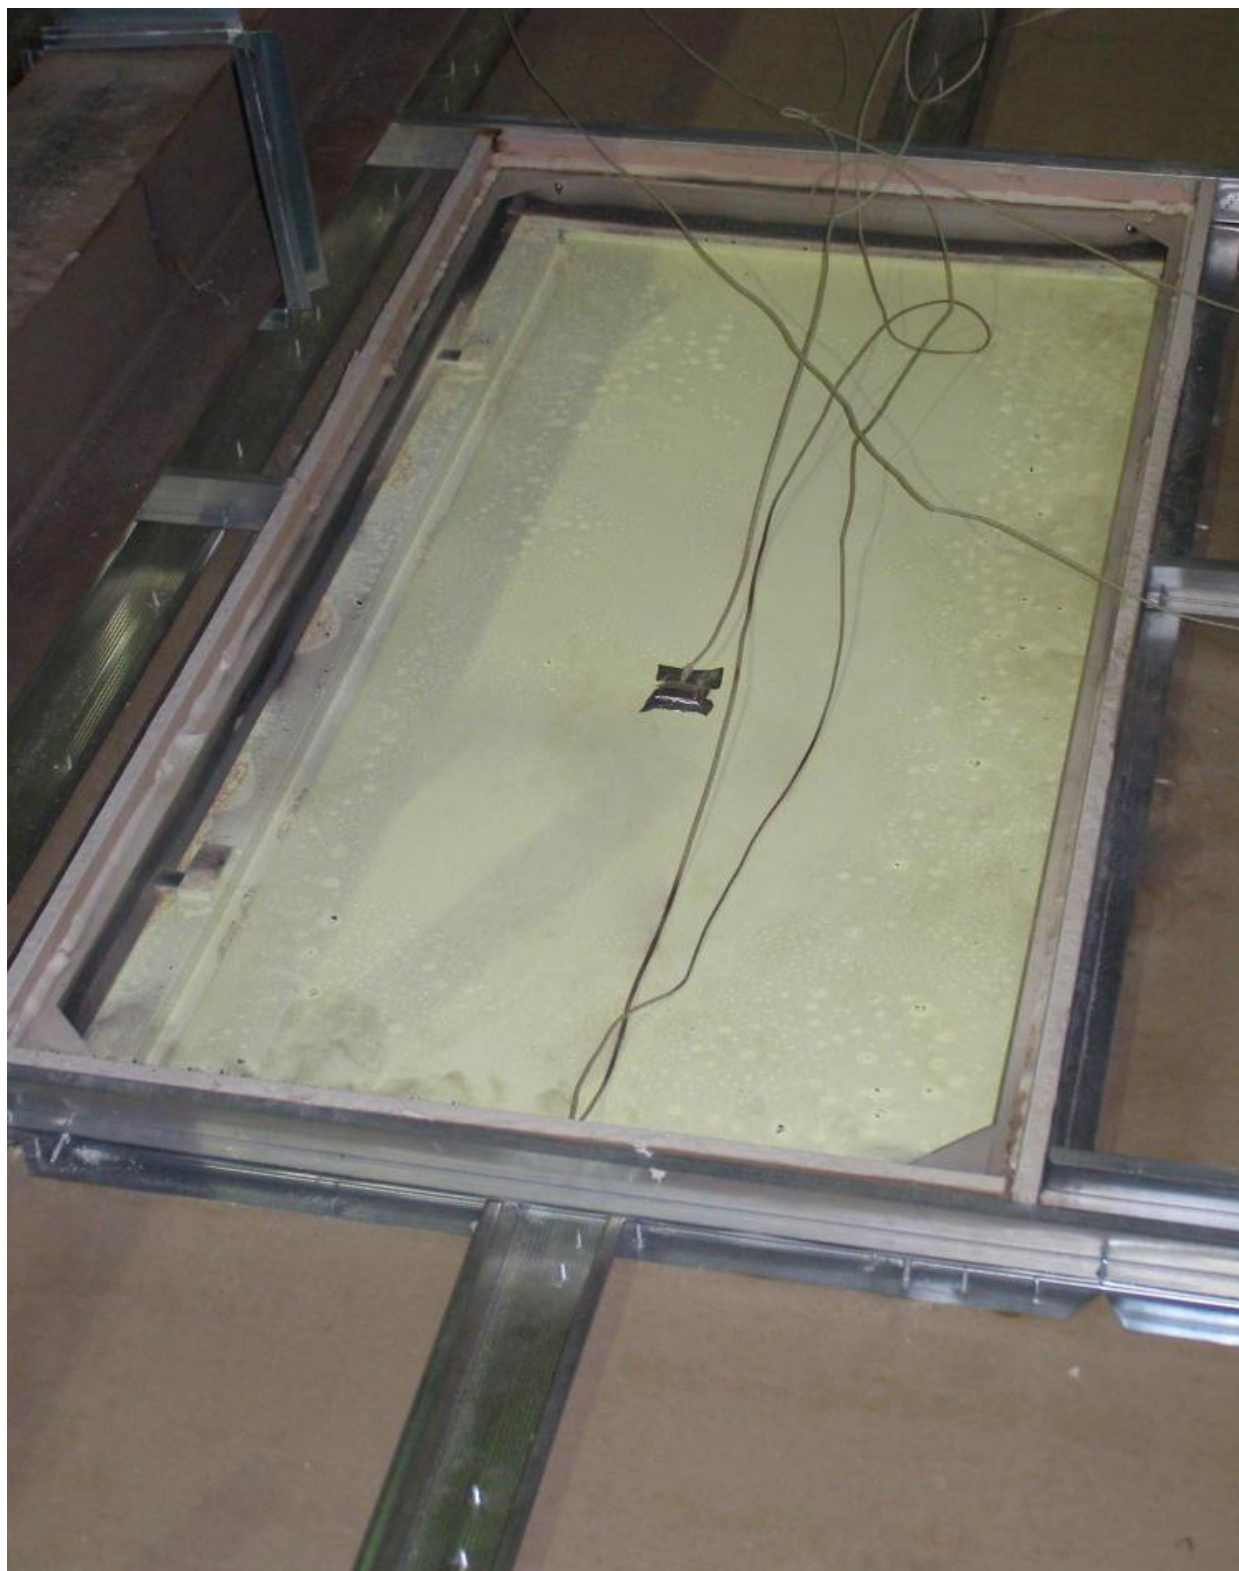
Unexposed face of ceiling showing MTFD access panel after 30 minutes.

Time minutes	Observation
0	Start test.
4 ½	Some smoke is coming from access panel MTFD. No smoke from panel Pbfd
6	Considerable smoke from access panel MTFD. Most of the smoke is coming from the access panel leaf / frame interface on the latch side.
10	The surface of access panel leaf MTFD is darkening to a black colour and some blistering of the surface is occurring.
11	Slight smoke form the latch areas of access panel Pbfd
13	Failure of integrity of access panel Pbfd using the 6mm gap gauge. The leaf has sagged, resulting in a gap between the leaf and frame at the top of the leaf.
15	The gap referred to at 13 minutes is now in excess of 25mm.
19	The surface of access panel leaf MTFD is now turning yellow in colour.
30	There are no gaps forming in any location on access panel MTFD.
35	On the exposed face, gaps at the joints between sheets of plasterboard on the exposed face layer have formed and are up to approximately 10mm. All boards are still in position.

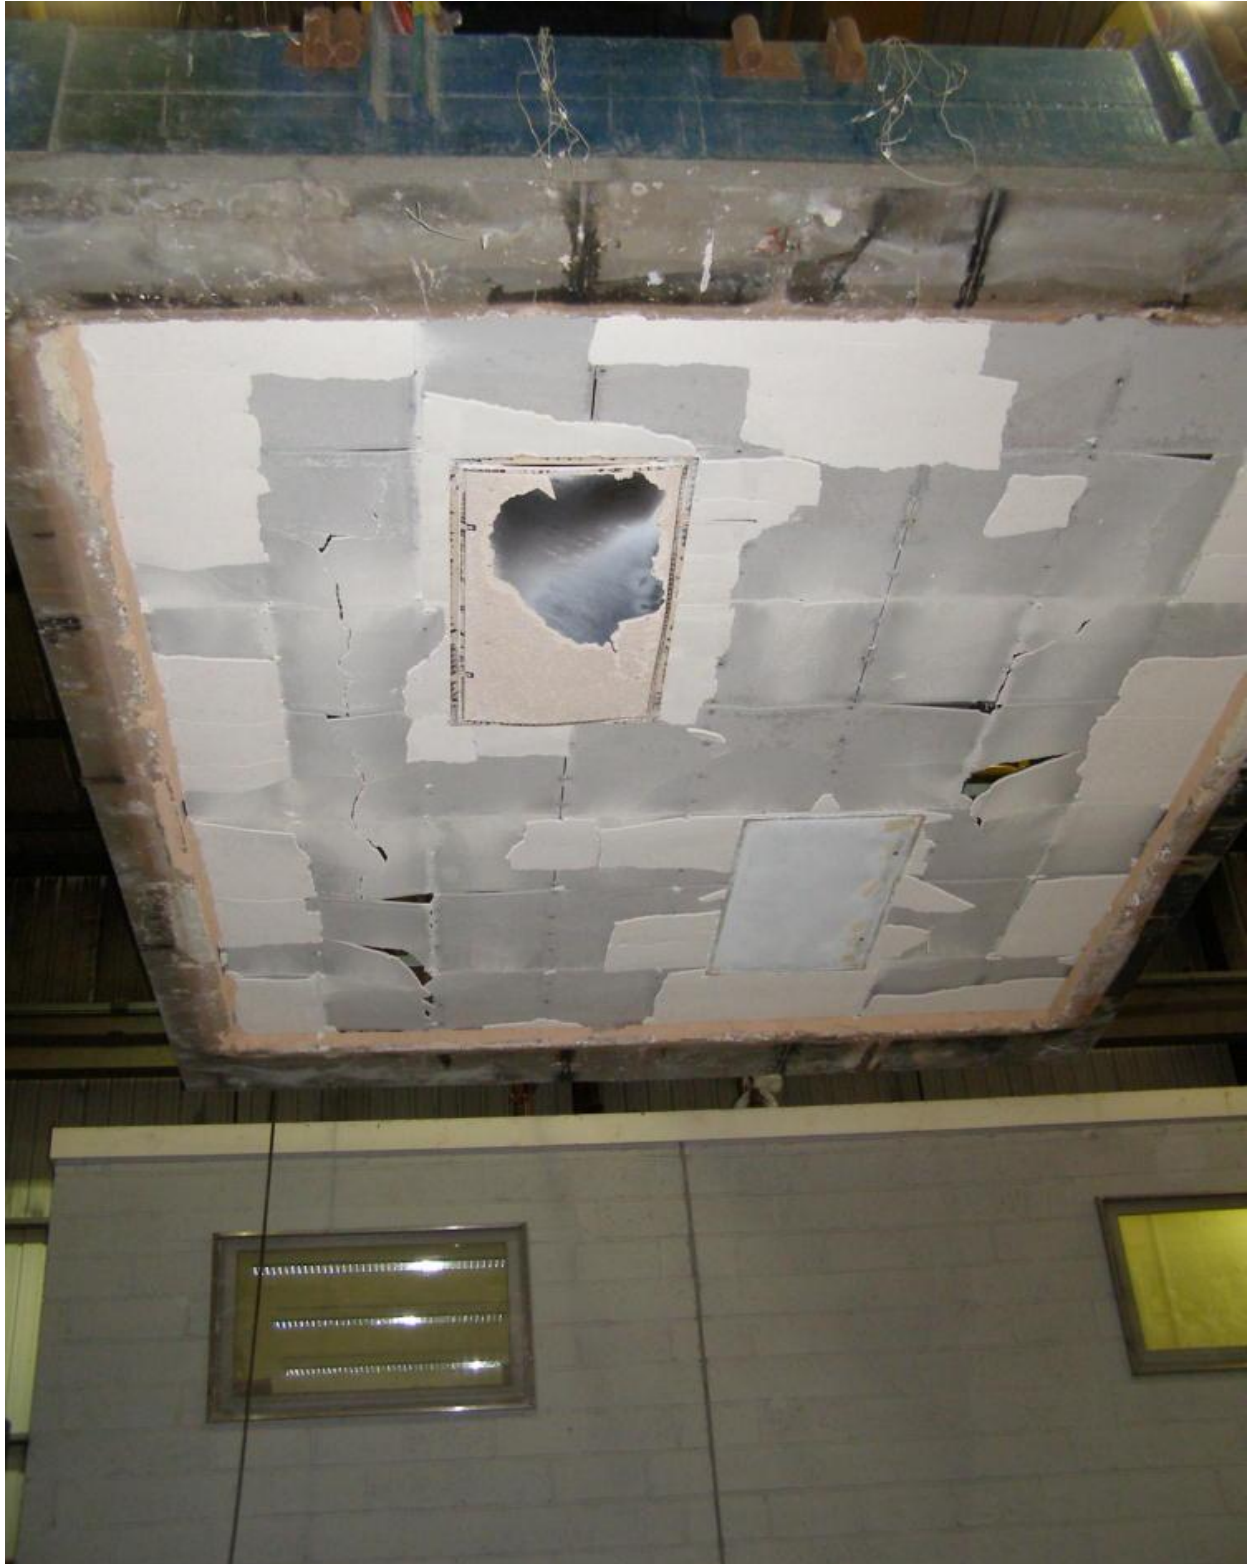
Exposed face of specimen after test.
