#### **REPORT TEST**

Fire resistance test in accordance with B.S. 476: Part 22: 1987 on a plasterboard ceiling membrane incorporating a Fire Proofing Services Ltd. access panel.

Fire Proofing Services Ltd., 13 Shilton Road, Barwell, Leicestershire, LE9 8NB.

18 October 2000

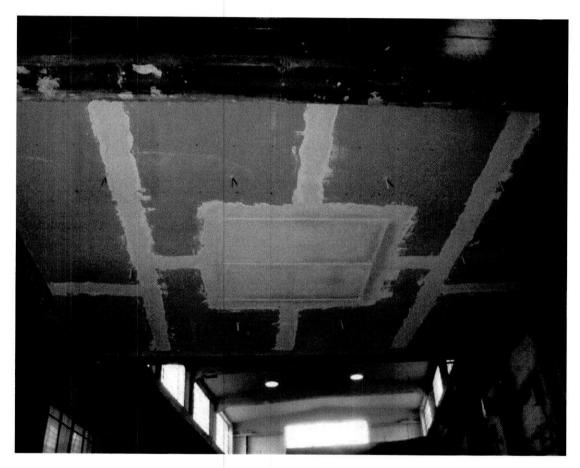
Plate 1 Exposed face of specimen before test showing furnace thermocouple locations

The construction is shown in Figures 1 to 4, and in Plates 1 to 4 before the test.

The furnace temperature was measured using ten bare-wire chromel/alumel thermocouples arranged in the furnace as shown in Plate 1, with their measuring junctions 100mm below the exposed face of the ceiling. The furnace was controlled so that the mean of these thermocouple readings followed the time/temperature relationship of B.S. 476: Part 20: 1987<sup>2</sup>. The mean temperature is plotted against time in Figure 5 with the specified curve for comparison.

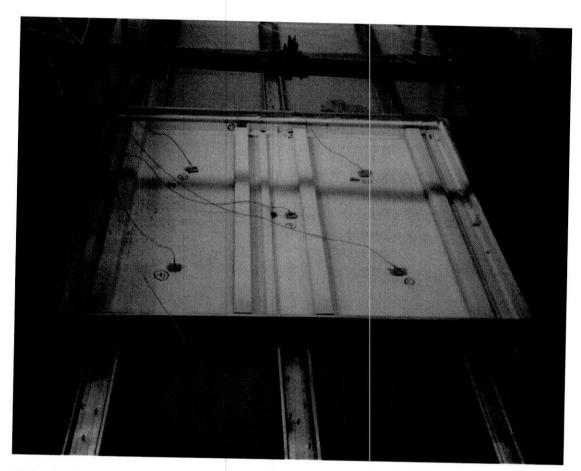
Plate 4 Unexposed face of access door before test
