Test Report :

Fire Resistance test in
accordance with B.S.476 : Part
22 : 1987 on two access panels
installed in a block wall

Test report number FG7586

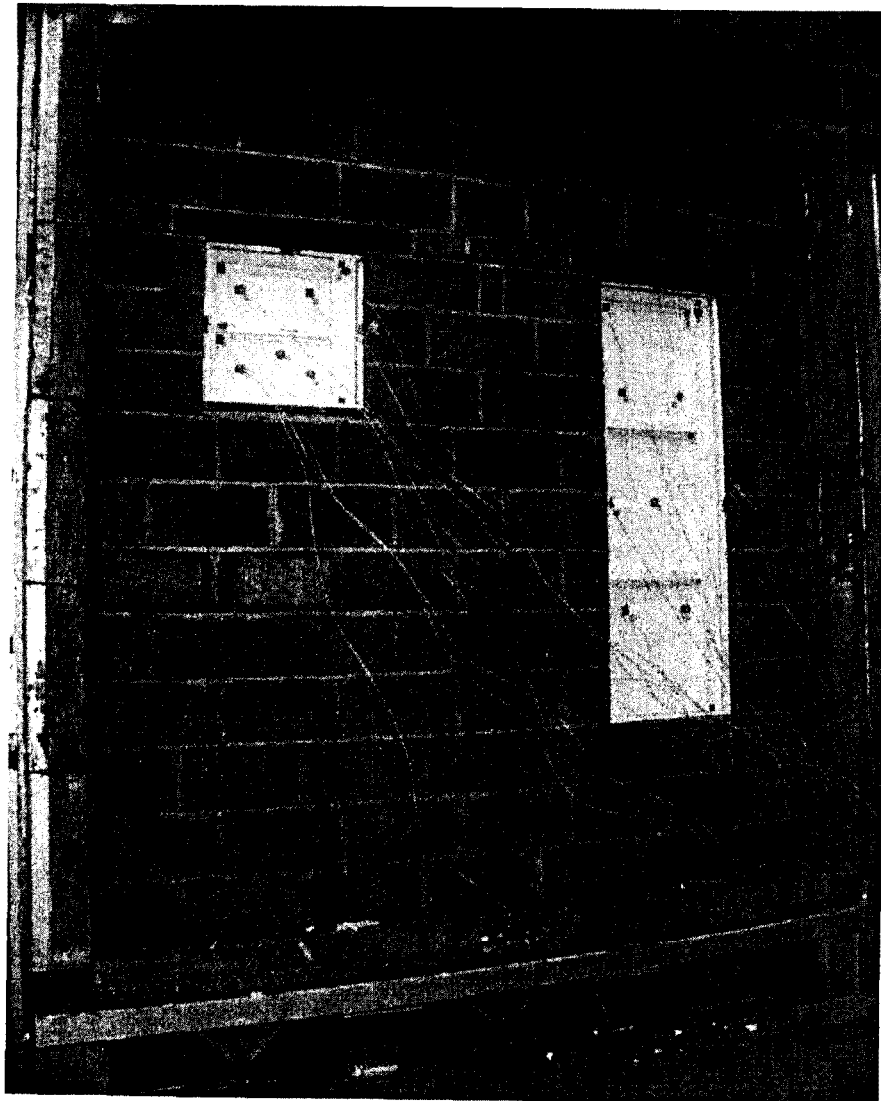
Plate 1 Unexposed face of access panels before test.

Full details of the specimen construction are shown in Figures 1 to 7 and the completed construction is shown before the test in Plates 1 and 2.
